GFA AIRWORTHINESS DIRECTIVE

- SUBJECT:** Flight controls:- Welded components inspection / replacement.
- BACKGROUND:** GROB has received isolated defect reports regarding cracks in welded components of the flight control system of the above G-102 models. The cracks progress slowly from the edges of the weld seams and may eventually result in component failure. So far no complete failures have occurred.

SERVICE BULLETIN MSB 306-35

ATA - Code: 27-00 Flight Controls

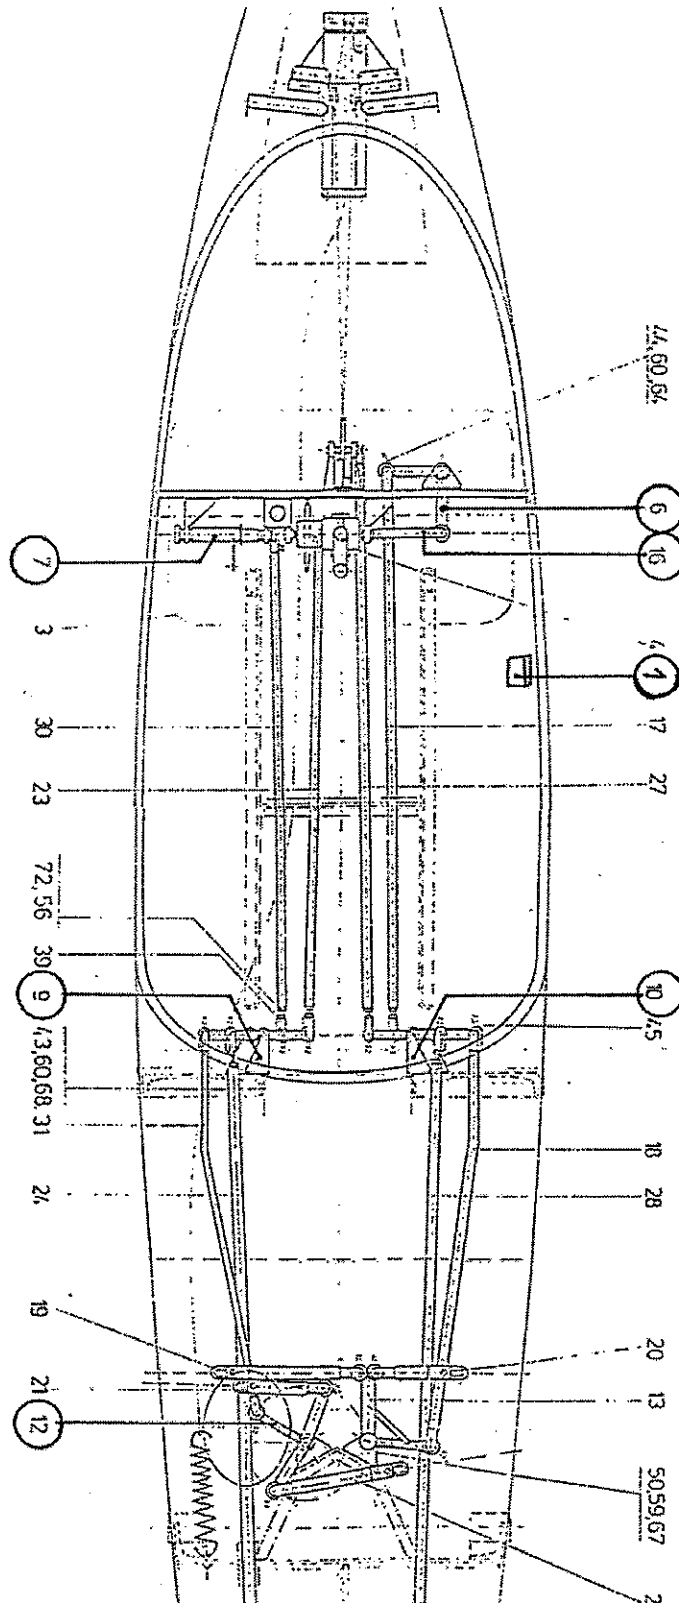
MSB 306-35
Page 5 of 5
27. April 2007

1.8.1 a) Welded parts of the flight control system (as listed below) shall be inspected for development of cracks or permanent distortion. (# numbers, refer to drawing page 5):

| - Aileron lever I | 102C3-4225 | (# 6) |
| - Aileron rod I | 102C3-4351 | (# 16) |
| - Air brake-trim-unit | 102C3-4230 | (# 7) |
| - Bell crank | 102C3-4261/ 4262 | (# 9, 10) |
| - Air brake lever III | 102C3-4266 | (# 12) |
| - Undercarriage lever | 102S3-5214 | (only G 102 STANDARD III) (# 1) |

d) In case cracks or permanent deformations are observed during inspection, the affected welded part shall be replaced with a new part before the next flight.

Caution: Repair of cracked or deformed flight control elements is not approved.
