GFA AIRWORTHINESS DIRECTIVE

SUBJECT: Flight controls:- Failure of elevator bellcrank bearing attachment bolt.

GFA AD-648	ISSUE: 1	26 June 2007	Page 2 of 7
------------	----------	--------------	-------------

Technical Note
No. 348/19, 843/26

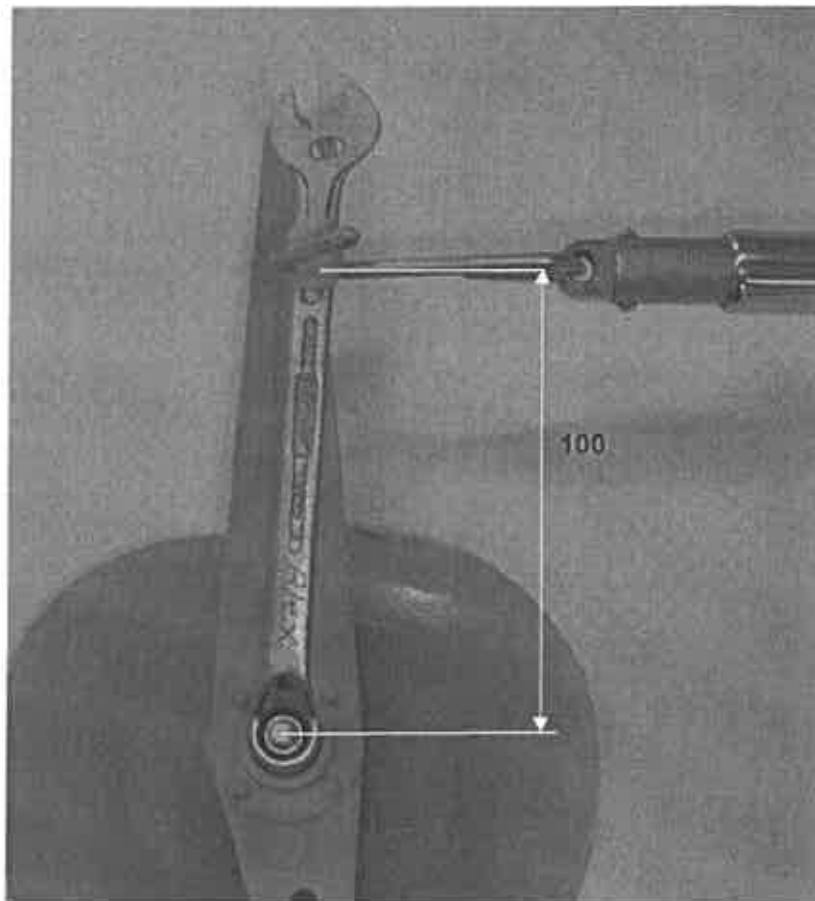
Check of the actual torque of the nut which fixes the bellcrank 5St19 to the bolt of the bearing stand

4. If no torque wrench is available which can be adjusted to a torque of 3 Nm the check may be executed with a 10mm spanner according to the photo below,
Fix a spring balance measuring range 50N (5kg, 10 lbs.) or 100 N (10 kg, 200 lbs.) at a distance of 100mm (4 in.) from the centre of the nut to the spanner e.g. with tape.
Retorque the nut with a force of 30 N (3 kg, 6 lbs.).
If retorquing was possible the actual torque was too low and instruction 2 of TN359/19 (replacing the bolt) must be executed prior to the next flight.
5. If the nut had still a torque of 3 Nm or higher and if you don't want to replace the bolt immediately retorque the nut with a torque wrench adjusted to a value of 12 Nm(9 ft. lb.)
6. Execute a control check.
7. Reinstall the baggage compartment floor and back cover plate.

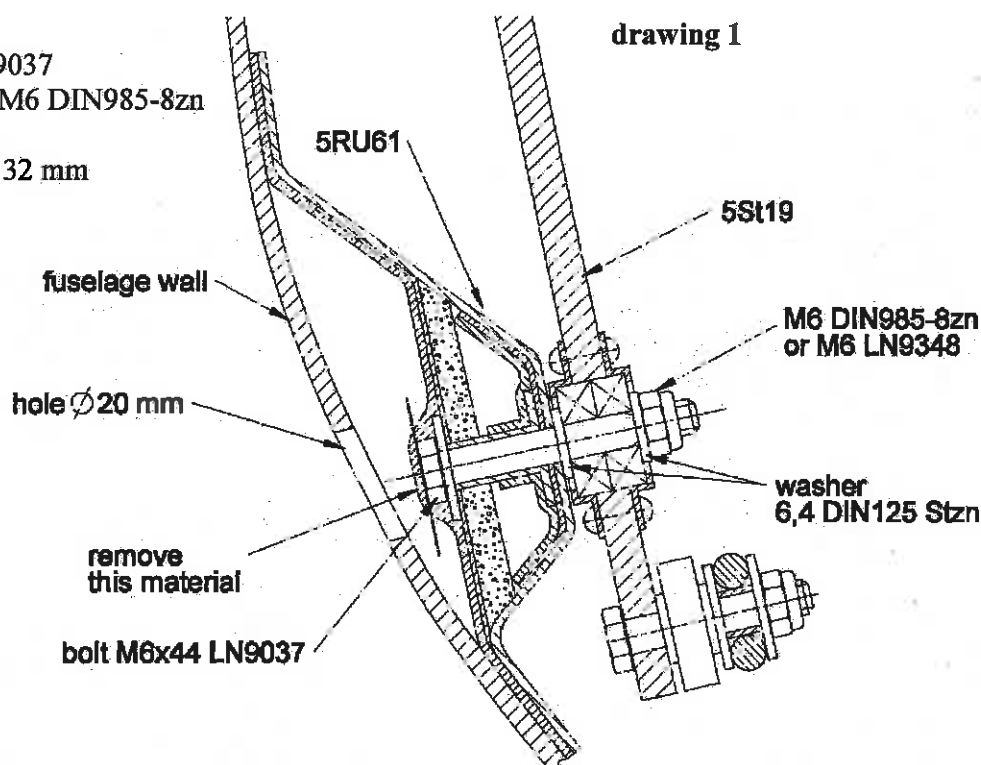
Replacing the bolt of bearing stand 5RU61

4. Drill a 6mm (1/4 in.) hole in the centre of the marking according to drawing 1. Enlarge this hole with a 10 mm (3/8 in.) drill. Then enlarge it to a dia. of max. 20 mm (6/8 in.) with a 6mm (1/4 in.) hard metal cutter. Shift the centre of the hole to the centre of the bolt head while enlarging the hole.
