## GFA AIRWORTHINESS DIRECTIVE

**TYPE AFFECTED:** STEMME S-10VT. All serial no's where Fuel pressure sensor type 11AB-K01 is installed.

**SUBJECT:** Differential fuel pressure Sensor: Inspection / Replacement.

<b>STEMME</b> F & D DO: EASA.21J.250	<b>Service Bulletin</b>		Document Number: <b>A31-10-081</b>
	<b>Differential fuel pressure sensor – S10-VT</b>		Am.-Index: 01.a
			Page: 3 of 9

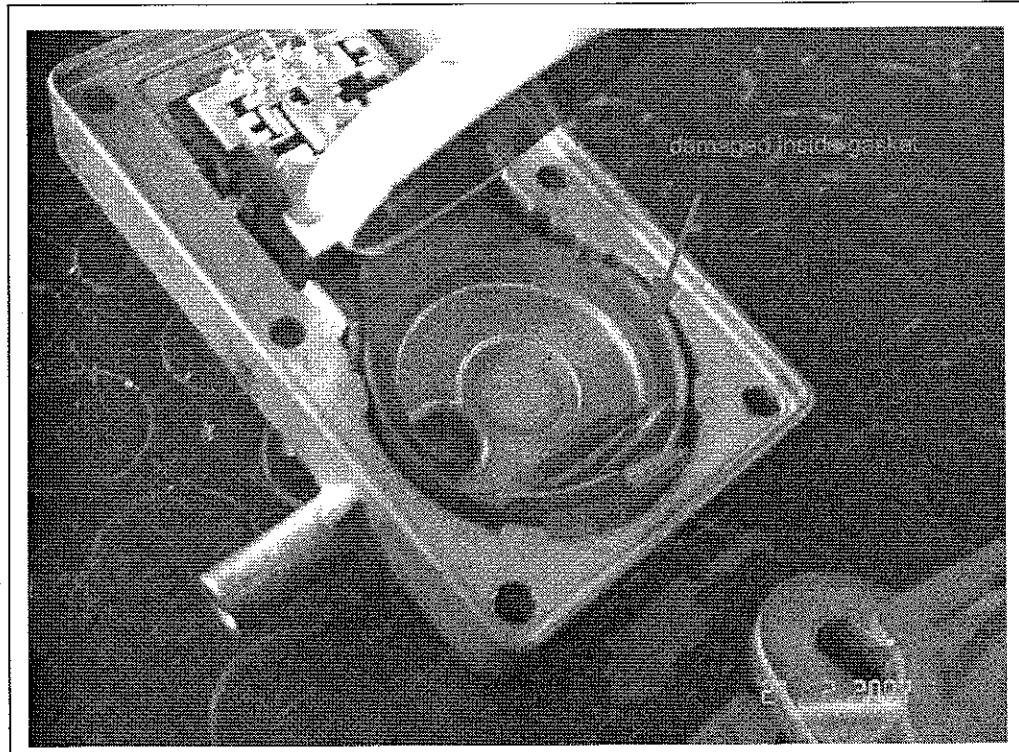
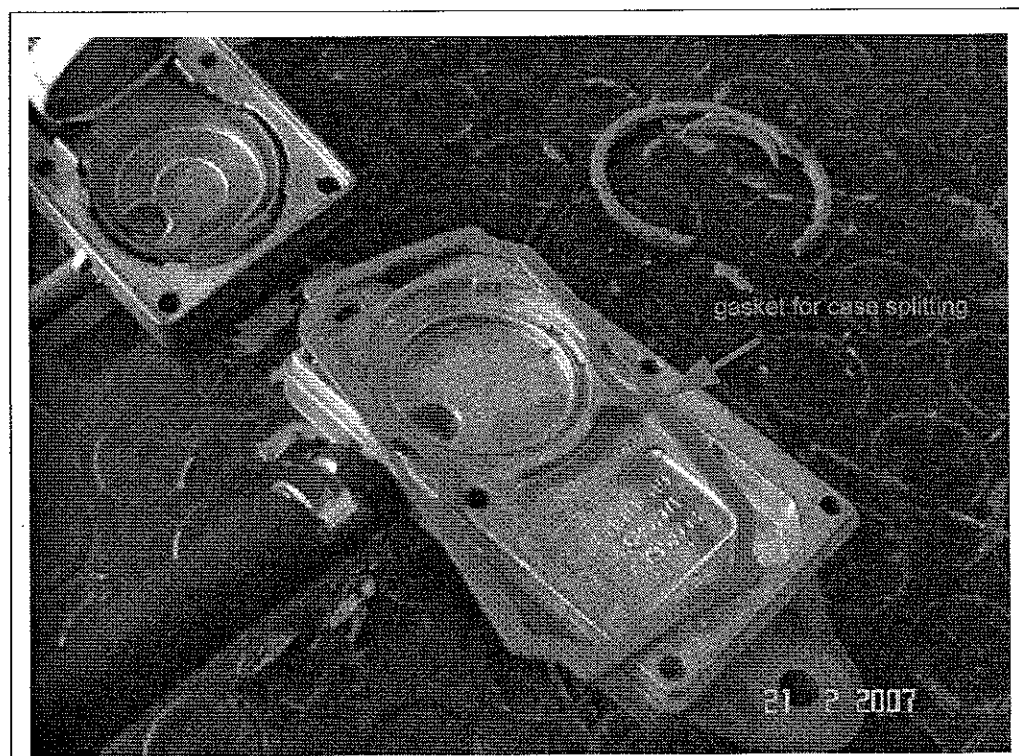
Actual Damages

As an result of a fault report of a operator of a Stemme S10-VT a investigation of this sensor was performed. The fault report describe a fuel leak through the air pressure line into the airbox. The fuel escape out via the drainage tubes.

After investigation of this differential fuel pressure sensor 11AB-K01 the possibility of a leak to the engine compartment can not be excluded.

A mandatory replacement of the old differential fuel pressure sensor 11AB-K01 will be introduced with this Service Bulletin.

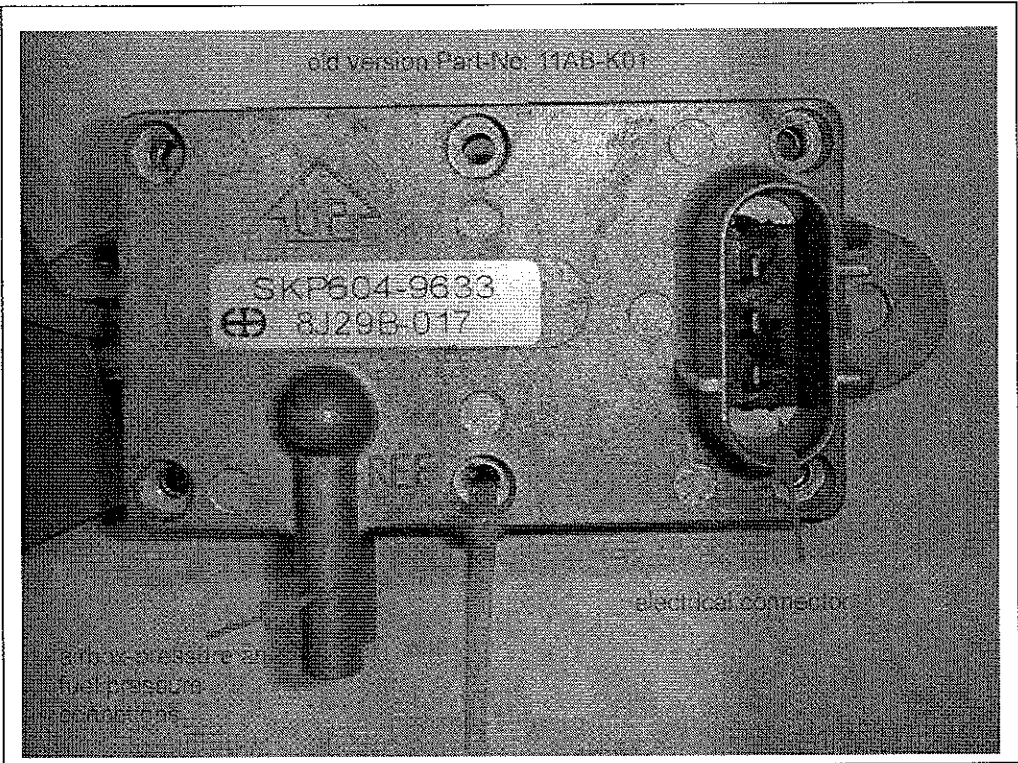
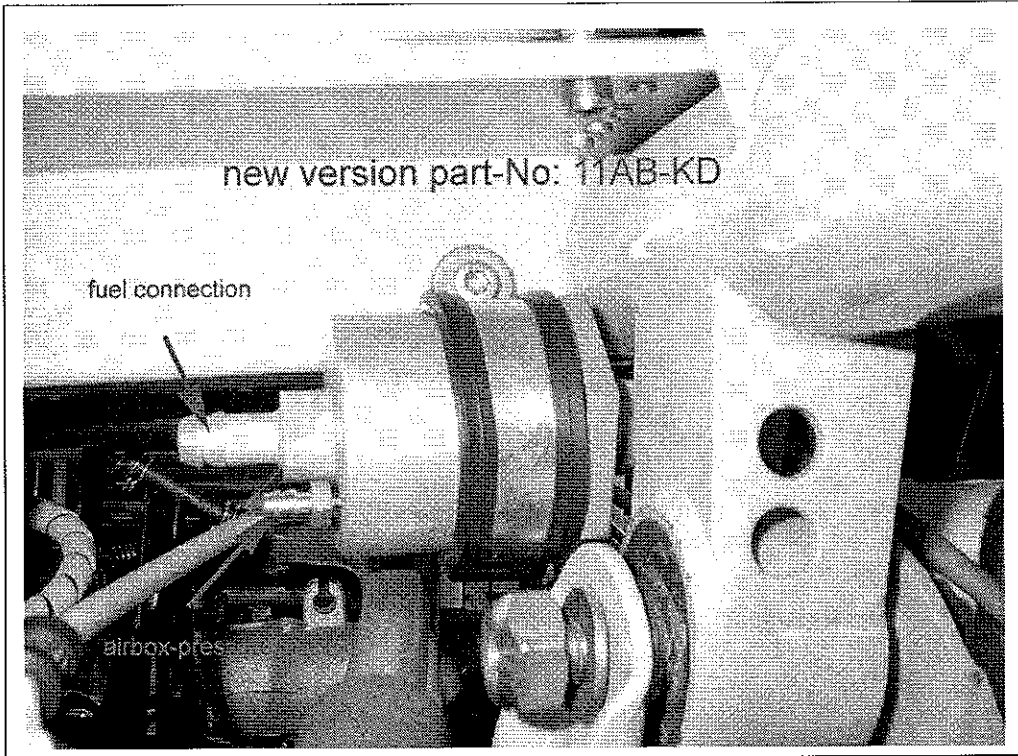
Lineup for identification

- Identification of the installed differential fuel pressure sensor
  - **old version** differential fuel pressure sensor 11AB-K01 **more actions are necessary**
  - **new version** differential fuel pressure sensor 11AB-KD **no more action are necessary**

- Replacement of the differential fuel pressure sensor 11AB-K01 by the new version 11AB-KD
- removal of the additionally introduced Flight Manual page with reference to this SB
