GFA AIRWORTHINESS DIRECTIVE

- TYPE AFFECTED:** DG-100 Series sailplanes TCDS LBA 301
DG-200 Series sailplanes TCDS LBA 323
- APPLICABILITY:** DG-100 series and DG-200 series. All serial no's.

- SUBJECT:** Flight Controls, Control column Rod end inspection / Replacement
- REASON:** During a pre-flight inspection of a DG-100 sailplane the adjustable Rod End of the aileron pushrod was found broken at the control column end. Early DG aircraft were fitted with rod ends manufactured from a standard grade steel. This is to be replaced with one of high grade steel, identifiable by an "X" stamped on the shank.

Subject : Rod end in control column

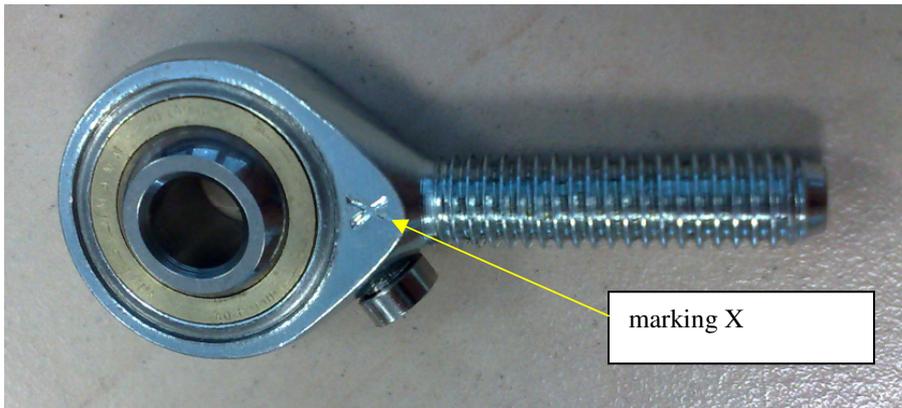
Reason : On one DG-100 during pre-flight inspection a broken rod end of the aileron control push rod in the control column was detected.
In the first years at Glaser-Dirks rod ends made from machining steel were used, later parts from high strength steel marked with an X (see photo) have been used.
All parts without an X have to be replaced by rod ends marked with an X

Instructions : 1. a. Remove the control column boot and check if the rod end is marked with an X. If the X is not visible from the top look with a mirror from the underside see photo 2.
If the rod end is not marked with an X and no damage or cracks are visible the glider may be operated with this rod end up to the execution of instruction 2.
b. If any damage was detected the rod end must be replaced prior to the next take-off.
2. Exchange the rod end against a new one marked with an X. Use a new self locking-nut.

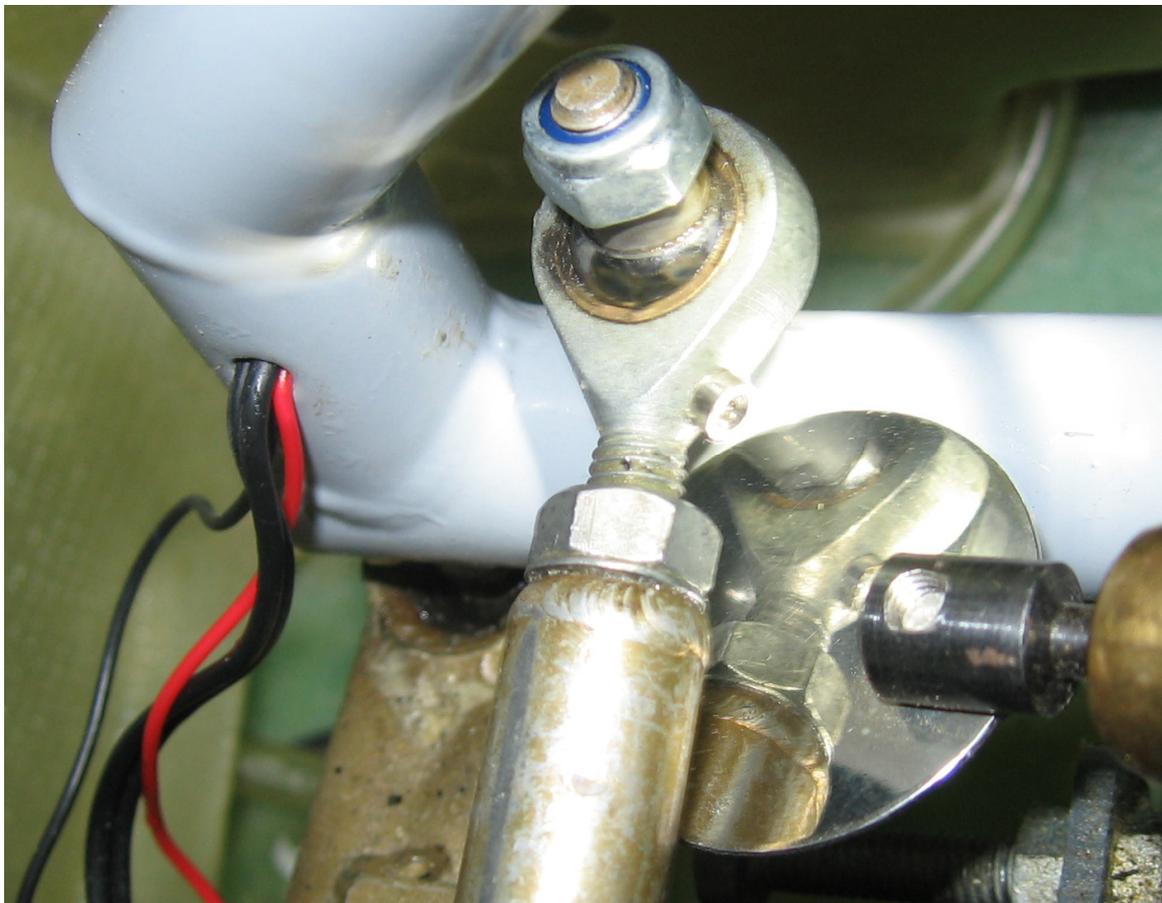
Inspection with a mirror, no X is existing, rod end must be replaced.
