AIRWORTHINESS DIRECTIVE

Grob G103 Twin II, Grob 103A Twin II Acro
Serial numbers 3501-3878 & 33879-34078

Inspection and reinforcement of welded parts of the
flight control system.

Service Bulletin
TM 315-37

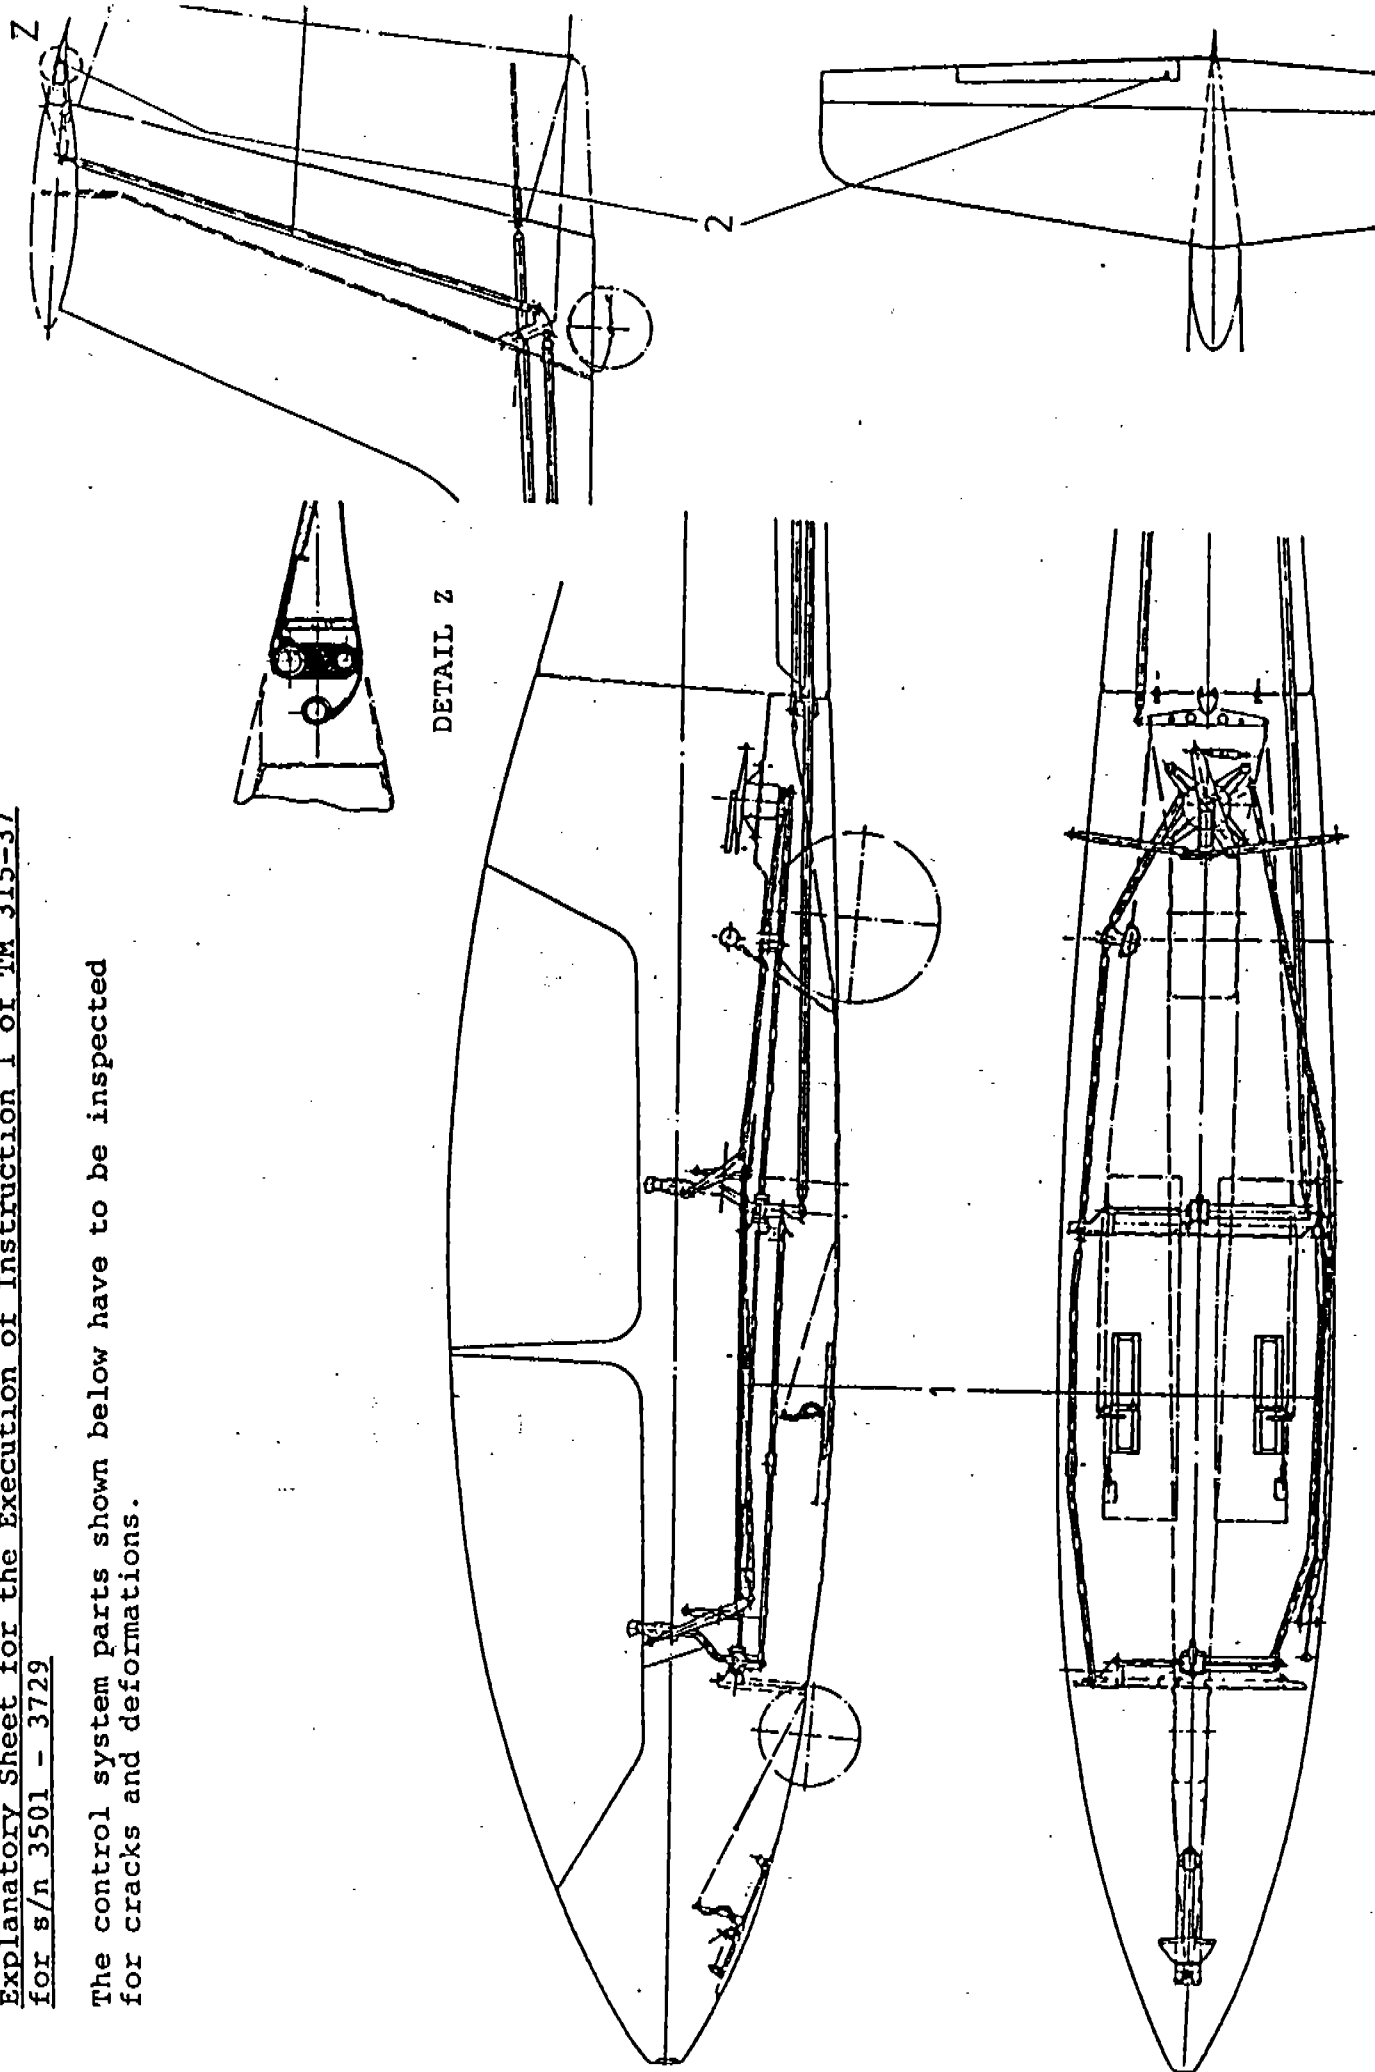
Explanatory Sheet for the Execution of Instruction 1 of TM 315-37
for s/n 3501 - 3729

- item 1 and 2	3501 - 3729
- item 10 through 24	3730 - 3878
- item 10 through 20 and 22 through 24	33879 - 34078

The control system parts shown below have to be inspected for cracks and deformations.

- 1.1 The control system parts concerned are visually inspected for any signs of cracks.
- 1.2 If there are no damages, instruction 1 does not have to be repeated until the reinforcement of the control system parts according to instruction 2.
- 1.3 In case of any damages, instruction 2 has to be carried out prior to the next take-off.

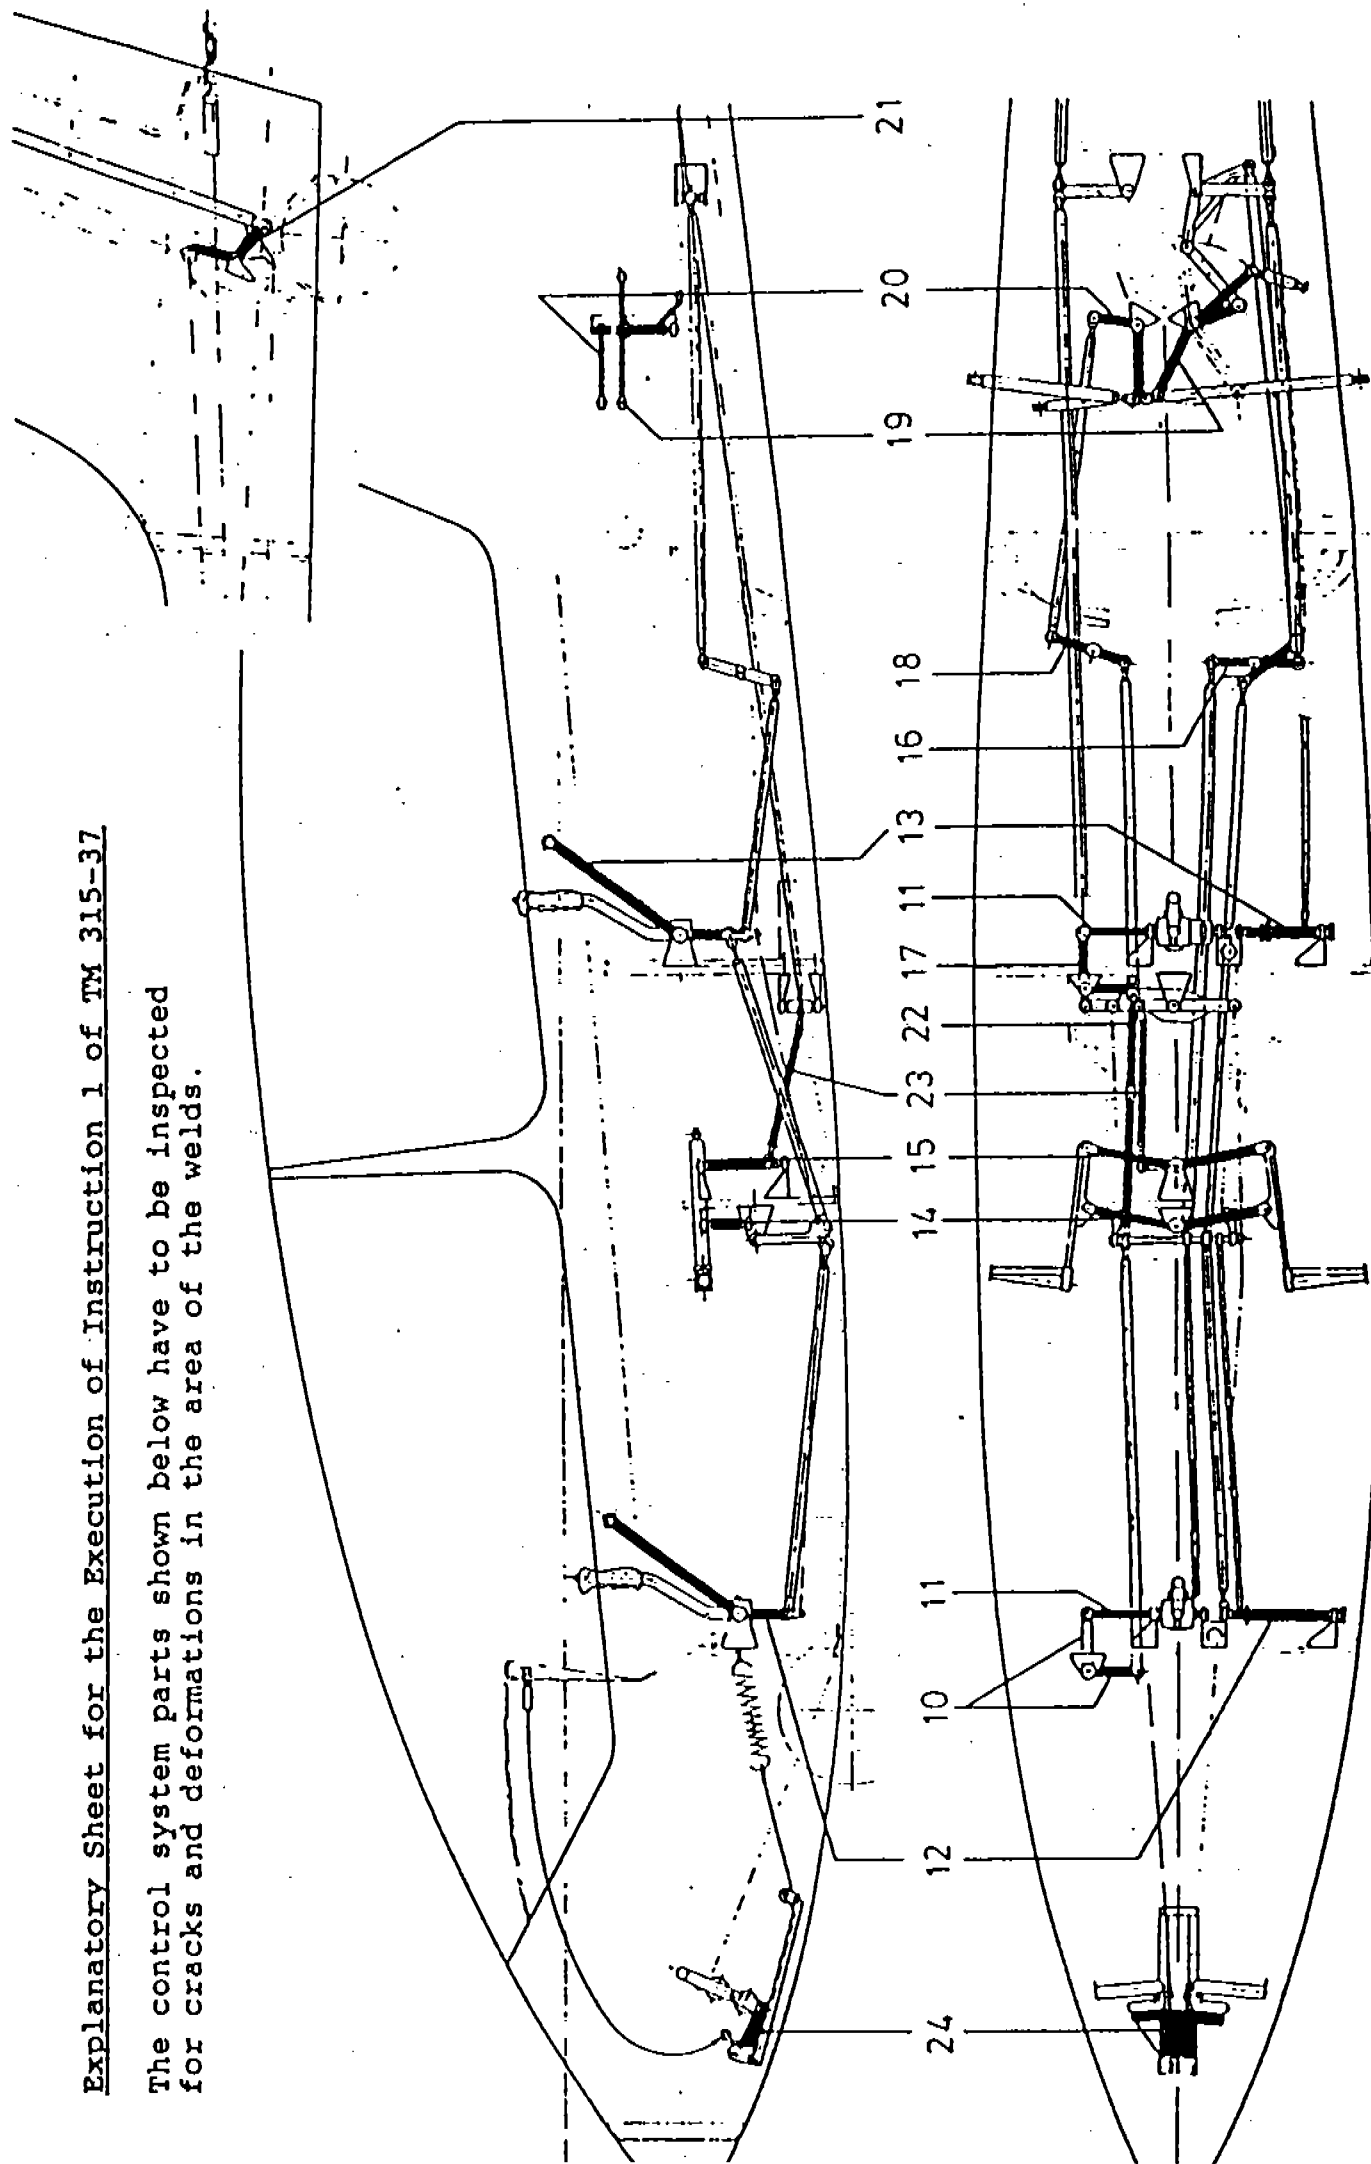
Explanatory Sheet for the Execution of Instruction 1 of TM 315-37

First, cracks appear in the area of the welds which may lead to a failure in an advanced stage. Therefore, all endangered control system parts will be reinforced through additional gussets as a precaution.

The control system parts shown below have to be inspected for cracks and deformations in the area of the welds.

The control system parts have to be reinforced according to the repair instructions to TM 315-37 by 31 March 1989.
