## AIRWORTHINESS ADVICE NOTICE

TYPE AFFECTED: LS 4  
LS 4-a  
LS 4-a TOP

SUBJECT: Miscellaneous airworthiness information.

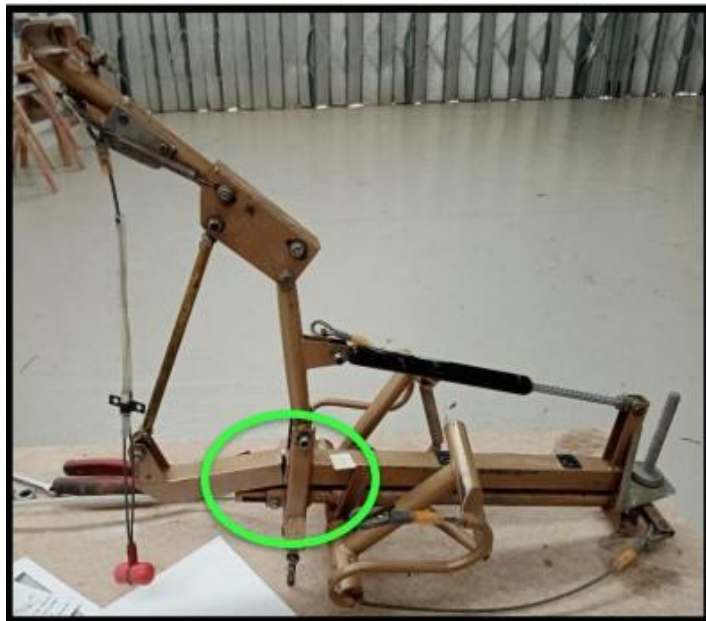
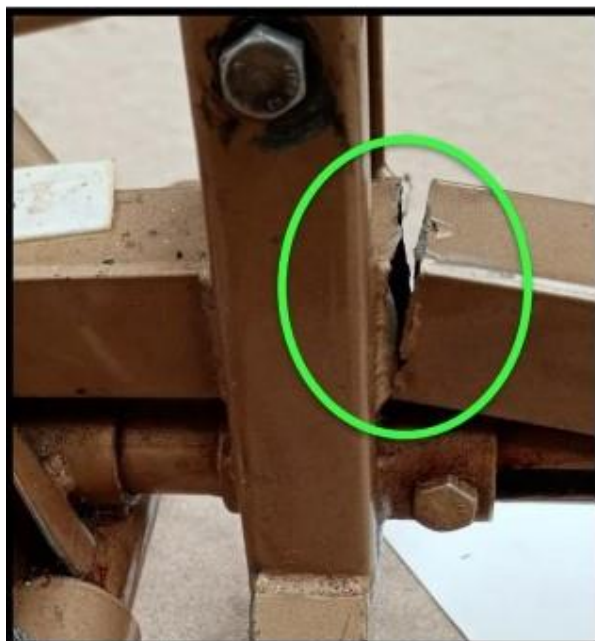
1. There have been defect reports received both here and overseas relating to canopy support structure failures in LS1, LS3 and LS4 type sailplanes.

The canopy when extended is supported on a structure which is subjected to in service fatigue loads caused by opening in windy conditions and tow-out with canopy unlocked (causing bouncing on the strut).

The fatigue accumulates and can result in failure of the lower 25 x 25 mm square (fore and aft) structure anchored to the floor. This tube is thin walled (<1 mm) and generally fails towards the rear end of the central tube. Refer photos.

Repair welding work requires the four floor mounting points to be jigged to ensure the geometry is maintained and the part fits back in place. The repair should be carried out in accordance with an engineering order or approved data equivalent.

It is highly recommended that the area be inspected for defects or cracking at every Daily Inspection.
