# AIRWORTHINESS ADVICE NOTICE

CFA/AN 58

BRASOV 2

Miscellaneous reported defects.

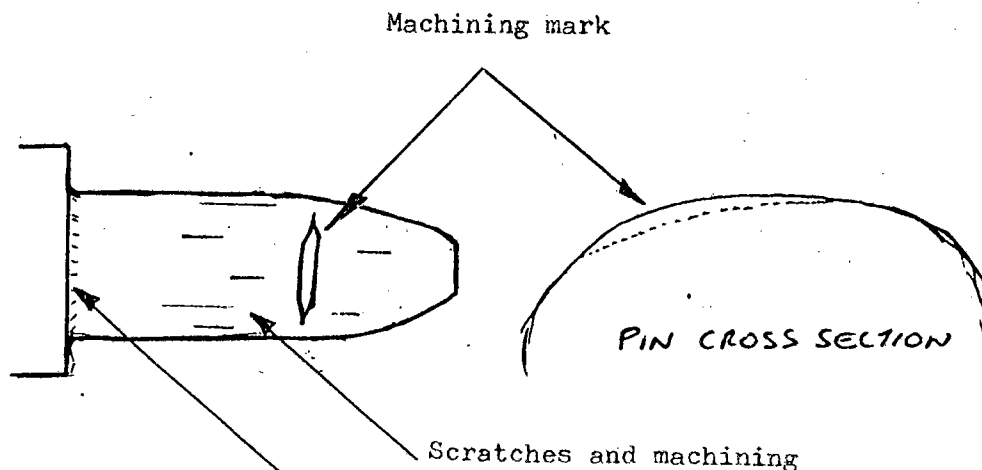
WING ROOT LOCATING PINS - CRACKS

Badly machined wing root locating pins have appeared to be cracked. Under magnification and dyecheck proven to be scores or scratches. If the scoring extends into the radiused area at the root of the pin, cracking may develop with time.

Pins should be checked at Form 2 inspections.

Any defects in the radiused area need to be inspected in more detail.

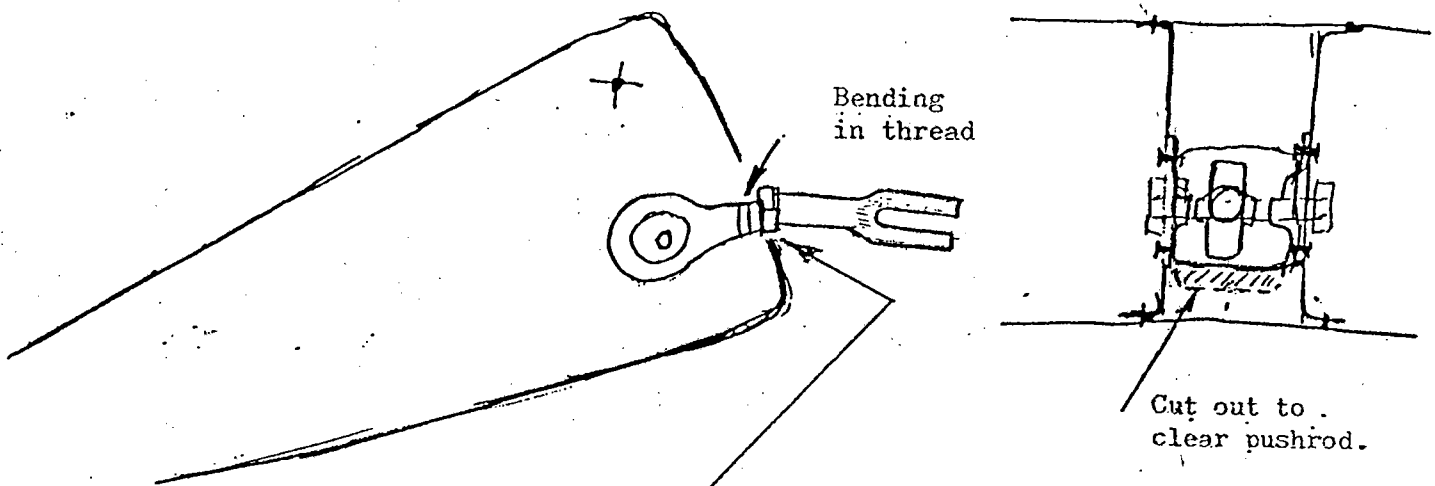
AILERON FULLY DOWN

### DEFECT No. 3      PUSH ROD BENDING/CRACKING

Most IS28B2s end up with the short push rod linking the aileron to the bellcrank measuring 95mm with the ailerons moving through their correct travel. In 4 cases reported the pushrod has interfered with the aileron leading edge cutout and bent rod has resulted.

Bending will occur if aileron leading edge is not relieved after adjustment of push rods on some gliders.

Ensuring that control systems are free of interference is part of a C. of A. inspectors responsibility, therefore this defect should never have occurred.

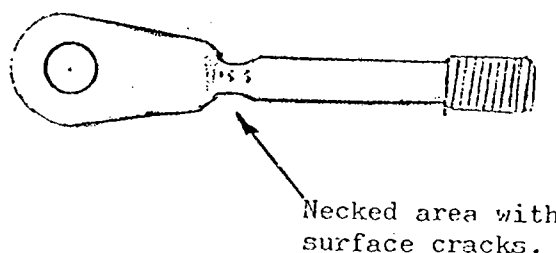
### DEFECT No. 5      POOR TURNBUCKLE FORK MANUFACTURE

A turnbuckle fork was removed from a control cable because of "necking" of the shaft, as illustrated, during manufacture. The "necked" area showed small surface cracks which may have led eventually to failure of the fitting.

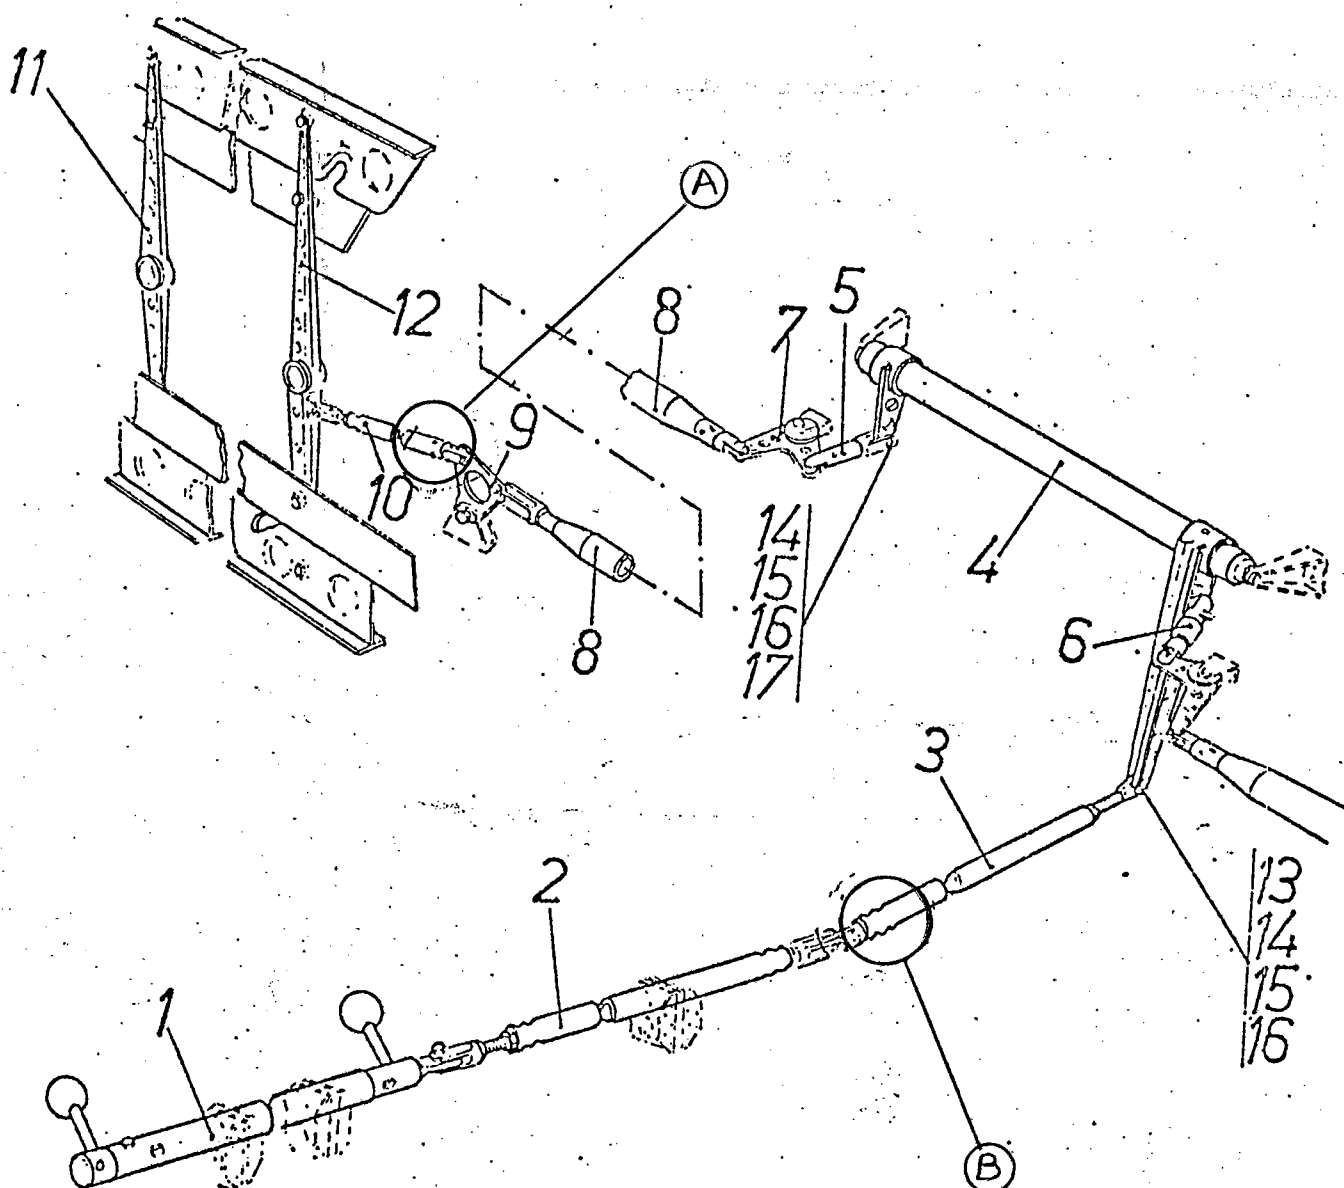
DEFECT No. 6. AIRBRAKE SYSTEM ROD ENDS

The rod ends at (a) and (b) are crimped. These have been found loose in service and rectified by drilling, reaming and through bolting with AN3 or similar bolt and locknut. Interference of bolt heads and nuts must be checked through full movement of the airbrake control system. Some serial numbers may have been bolted in production.

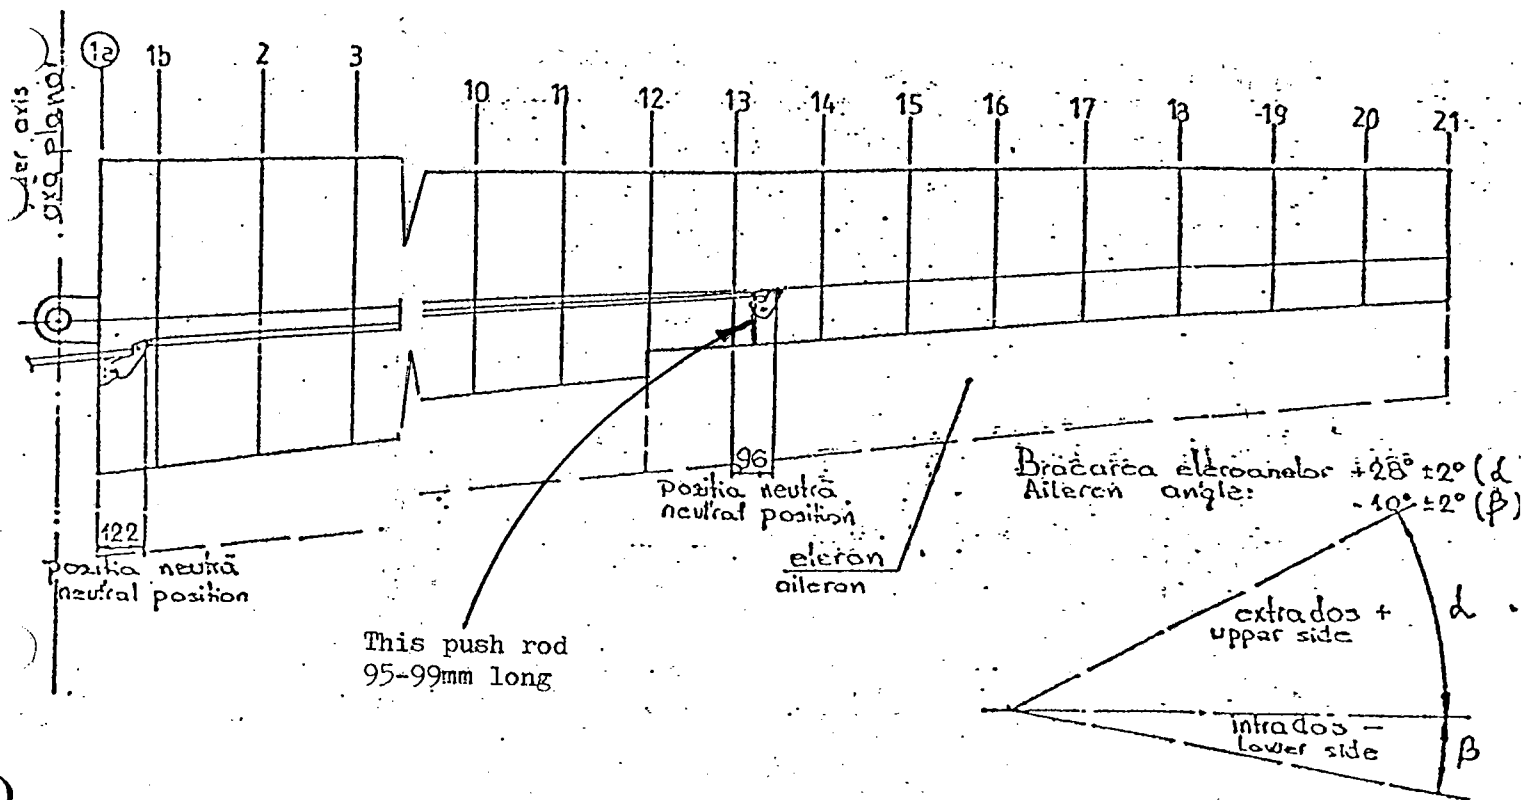
(2) The diagram supplied in AD 198 was wrong as supplied by the factory (Twice). The link joining the aileron to the bellcrank has been found by field experience to measure 95-99mm with the correct aileron travels, not 105 as proposed by the factory. It seems likely that individual sailplanes will show variations in these dimensions.

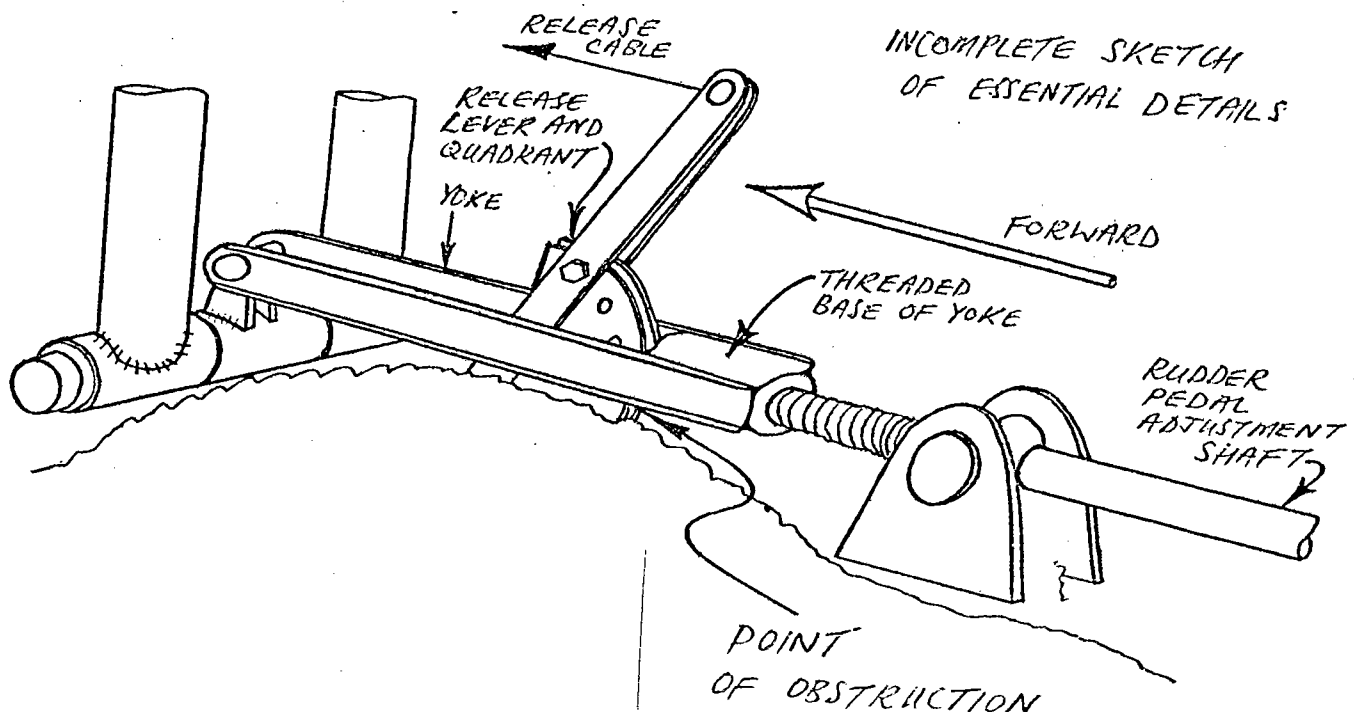
DEFECT No. 12FAILURE TO RELEASE

We have several reports of interference between the front cockpit rudder pedal adjustment mechanism and the aerotow release. With the adjustment fully forward it is possible for the release mechanism to be blocked sufficiently to prevent release of the tow rope.

The solution adopted and recommended is to file away the material at the base of the yoke at the offending point of interference. This can be with a  $\frac{1}{4}$ " diameter fine file in situ. The material of the threaded base of the yoke is not a hardened steel so it files easily. A clearance in the worst case of  $\frac{1}{8}$ " should be created.
