AIRWORTHINESS ADVICE NOTICE

TYPE AFFECTED: DG-400.

SUBJECT: Miscellaneous airworthiness information.

GFA AN 74	ISSUE: 8	11 June 2003	Page 2 of 4
-----------	----------	--------------	-------------

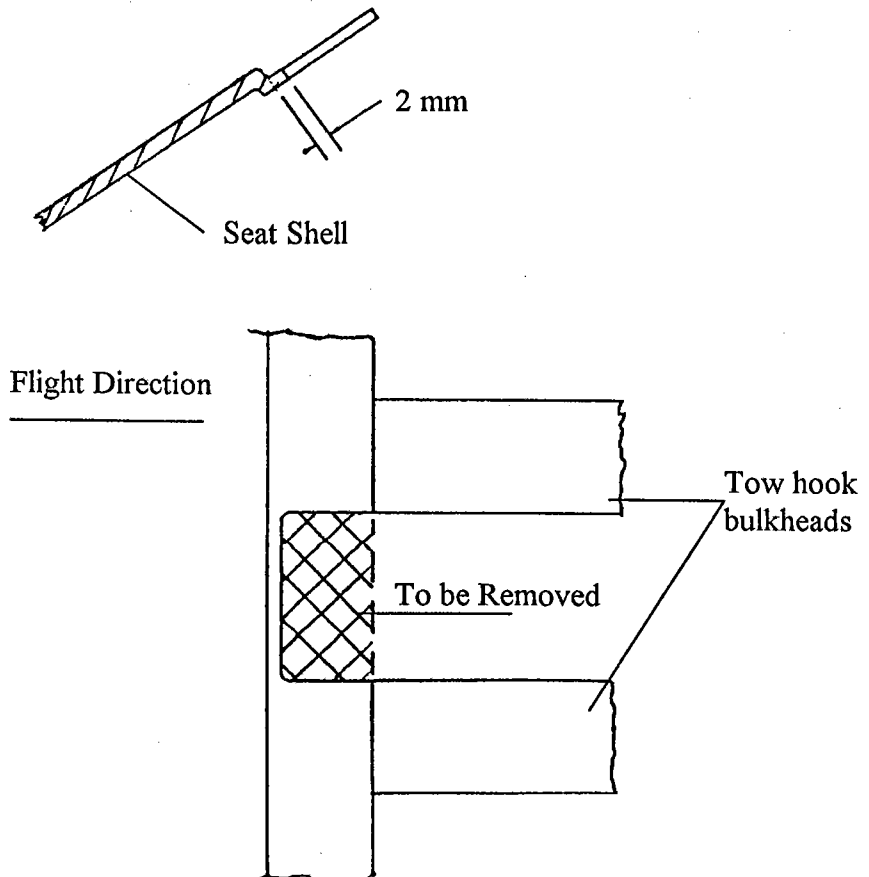
FIGURE 1 RELEASE CUT OUT

1. *SIMPLIFIED CG RELEASE REMOVAL.* The relatively small access hole for the belly release makes removal of the release at each annual inspection difficult. The cut out in the seat shell can be enlarged in accordance with Figure 1 to make removal of the release easier.
