AIRWORTHINESS ADVICE NOTICE

GFA AN 78

All Schweizer sailplanes

SUBJECT: DAILY INSPECTION OF AIRCRAFT STRUCTURES; DETAILED VISUAL INSPECTION OF TAIL RUDDER, ELEVATORS, VERTICAL TAIL SURFACE (TAIL FIN), AND FUSELAGE.

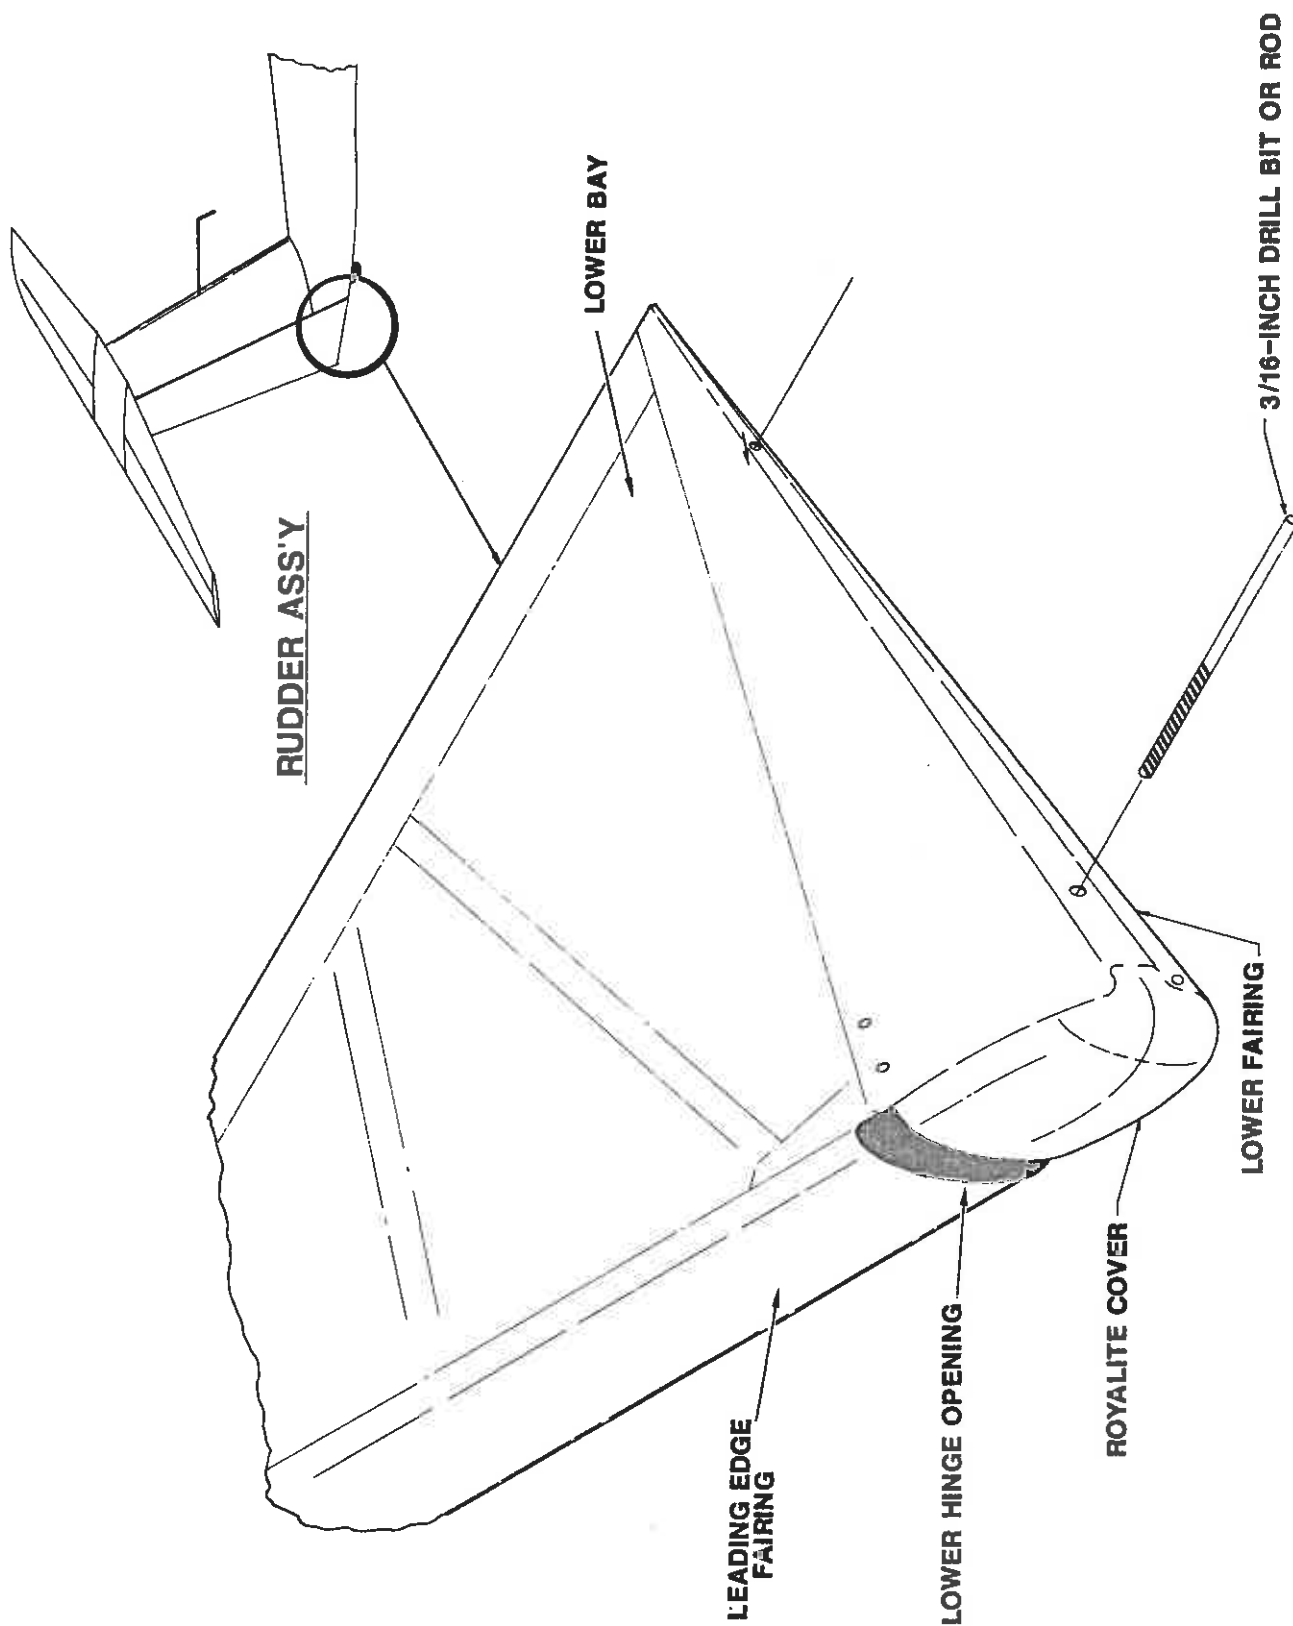
FIGURE 1

Rodents may gain access and deposit debris at four different locations within the tail rudder. Debris may be present between the leading edge fairing and the spar, inside the lower fairing, inside of the lower bay or inside the upper bay. (Refer to Figure 1.) Each of these areas should be thoroughly inspected with flashlight and inspection mirror.

- (1) Carefully adjust rudder position to extreme left or right.
- (2) Using a flashlight, inspect for debris inside lower fairing (Figure 1) by looking through lower hinge opening.
- (3) If debris is found, use a vacuum cleaner with flexible extension hose to remove debris.
- (4) Check two drain holes (Figure 1) at bottom of fairing for obstruction. Clear obstructions with 3/16-inch drill bit.
- d. Open access door on horizontal stabilizer stub (Figure 2) and use a flashlight to inspect upper fin and stabilizer stub area for debris. Use vacuum cleaner to remove debris.
- e. Inspect brake/wheel area for obstructions. Remove obstructions as required.

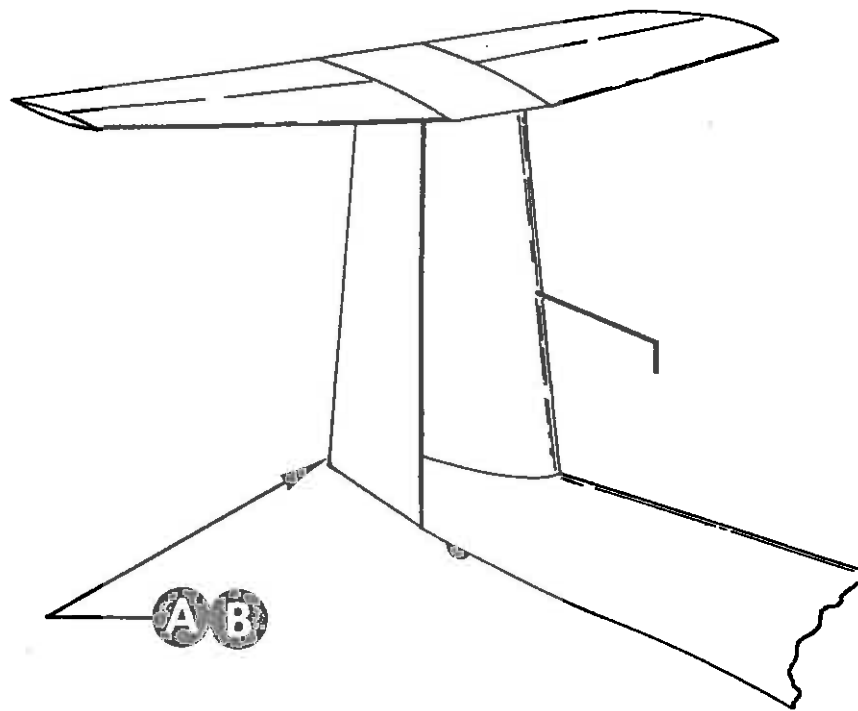
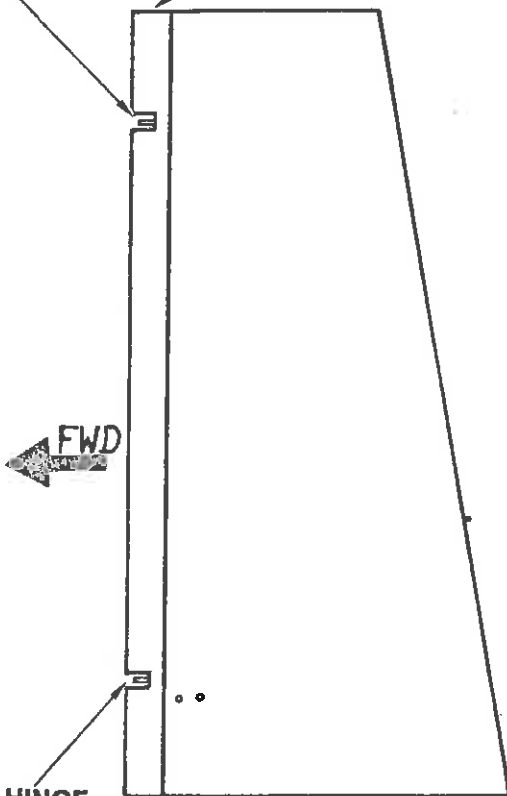
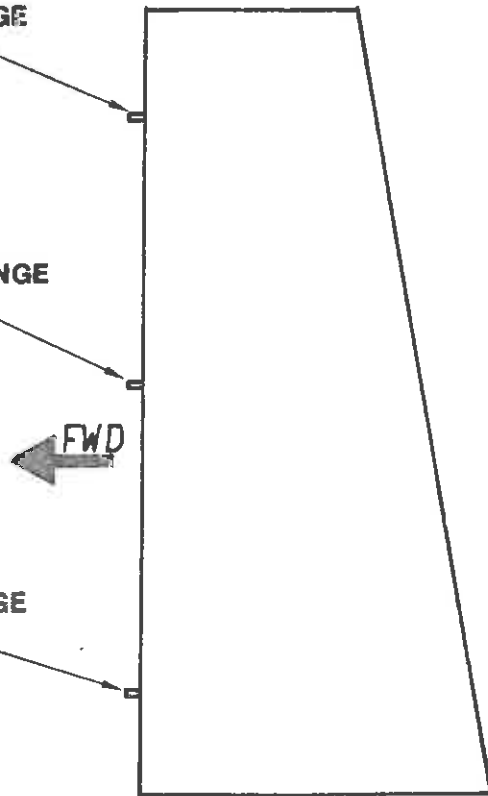
FIGURE 3

One of two types of tail rudders may be installed on the affected aircraft. The earlier type is an unsealed unit without a leading edge fairing (Figure 3, Detail B). The later type is sealed at the leading edge by a fairing (Detail A). Removal of an unsealed rudder is accomplished by performing step a(1) through a(3). A sealed rudder is removed by performing steps b(1) through b(3).

- c. Using a flashlight and inspection mirror, inspect for debris inside of rudder by looking through hinge openings (Figure 3, Detail A or Detail B, as applicable).
- d. If debris is noted between leading edge fairing and spar, remove debris through upper hinge opening, using vacuum cleaner and flexible extension hose.
