AIRWORTHINESS ADVICE NOTICE

TYPE AFFECTED: KR-03A Puchatek.

SUBJECT: Miscellaneous airworthiness information.

GFA AN 86	ISSUE: 3	20 July 2001	Page 3 of 3
------------------	-----------------	---------------------	--------------------

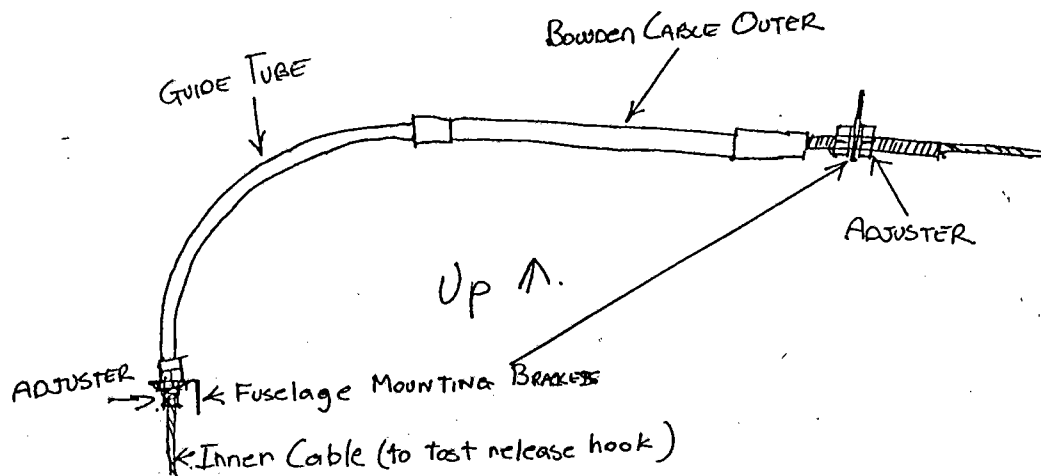
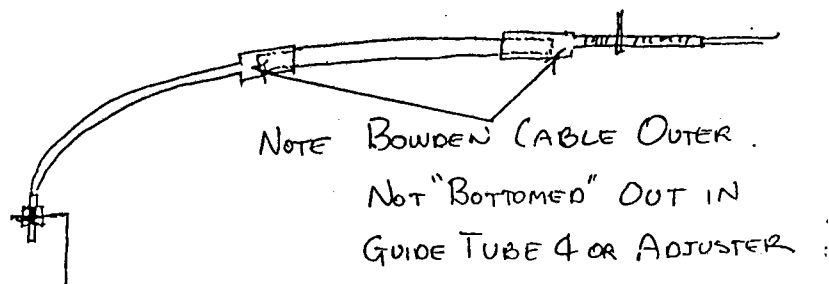
Puchatek nose release - basic layout

A case has been reported of insufficient travel of the actuating cable of the nose-release, caused by flexing of the lower fuselage bracket to which one end of the Bowden cable is attached, together with consequent cracking of the Bowden cable guide tube. The problem was found on VH-GKD after 1600 hours time in service.

Whether the problem is present on any particular aircraft can only be checked by removing the nosecone and having a really good look. The following sketches and associated notes were provided by Rod Haase, Southern Downs Soaring Club.

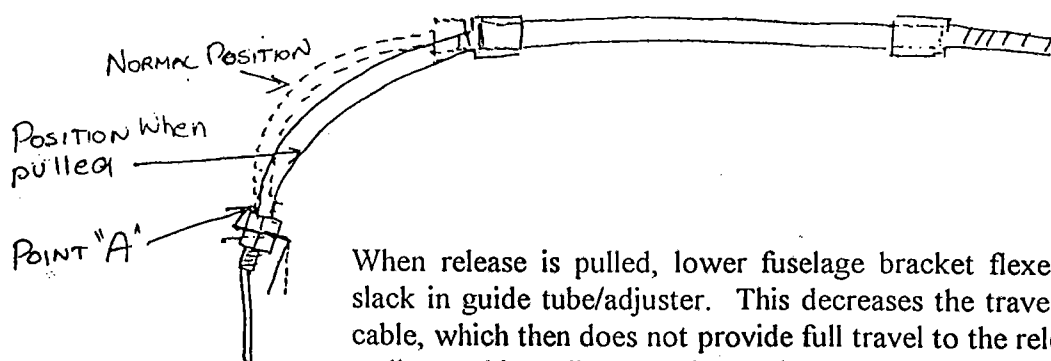
What happens when the release is pulled

When release is pulled, lower fuselage bracket flexes to take up slack in guide tube/adjuster. This decreases the travel of the inner cable, which then does not provide full travel to the release hook, as well as making adjustment impossible.

On GKD, the guide tube had broken due to fatigue at point "A". This left the sharp edges of the guide tube bearing against the inner cable, which it damaged.

This had the effect of possibly jamming the hook so that it may either fail to release or cause premature release.
