## AIRWORTHINESS ADVICE NOTICE

**TYPE AFFECTED:** SZD-51-1 JUNIOR

**SUBJECT:** Miscellaneous reported defects and airworthiness information.

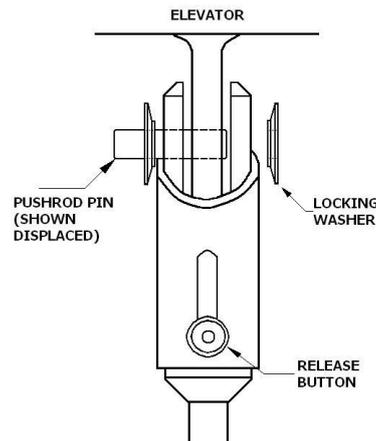
FIGURE 1.

2. Experience has shown that the locking washer on the connecting pin in the elevator connector may work loose allowing the control to be connected incorrectly as shown in Fig 1.

Should the locking washer be loose then the defect must be rectified before the next flight.

The defect may be rectified by either replacing the washer (the best option) or by cold forming the washer until the hole is between 5.980 & 5.990 mm diameter.

Cold forming should be carried out by either pressing the washer between flat plates or by placing a steel ball (approx 20 mm dia) on the hole and then tapping with a hammer. If using the steel ball method the washer should be turned over and the process repeated.

Before pressing the washer onto the pin, the pin diameter should be checked for correct sizing:- 5.992 to 6.000 mm dia.
