## AIRWORTHINESS ADVICE NOTICE

TYPE AFFECTED: Duo Discus, Duo Discus T.

SUBJECT: Miscellaneous airworthiness information.

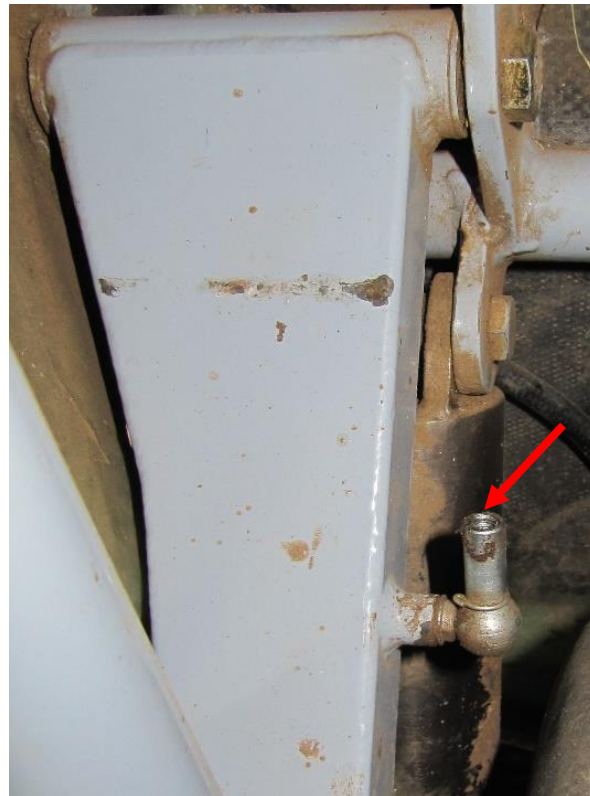
3. UNDERCARRIAGE GAS STRUT FAILURE: The gas strut bottom end is suspected to have unwound at the bottom end fitting from the barrel of the gas strut. After detaching, the top attachment ball failed during operations and the gas strut penetrated the parcel shelf behind the rear cockpit.

*Figure 1: View in the wheel wheel looking forward showing port undercarriage arm and disconnected gas strut connection*

1. LUBRICATION: The ball ends of the undercarriage gas strut should be lubricated every annual inspection.
2. THREAD LOCKING: The threaded junctions on the undercarriage gas strut should be secured against unwinding by use of a thread locking compound (recommend Loctite 243).
3. BALL REPLACEMENT: The ball ends are subject to significant fatigue loads due to the high oscillatory loads on the rocker arm mechanism on the ground roll during take off and landing, and during towing. It is recommended to replace the ball ends whenever the gas strut is replaced.
4. GAS STRUT REPLACEMENT: Replace the gas strut when it becomes noticeable that the retraction effort has increased significantly. Pay attention that the gas strut force rating matches the mainwheel type installed. Refer maintenance manual.

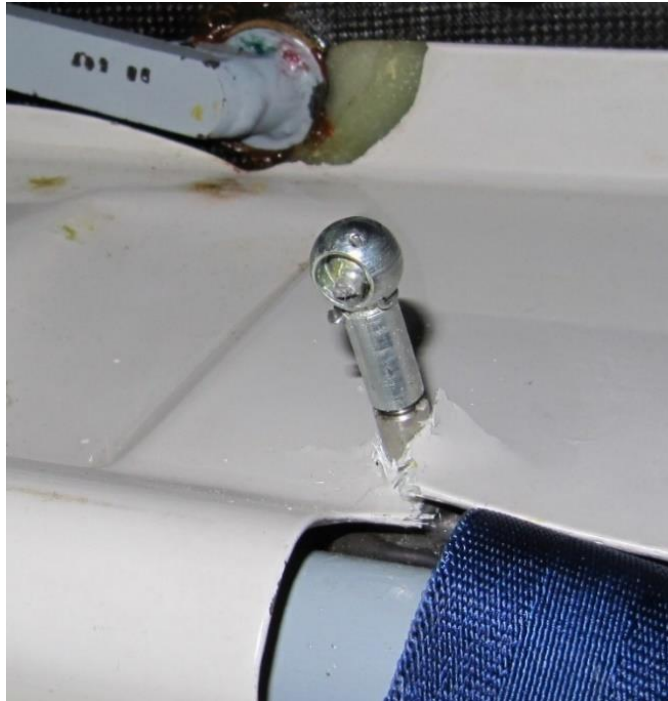
*Figure 2: Gas strut end protruding through parcel shelf.*

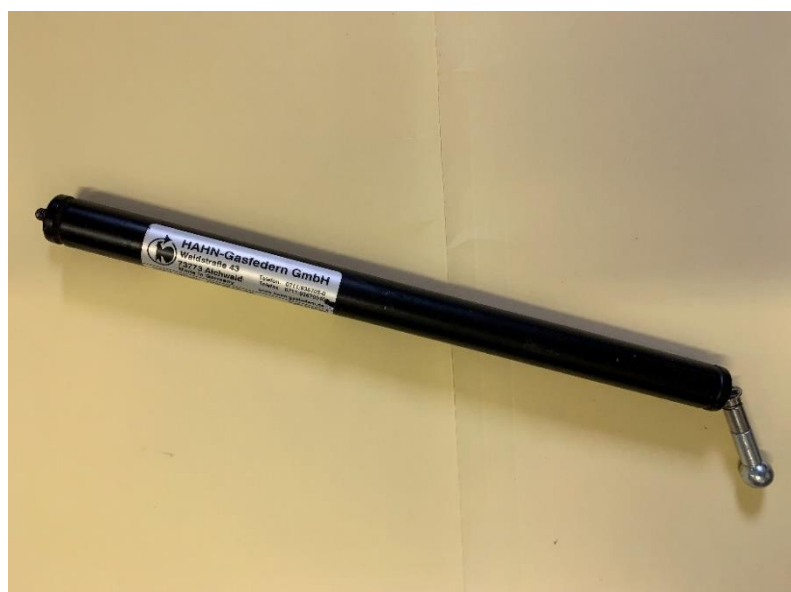
4. UNDERCARRIAGE GAS STRUT FAILURE: While preparing to put the fuselage in the trailer, the undercarriage gas strut was found disconnected from the lower and upper attachment points. The ball ends had sheared and the end attached to the top of the gas strut rod was bent. Reference defect 3 above, this was the second gas strut failure experienced on the same aircraft.

*Figure 3: Failed gas with bent strut.*

The gas strut rating can vary depending on the mainwheel fitted (TOST or lighter Penta). It acts in tension to assist with retracting the undercarriage. It is attached at the lower end to the undercarriage rocker arm which is part of the shock absorption system. The main wheel mounted to the rocker arm is subject to high oscillatory loads due to the rough nature of Australian grass runway strips for sailplane operations.

The balls which attach the strut are similar in design to L'Hotellier balls in control circuits, but smaller. Rather than being lubricated on a regular basis, they may or may not be lubricated subsequent to entering service and may not be lubricated at an annual inspection.
