## AIRWORTHINESS ADVICE NOTICE

**TYPE AFFECTED:** DG 500 series gliders however other DG gliders may exhibit the same problem.

**SUBJECT:** Serious deterioration of airbrake arm ball bearings due to water ingress as a result of water collecting in the dive brake box.

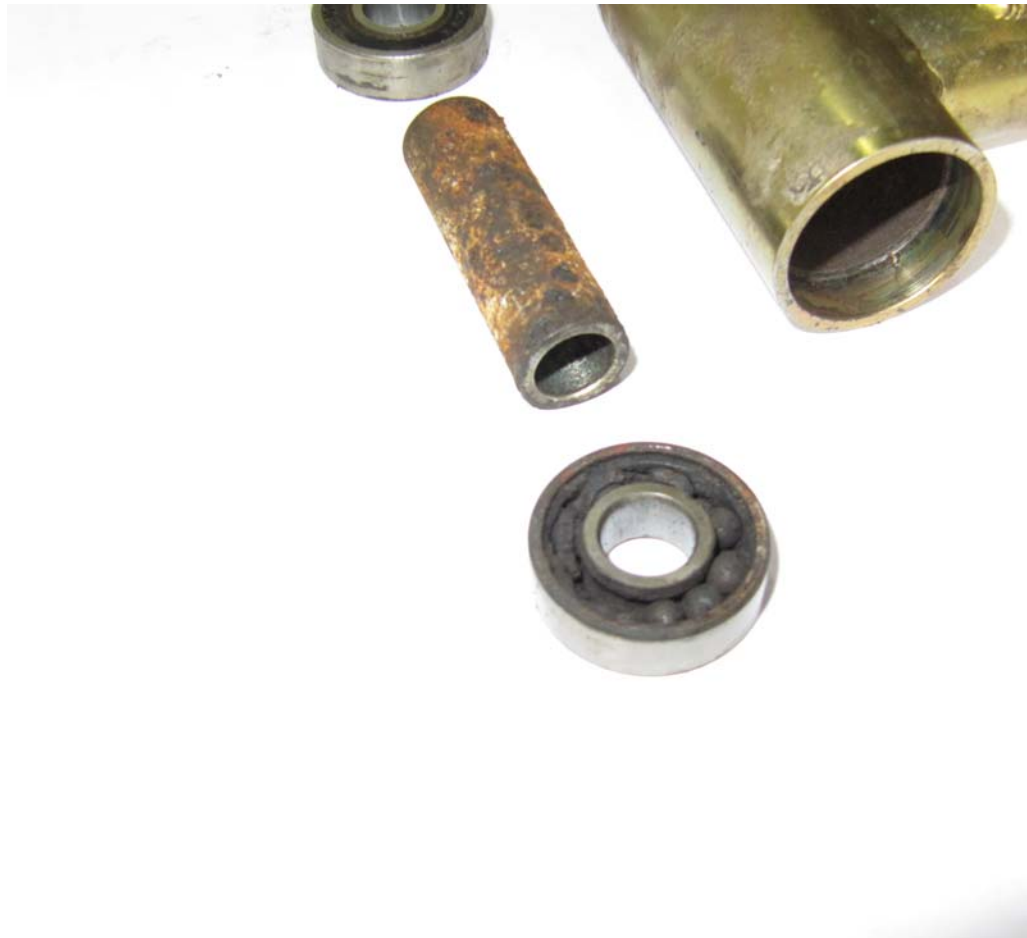
**BACKGROUND:** DG 500 glider VH-VMF serial number 5E251X80 was exhibiting increasing freeplay in the chordwise direction at the inner airbrake arms where the swinging arm attaches to the airbrake paddle. The problem was evident on both wings; freeplay with the airbrakes fully extended was of the order of 3 to 4 millimeters. The problem had become steadily worse over the period of a year. Removal of the swinging arm assembly revealed the problem as shown in the attached photograph. There was severe corrosion in the pivot arm ball bearings due to water ingress past the plastic face seal to the point where in places the bearing cage was nonexistent. The inner surface of the tubes which form the tunnels into which the bearings are pressed also showed corrosion.

Damaged Dive Brake Pivot Arm Bearing and Corroded Spacer Tube Removed from DG 500 Glider VH-VMF

Warning, if the pivot assembly is severely corroded then it may prove difficult to remove the bolt intact. The bearings can be readily removed from the lever arm assembly. Replace any corroded bearings, remove any corrosion evident on the spacer sleeve and bearing tunnel tube and paint with Stits epoxy chromate primer. Re assemble the airbrake actuating arms into the glider. Repair the inspection openings made in the wing lower surface observing the repair procedures and materials specified in the manufacturer's manuals.
