Collision on runway between Grob G103 Twin Astir glider, VH-UIZ and Cessna 150F, VH-ROZ

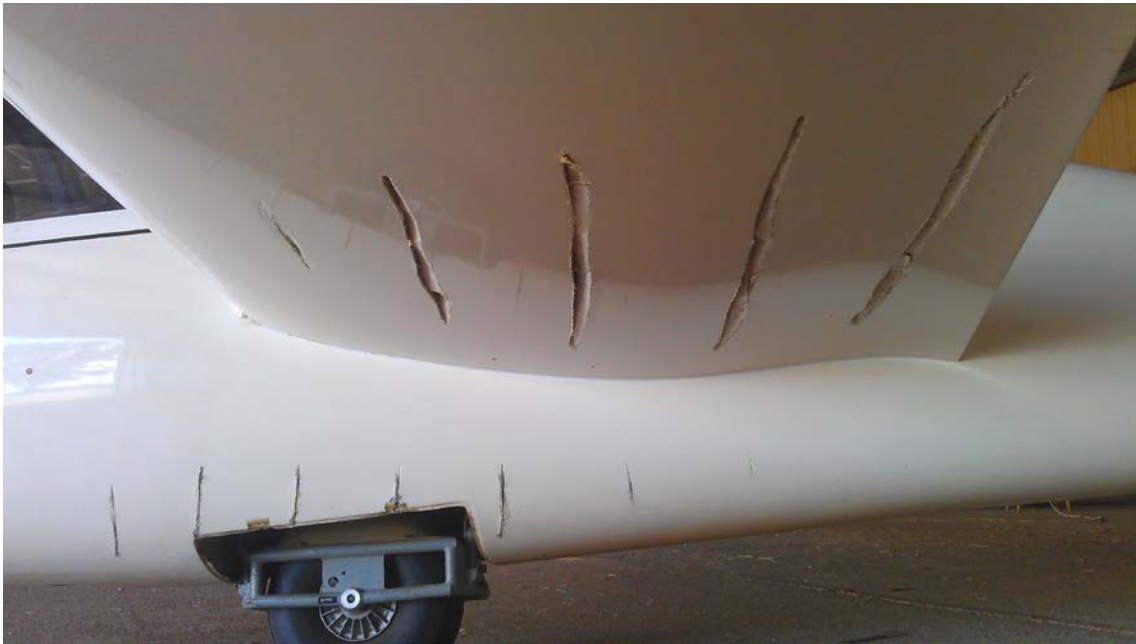
Figure 1: Damage to VH-UIZ

The pilot of UIZ was uninjured and landed the glider well down the runway. Although UIZ was fitted with a FLARM² collision warning system, no alarm was triggered, as the tug aircraft was not fitted with a similar FLARM system. On exiting the glider, the pilot observed damage on the left wing and fuselage. However, he was not aware that he had landed on the tug aircraft until club personnel arrived in an airfield vehicle.

Both gliding clubs operated under the rules and procedures proscribed by the Gliding Federation of Australia (GFA). The investigation conducted by the GFA determined that glider and tug landed together with the glider on top. Propeller strikes caused damage to the underside of the glider's left wing and along the fuselage near the main landing wheel (Figure 1). There was no damage to the C150.
