Aircraft proximity event between a Janus glider, VH-IZI and a McDonnell Douglas 500N, VH-KXS

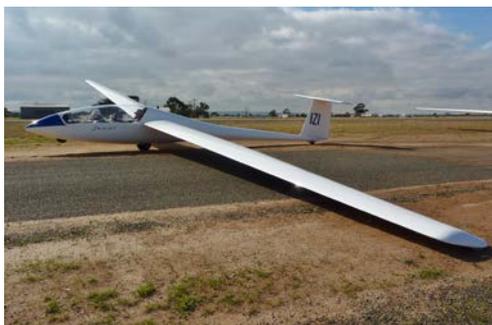
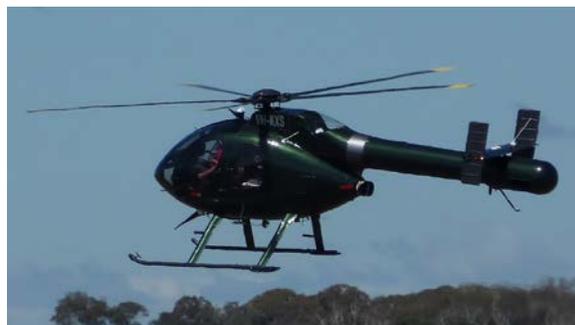
Figure 1: VH-IZI and VH-KXS

On 29 June 2013, a Janus glider, registered VH-IZI (IZI), departed runway 27 at the Bacchus Marsh aeroplane landing area (ALA) to conduct a local flight (Figure 1). During the flight, the wind direction at the ALA changed, resulting in runway 19 becoming the active runway.

At about the same time, the pilot of a McDonnell Douglas 500N helicopter, registered VH-KXS (KXS), was conducting circuits (Figure 1). He was on his fifth circuit and had reported broadcasting on the common traffic advisory frequency (CTAF) immediately prior to turning base for runway 19.¹

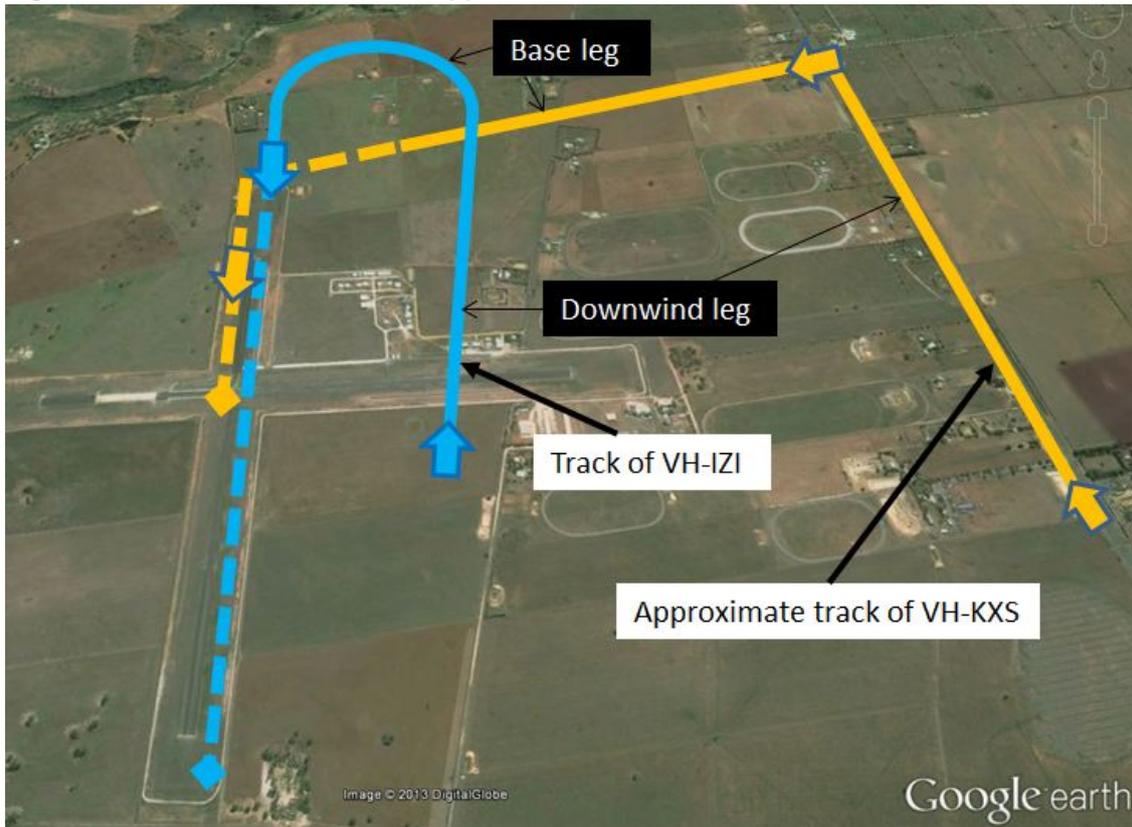
Figure 2: GPS track of VH-IZI and approximate track of VH-KXS

At about 1430 Eastern Standard Time,² IZI joined the downwind leg of the circuit for runway 19. After ensuring the radio volume was turned up, the pilot reported broadcasting a downwind call on the CTAF. Towards the end of the downwind leg, while descending through about 500 ft, the passenger in the front seat of IZI observed a helicopter (KXS) in his 12 o'clock³ position. The pilot then observed KXS below him, on a diagonal track for runway 19 (Figure 2). The pilot estimated that KXS passed about 100 ft below IZI. He further reported that he did not hear any calls from the pilot of KXS on the CTAF.

When established on late base, at 500 ft, the pilot of KXS reported sighting IZI on downwind, in his 10 o'clock position, about 100 ft above and 100 m away. The pilot stated that he did not believe there was any risk of a collision with IZI and continued with the circuit. He reported that he did not hear a downwind call from IZI.⁴
