# Hard landing involving a Rolladen-Schneider Flugzeugbau LS7-WL, VH-XJJ

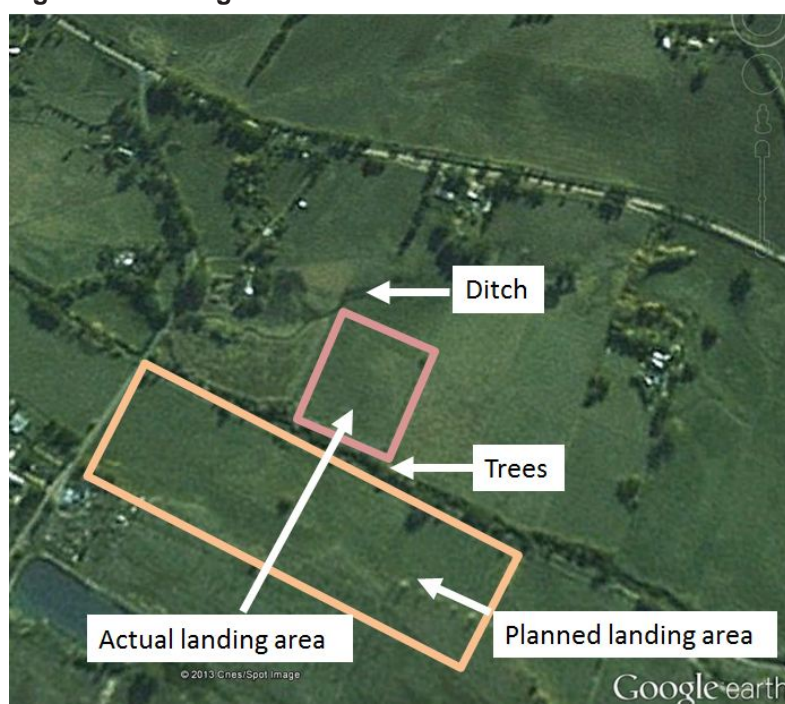
**Figure 1: Landing area**

The alternative field was perpendicular to the planned landing area and the glider would be landing towards the north-east (Figure 1). There was a row of trees on the approach end of the field and a ditch at the far end. The pilot conducted an approach to the field and the glider passed over the trees at about 50 ft AGL. The pilot then attempted to reduce altitude and airspeed by conducting shallow turns and flying diagonally across the field. The glider landed heavily in the north-eastern corner of the field. The pilot sustained a serious injury due to the hard landing and the glider was substantially damaged.
