Near collision between a Piper PA-25, VH-MLS, and an AMS-flight DG-303, VH-DGA

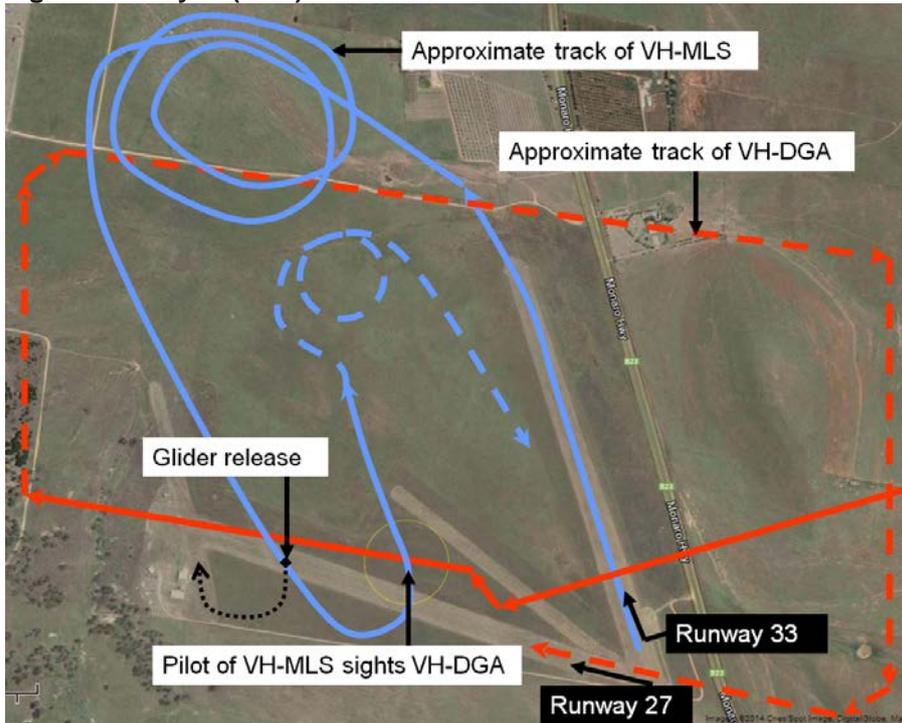
Figure 1: Bunyan (ALA) and aircraft tracks

About 10 minutes later, the pilot of a Piper PA-25, registered VH-MLS (MLS), broadcast a lining up and rolling call and took off from runway 33 at Bunyan to launch a glider from overhead the aerodrome (Figure 1).

At about 1515, when at about 4,000 ft AMSL, in anticipation of the glider pilot releasing the tow cable, the pilot of MLS turned to look behind the aircraft. He confirmed that the glider had released successfully and, in accordance with standard operating procedures, he then commenced a descending turn to the left.

The pilot of DGA sighted MLS release the glider and commence the turn. The two aircraft were at about the same altitude and he then observed MLS with the wings level, he assumed the aircraft would then track straight ahead. He commenced a right turn to increase separation between them, and to track towards the joining point for a right downwind for runway 27. He reported that he assumed the pilot of MLS had sighted DGA at that time, and that he did not see MLS again until it was on downwind.

As the pilot of MLS rolled the aircraft's wings level from the turn, he saw DGA as a white flash passing about 30 ft below him, and reported that he could see the rivets on the glider's airbrakes.
