The Gliding Federation of Australia Inc

Occurrence Summaries

01/01/2012 to 31/12/2012

The Gliding Federation of Australia Inc
SOAR Accident and Incident Occurrences

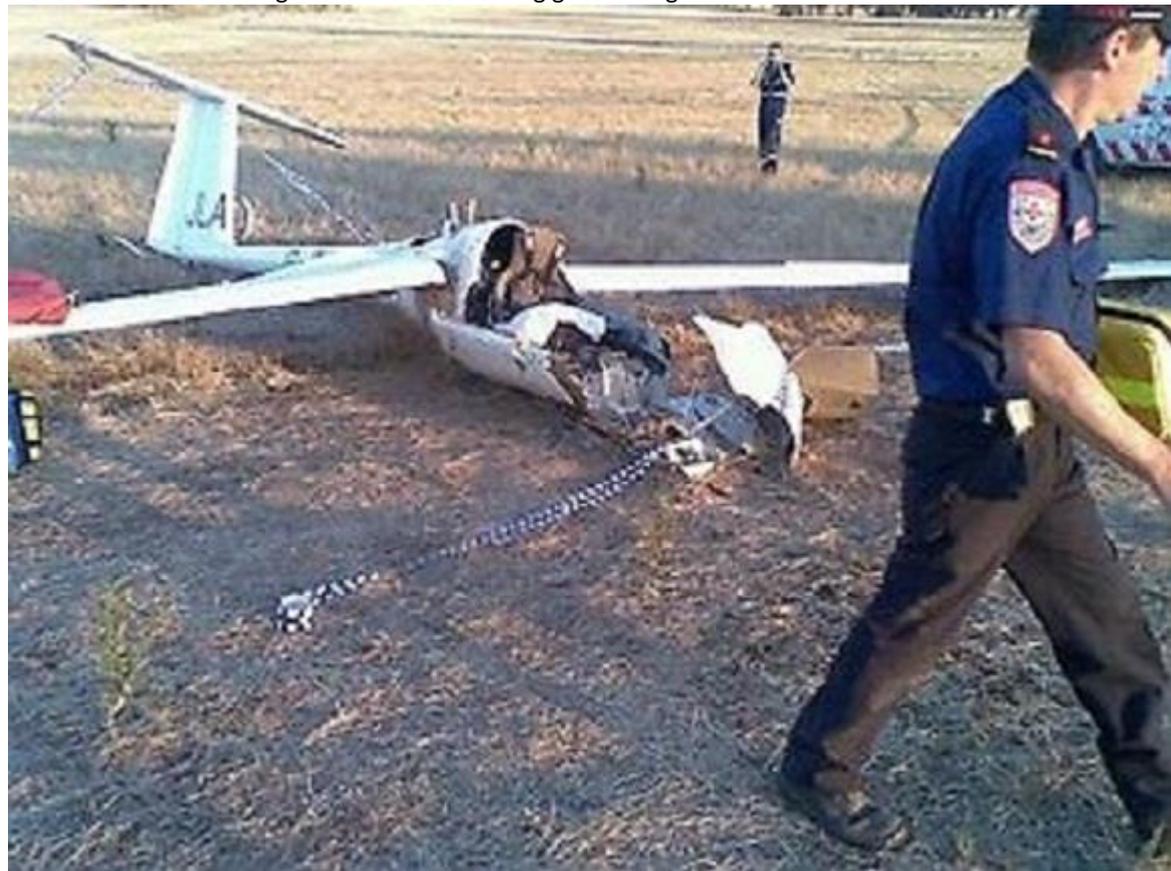
Date	1-Jan-2012	Region	VSA	SOAR Report Nbr	S-0143		
Level 1	Operational	Level 2	Terrain Collisions	Level 3	Controlled flight into terrain		
A/C Model 1	Ventus 2CT		A/C Model 2				
Injury	Serious	Damage	Write-off	Phase	Outlanding	PIC Age	83

After losing final glide due to a large area of sink, the pilot elected to use sustainer to self retrieve. The sustainer engine could not overcome the high sink rate and the pilot, realising she could not clear the Hills enroute, made a late decision to land in a paddock. Flying into rising ground the pilot conducted a low turn whereupon the starboard wingtip struck the ground. The aircraft impacted at approx 40 degrees nosedown under power, followed by a ground-loop before coming to rest. The aircraft was substantially damaged. Causal factors include fatigue and high workload leading to poor decision making. This accident serves as a reminder to pilots of powered/sustainer sailplanes of the importance of understanding the performance limitations of the sailplane under power. Pilots must also ensure they allow themselves sufficient height to make a successful landing in the event something goes wrong.

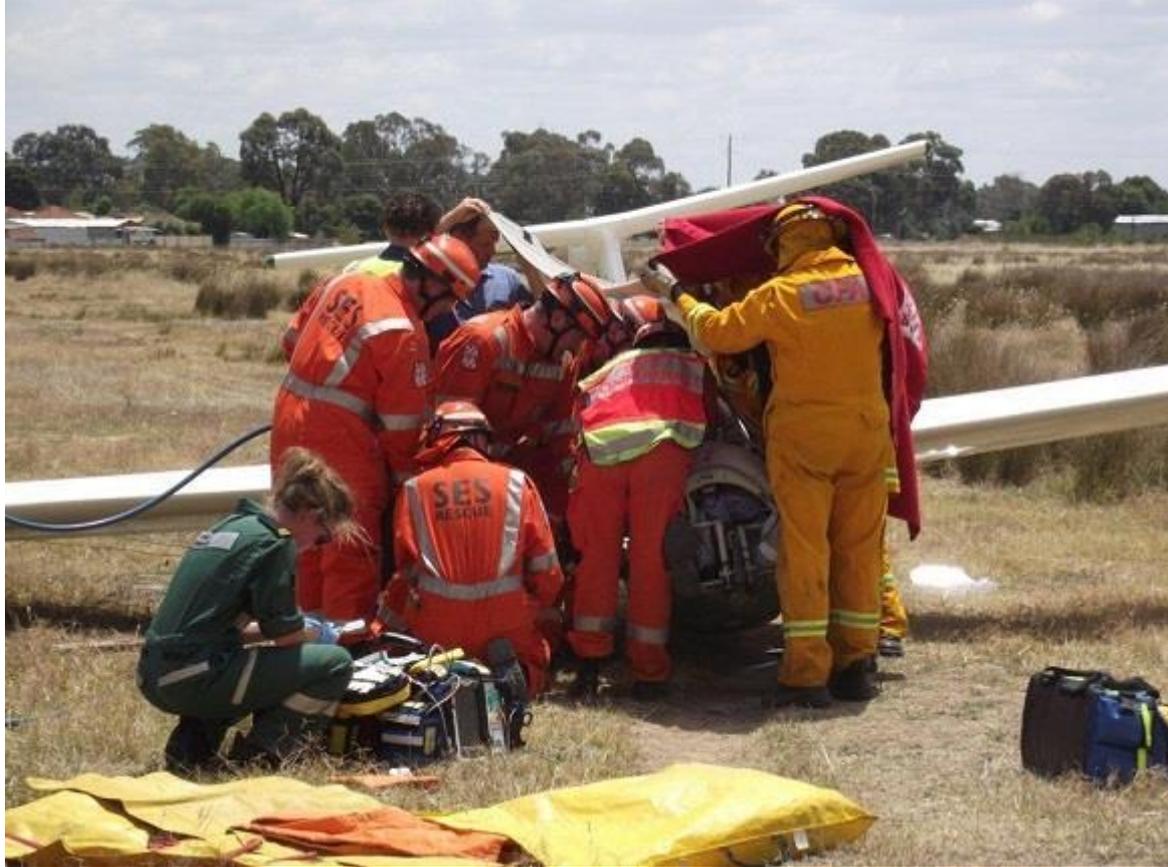
Date	15-Jan-2012	Region	VSA	SOAR Report Nbr	S-0149		
Level 1	Operational		Level 2	Terrain Collisions	Level 3	Collision with terrain	
A/C Model 1	IS-28B2			A/C Model 2			
Injury	Serious	Damage	Write-off	Phase	Landing	PIC Age	78
<p>Pilot deployed airbrakes during late downwind and maintained them open. During the turn onto base leg at about 450ft AGL the pilot allowed the speed to decay resulting in the aircraft stalling, pitching down and impacting the ground in a nose-down attitude. It was noted post crash that the undercarriage had not been</p>

lowered. The pilot did not complete his pre-landing check and did not maintain control of the aircraft during the turn onto base leg. The pilot could not explain his actions nor why appropriate corrective actions were not taken.

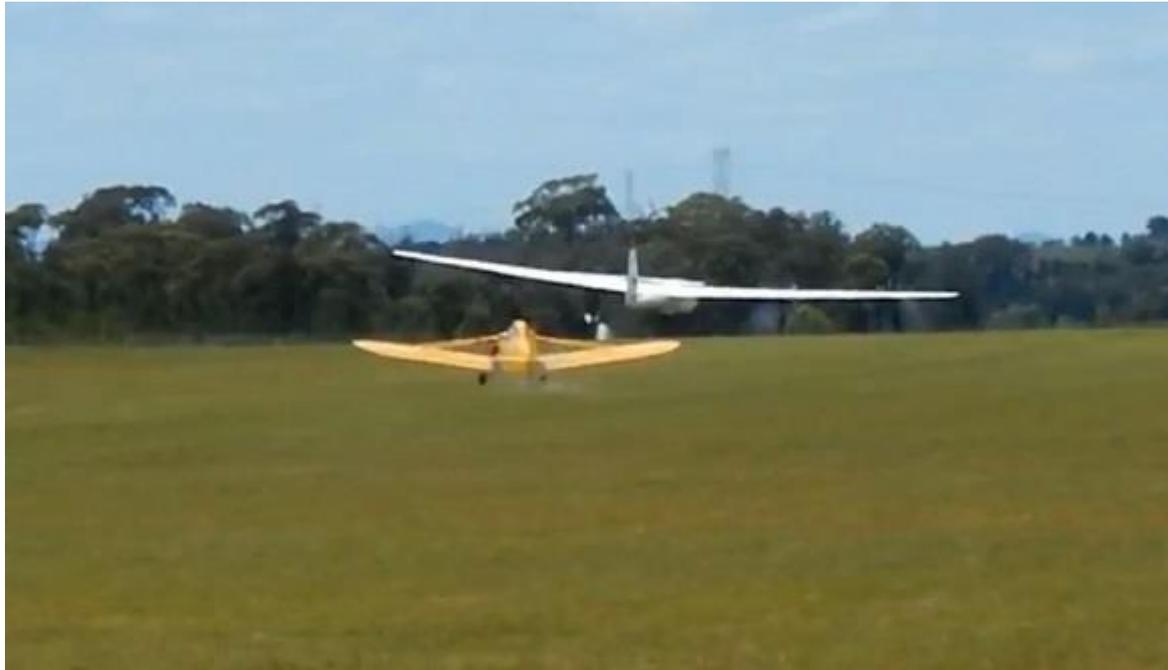
Date	29-Jan-2012	Region	NSWGA	SOAR Report Nbr	S-0141		
Level 1	Technical		Level 2	Powerplant/Propulsion	Level 3	Engine failure or malfunction	
A/C Model 1	SZD-50-3 Puchacz			A/C Model 2	Piper PA-25-235		
Injury	Nil	Damage	Nil	Phase	Launch	PIC Age	41

During the aerotow launch, the tug lost power just after the glider had left the ground but before the tug left the ground. The instructor in the glider noticed the rope went slack and took control, releasing the tow rope. The tug diverted to the left and released the tow rope. The glider diverted right and landed straight ahead. The tug engine was inspected but no fault could be found.

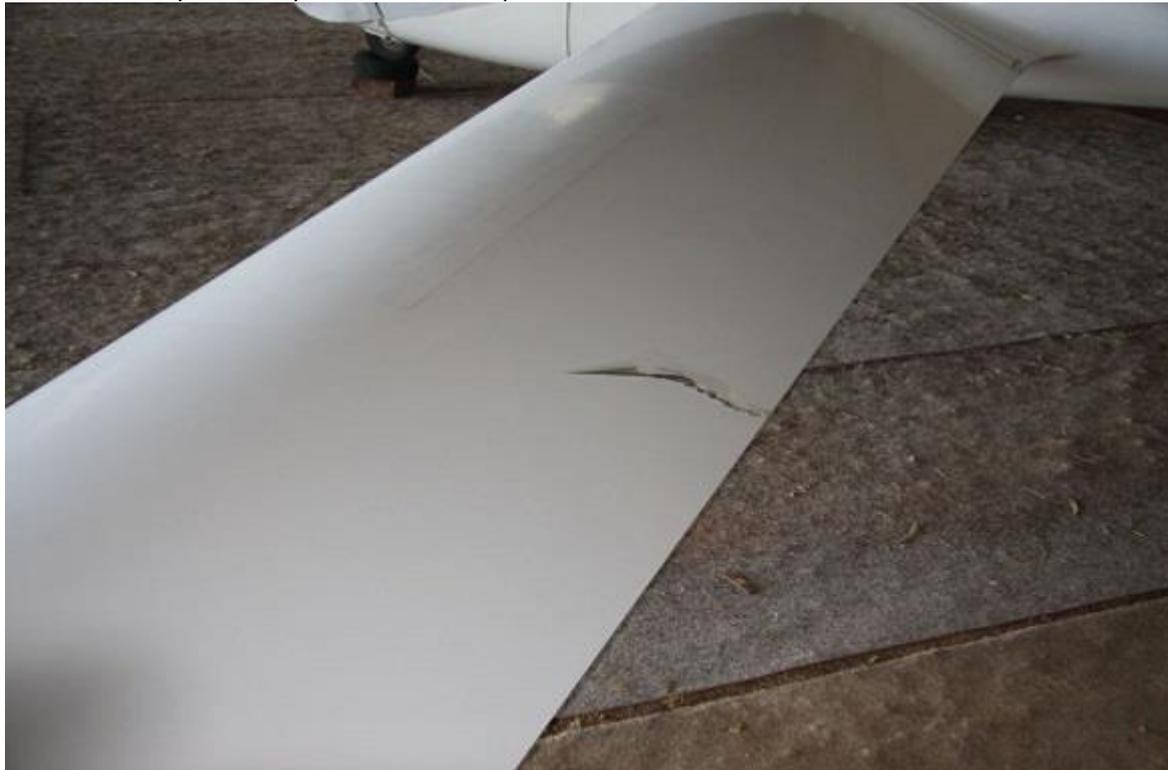
Date	9-Mar-2012	Region	WAGA	SOAR Report Nbr	S-0154		
Level 1	Operational	Level 2	Miscellaneous	Level 3	Rope/Rings Airframe Strike		
A/C Model 1	ASK-21			A/C Model 2	Piper PA-25-235		
Injury	Nil	Damage	Substantial	Phase	Launch	PIC Age	72

While practicing a 'hook-up' procedure, the student pilot returned to high tow position without keeping the rope tight. Excessive slack developed in the rope, which trailed back under the left wing. The tow pilot commenced a climbing turn which resulted in the rope passing up and over the rear of the port wing. The rope cut into the trailing edge of the wing and then broke. The Instructor took control and landed the glider safely with the rope still attached to the wing. This incident highlights the importance of Instructors taking control before the situation becomes irretrievable, and to be prepared to release the rope if a loop develops and immediately turn away to achieve safe separation.

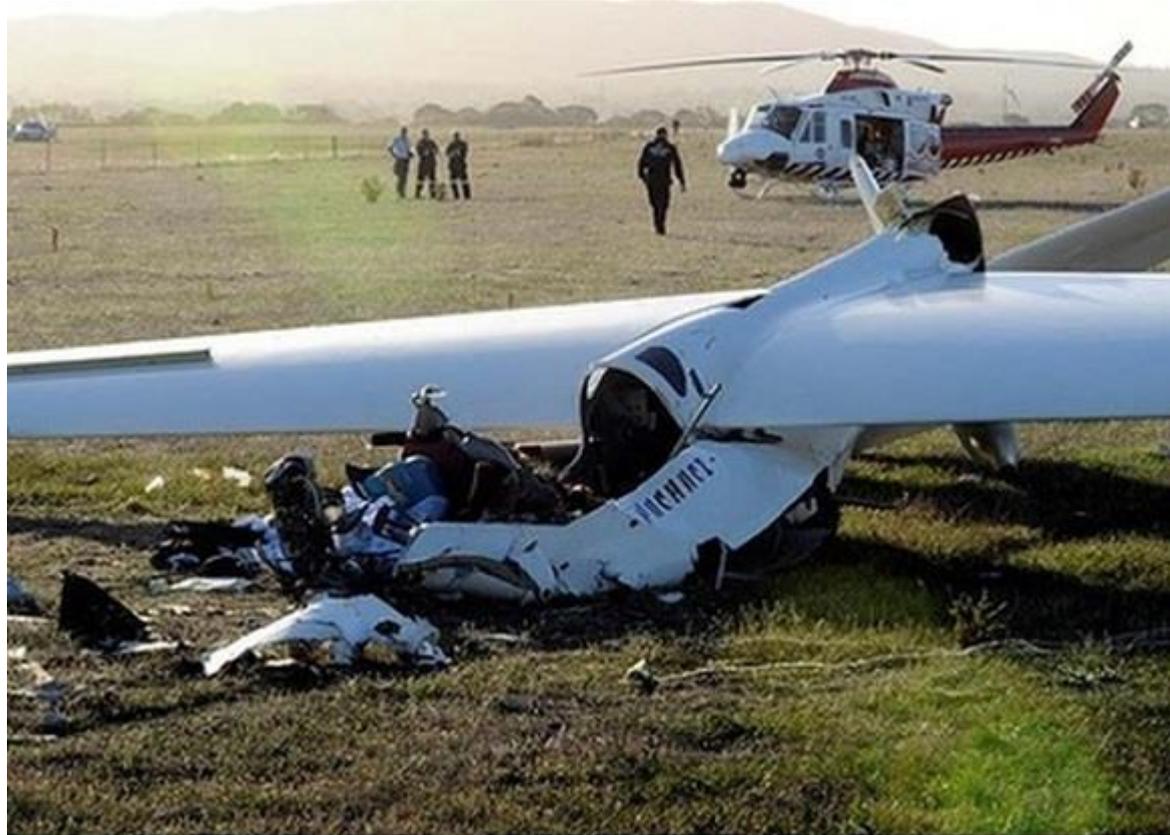
Date	1-Apr-2012	Region	VSA		SOAR Report Nbr	S-0160	
Level 1	Operational		Level 2	Terrain Collisions		Level 3	Collision with terrain
A/C Model 1	PZL Bielsko SZD-50-3 Puchacz S/N:B1979			A/C Model 2			
Injury	Fatal	Damage	Write-off	Phase	Launch	PIC Age	59
<p>GFA FIELD INVESTIGATION - FACTUAL INFORMATION</p> <p>On 1 April 2012, at 1518 Eastern Standard Time, a PZL Bielsko Puchacz glider was being used by the Grampians Soaring Club for flight training at Ararat aerodrome, Victoria. A Gliding Federation of Australia (GFA) Level 2 Instructor occupied the rear seat of this tandem glider. Shortly after take-off at a height of about 100ft above ground level (AGL) the glider was observed to commence at least two divergent excursions to the left and then right of the towplane centreline, culminating in the towline weak-link breaking at an estimated height of 200ft-250ft AGL. The glider was then observed to return to 'wings level' flight and commence a left-hand turn. During the turn the glider's left wing dropped, the nose pitched down and the glider impacted the ground in a steep nose-down attitude. Both occupants suffered fatal injuries and the glider was seriously damaged. The Australian Transport Safety Bureau was notified shortly after, but declined to investigate. A GFA Field Investigation was undertaken the following morning to assist the Police.</p>

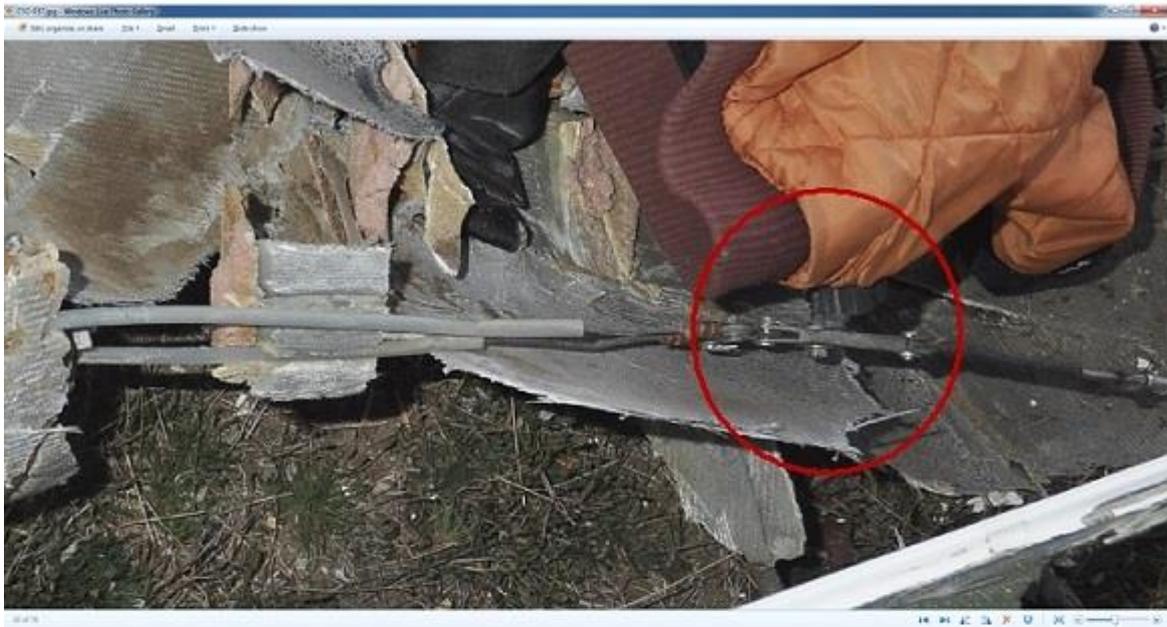
The SZD 50-3 Puchacz has the known issue of the possible bending of the turnbuckle ends attaching the rearwards running rudder cables to the rear rudder pedals. The danger of the rear occupant's foot pressing sideways at the top of the rudder pedal and onto the turnbuckle end leading to high loads and eventual fracture of the turnbuckle end is advised in the factory bulletin (BE-054/SZD-50-3/2003). Subsequently, the manufacturer issued Mandatory Bulletin BE-057/SZD-50-3/2006 in October 2006 to deal with further issues with the original design of the rudder cable attachment to the rudder pedal. The GFA considered the manufacturer's attempts to deal with the original problem did not introduce better integrity and an improved modification was approved. This modification was implemented during the aircraft's annual inspection in September 2011. In order to discount failure of the modification as a casual factor in this accident, photographs of the rear rudder pedals taken by the Victoria Police at the accident site were reviewed. These photographs confirmed the modification was intact on both rear rudder pedals, and the cables were still secured.

Left Rudder pedal with modification intact

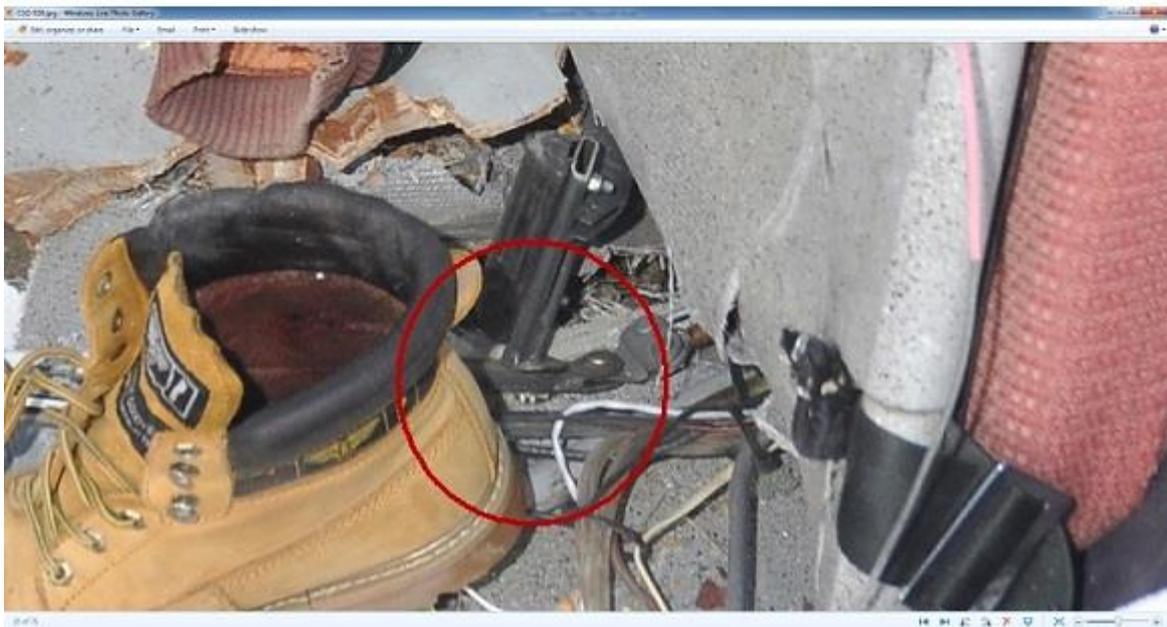
Right Rudder pedal with modification intact

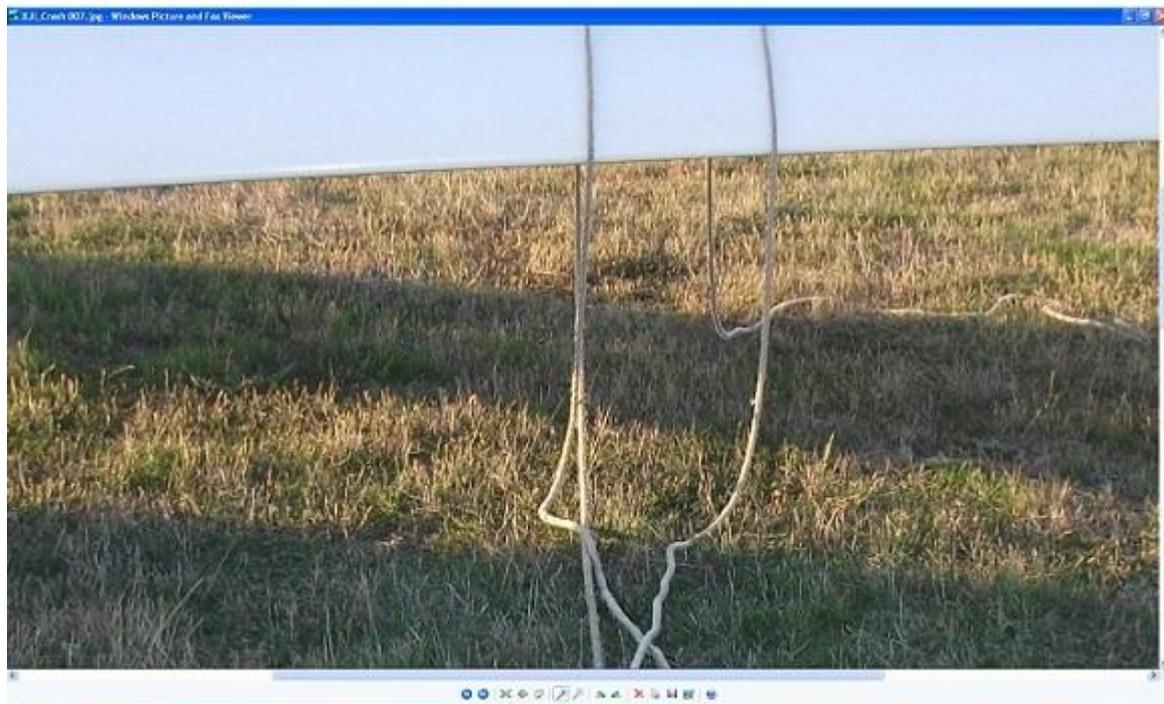
over the wing of the glider. There is a danger that a rope falling over a wing could lodge between the wing and aileron causing the aileron to lock and make control of the glider difficult. It was clear from examination of the aerotow rope that the weak-link had failed under load. The rings were still attached to the towplane. The 'glider end' rings of the aerotow rope were found near the front of the fuselage. The nose release was still functional after the accident but there was evidence of impact damage to the release actuating lever. It is most likely the rope remained attached to the glider after the weak-link broke and released from the glider at the moment of impact with the ground. After impact the rope was found draped around the left wing but there were no 'witness' marks in the aileron to wing cut-out to indicate the rope interfered with the aileron or played a role in the accident. Post-accident review indicates the rope was most likely trailing below the aircraft, and upon impact it fell and draped itself over the left wing. Normally following a rope break the pilot would release the rope from the glider to minimise the likelihood of it fouling in fences or trees during the landing. Investigation revealed some Club members were in the habit of bringing the rope back with the glider to avoid losing same when a break occurred during launch. In this case it appears the pilot either deliberately chose not to release the rope or was otherwise pre-occupied.

Close Up clearly showing rope draped over the wing.

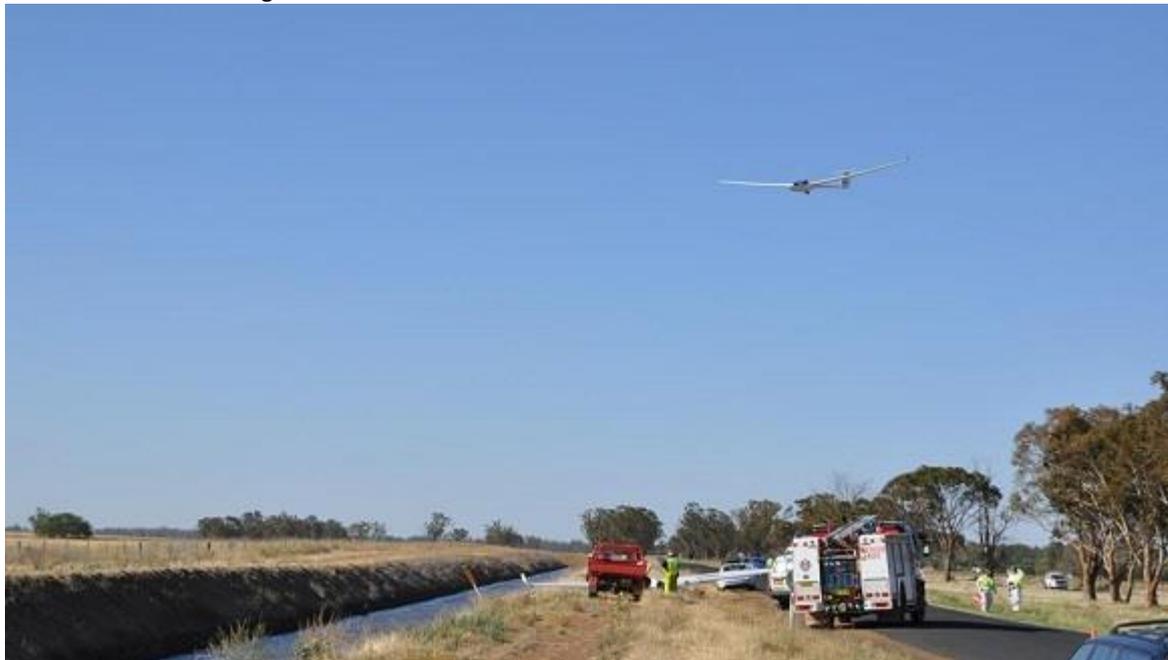
On 5 December 2012, at 1739 Eastern Daylight Savings Time, a Rolladen-Schneider LS8A glider was being flown by the registered owner and operator on a cross-country competition flight during the NSW State Championships. The flight was a closed circuit course of three legs flown from Narromine aerodrome totalling a distance of 331kms. Total flight time was 3 hours 22 minutes. When returning to Narromine aerodrome at the completion of the competition task, the glider struck the top of a tree on approach to runway 22 grass right and cart wheeled into the ground suffering serious damage. The pilot was seriously injured and suffered a pattern of multiple injuries consistent with a rapid deceleration. The pattern of injuries rapidly and inevitably led to his death in the ambulance on the way to the hospital. The Australian Transport Safety Bureau was notified shortly after, but declined to investigate. A GFA Field Investigation was undertaken that evening to assist the Police.

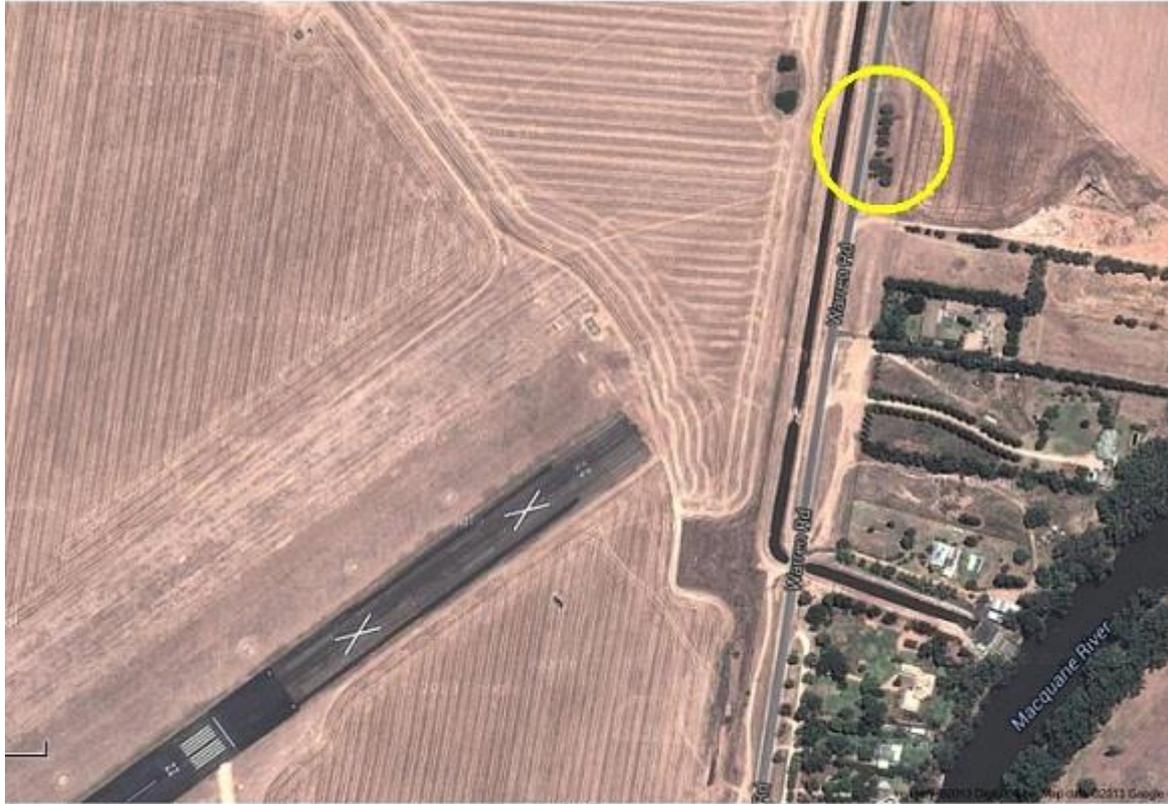
The short line of trees (circled) along the eastern side of Warren Road opposite the threshold of 22 grass right with which the glider collided.

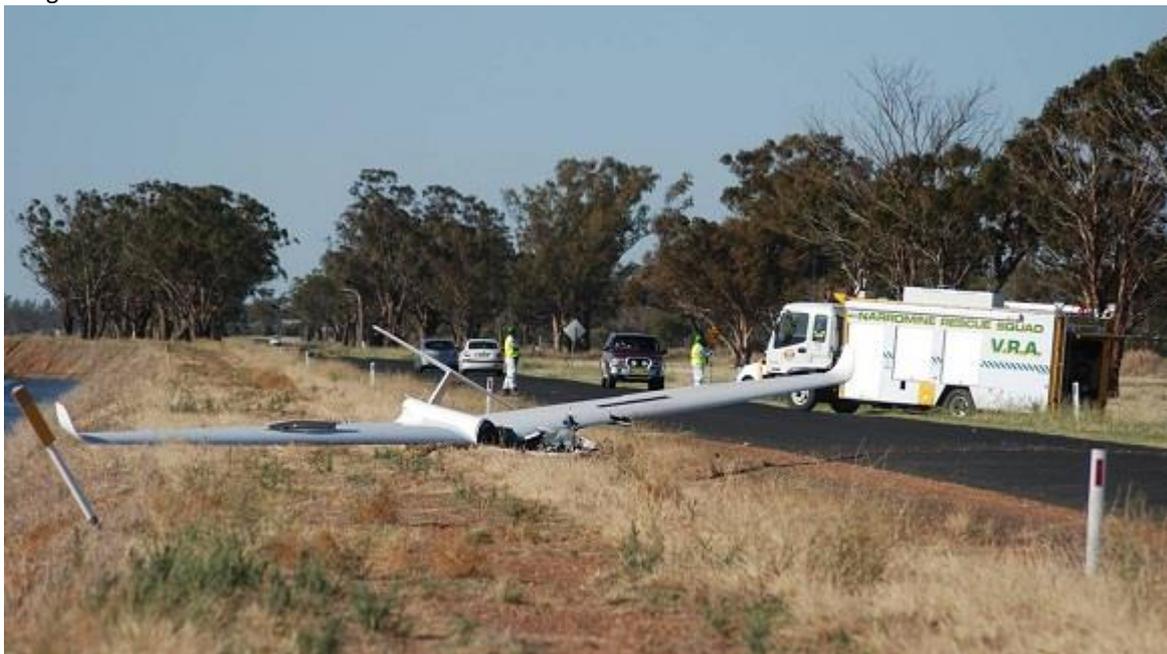
The data logger traces both show that the flight appeared well managed with good climbs and no significant low points. Lowest height before final glide was 4,500'. Duration about 3 hours. The trace confirms the strong winds but these do not seem to have affected the flight or created significant difficulty. The final glide was set some 70 – 80 kms from the finish and was executed at ca 100 knts and, while the pilot investigated some areas of potential lift and used an effective energy line for some 40 kms or more, no additional climb was required to reach the finish at an acceptable height and speed. The task was an assigned area task, which allows the pilot to vary the specific task flown within limits imposed by the 'assigned areas' and, specifically, in this instance, allowed the pilot to fly north of Mungeribar a distance chosen by the pilot and then return to the finish line at Narromine airfield. The pilot did just that, and turned into wind north of Mungeribar to return to Narromine with sufficient height to reach a safe finish. The glider reached the finish circle at Narromine (2.5 kms radius) at about 500 - 600' AGL and 100 knts aligned with the glider RWY 18 . The pilot altered course smoothly to align with the preferred runway, 22 grass right, and, without any significant pull up, continued at about 100 – 90 knts to approach 22 grass right. The pilot made appropriate calls and may have asked for some obstructions to be removed from the runway. To this point the flight looked routine and well managed. And there was no evidence of tiredness, stress or partial incapacity at any time. The physical evidence combined with witness reports shows that, over the last few points in the data logger trace, the glider was slowing and descending at an increasing rate and that at a point some 300 m from the threshold, and beyond the last data point, the glider flew into a tree some 50 ft or so high, wings level, and with no apparent attempt to pull up to avoid that tree. And the glider cartwheeled violently into the ground.

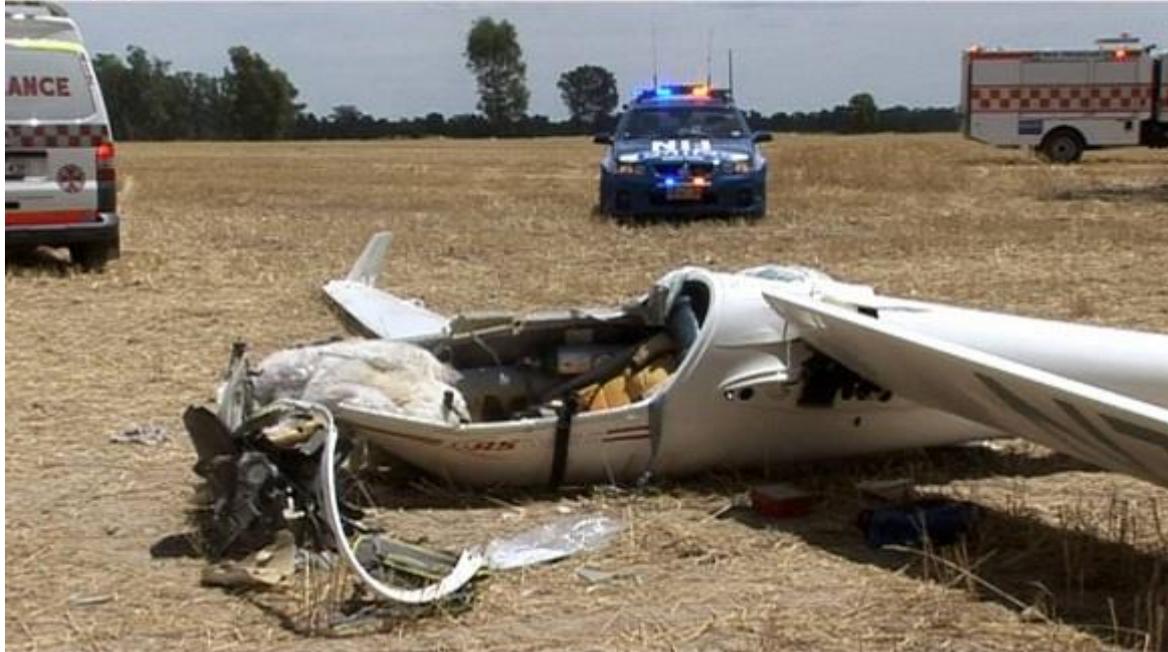
some 1,000 metres from the runway the glider pilot considered that he was too high and deployed airbrakes but heavy sink was encountered resulting in him closing the airbrakes. The pilot dived towards the ground in an effort to turn height into speed with the aim of converting the speed back into height to clear the trees ahead of him on the landing approach. The right wing on the glider impacted the tree in the middle of the paddock he was overflying causing the aircraft to slew sideways to the right. The left wing took the initial impact with the ground followed by the fuselage. The aircraft was substantially damaged and the pilot seriously injured.

Potential causal factors include: the pilot's pre-occupation with maintaining separation from the tow plane ahead of the glider; flying too far downwind of the operational runway; experiencing heavy sink on final approach; application of the theory of converting height into speed in an effort to pull up over obstacles; and cognitive tunnelling or 'tunnel vision' under stress resulting in the pilot not perceiving the tree he collided with as a threat).
