# The Gliding Federation of Australia Inc

## Occurrence Summaries

01/01/2014 to 31/12/2014

The Gliding Federation of Australia Inc  
SOAR Accident and Incident Occurrences

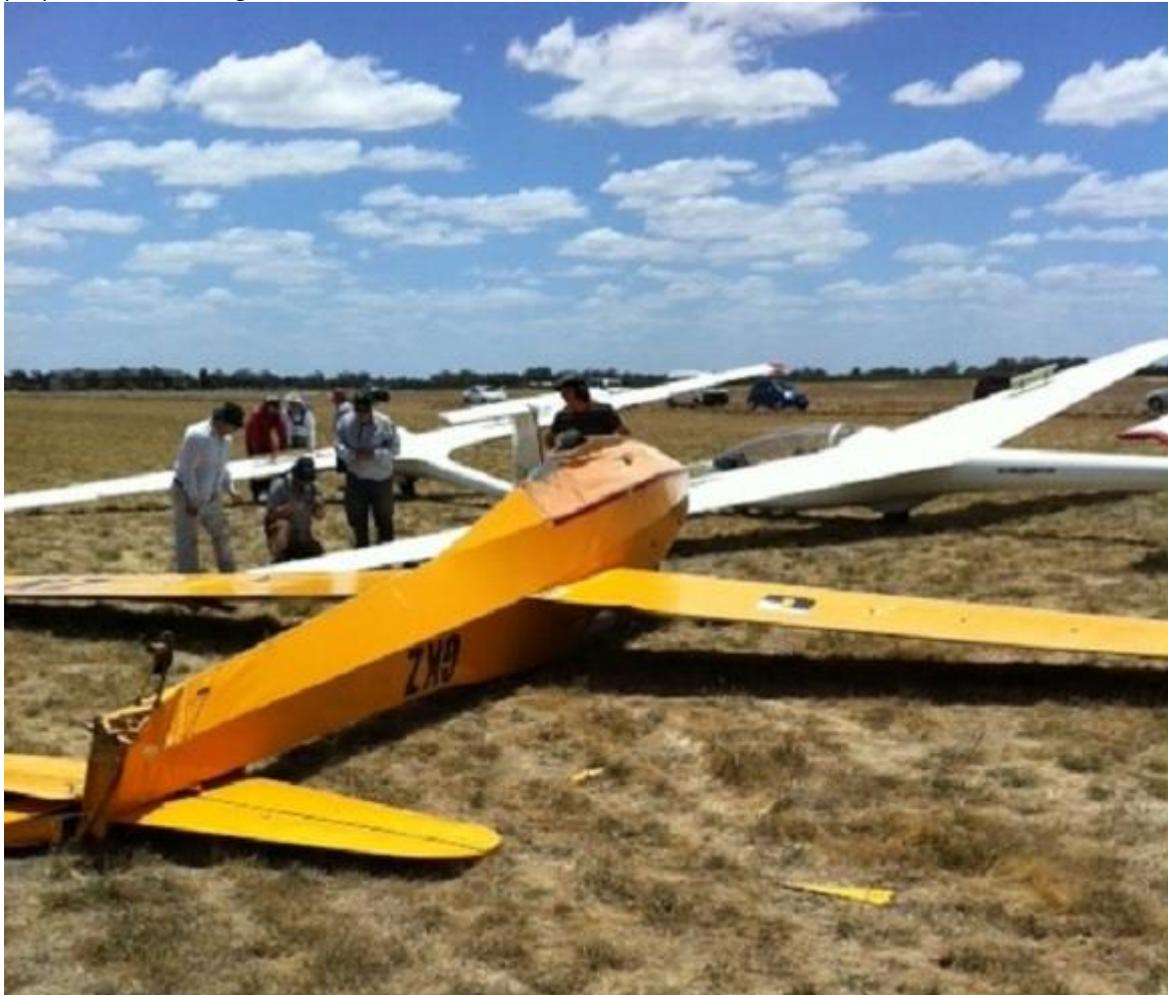
The Bergfalke was blown over by a gust/thermal while on the flight line unattended. The right wing fell across the left wing of a Puchacz glider awaiting launch, causing minor damage to the wing skin. The Bergfalke showed signs of poor glue adhesion and is beyond economical repair. This accident serves as a reminder to not leave gliders unattended on the flight line. In this case, the accident may have been prophetic due to the glue failure.

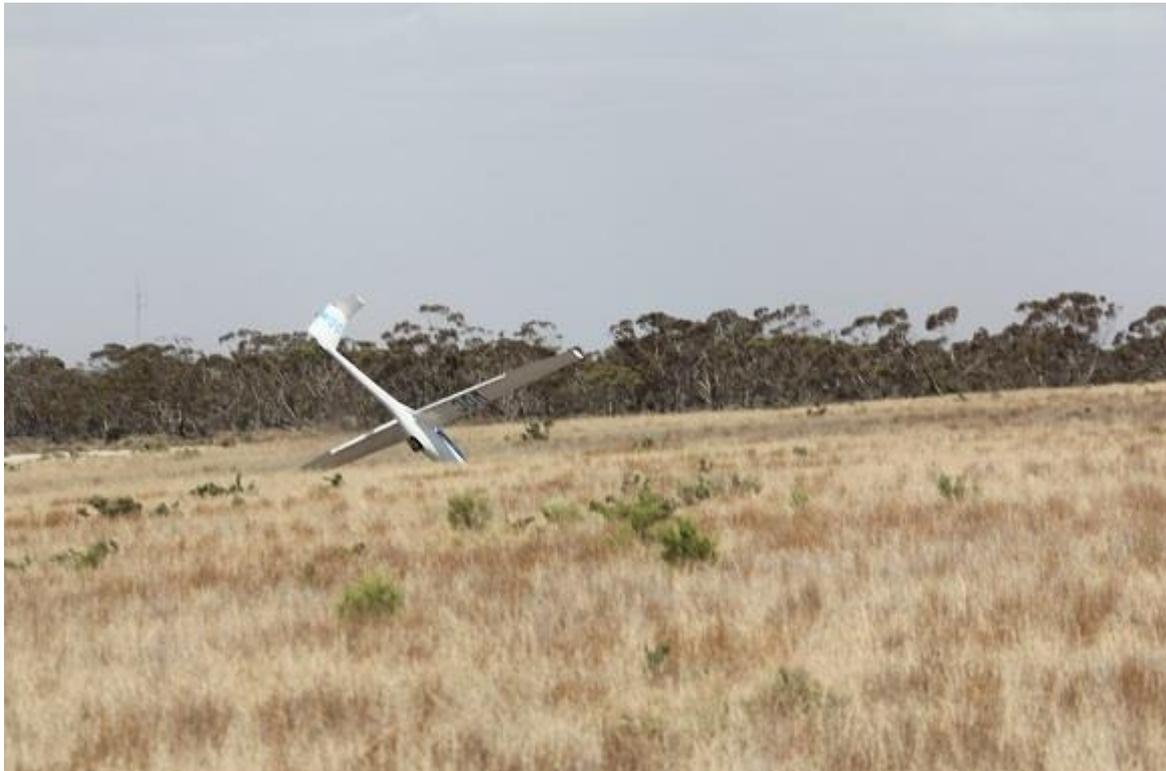
During final glide in strong and gusty wind conditions (30 to 40 knots) the pilot realised he was not going to land on the aerodrome and elected to land in a paddock outside the aerodrome boundary. Approach control

was difficult due to wind speed and lack of airbrakes (just landing flaps) and the pilot struggled to get the aircraft out of ground effect. The aircraft struck the ground main wheel and port wing first, then impacted the nose before coming to rest facing the direction of travel. Aircraft suffered broken canopy and fractured tail boom.

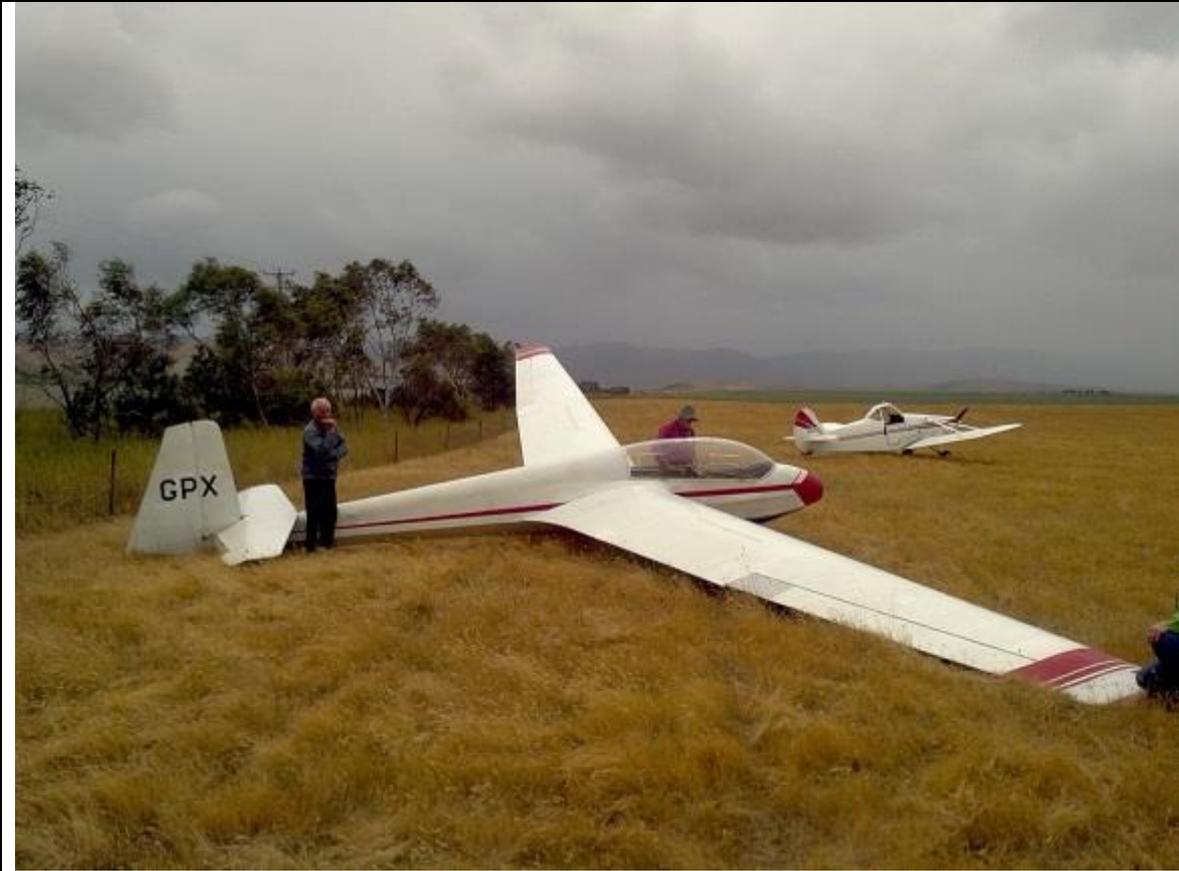
Conditions pre launch looking north.

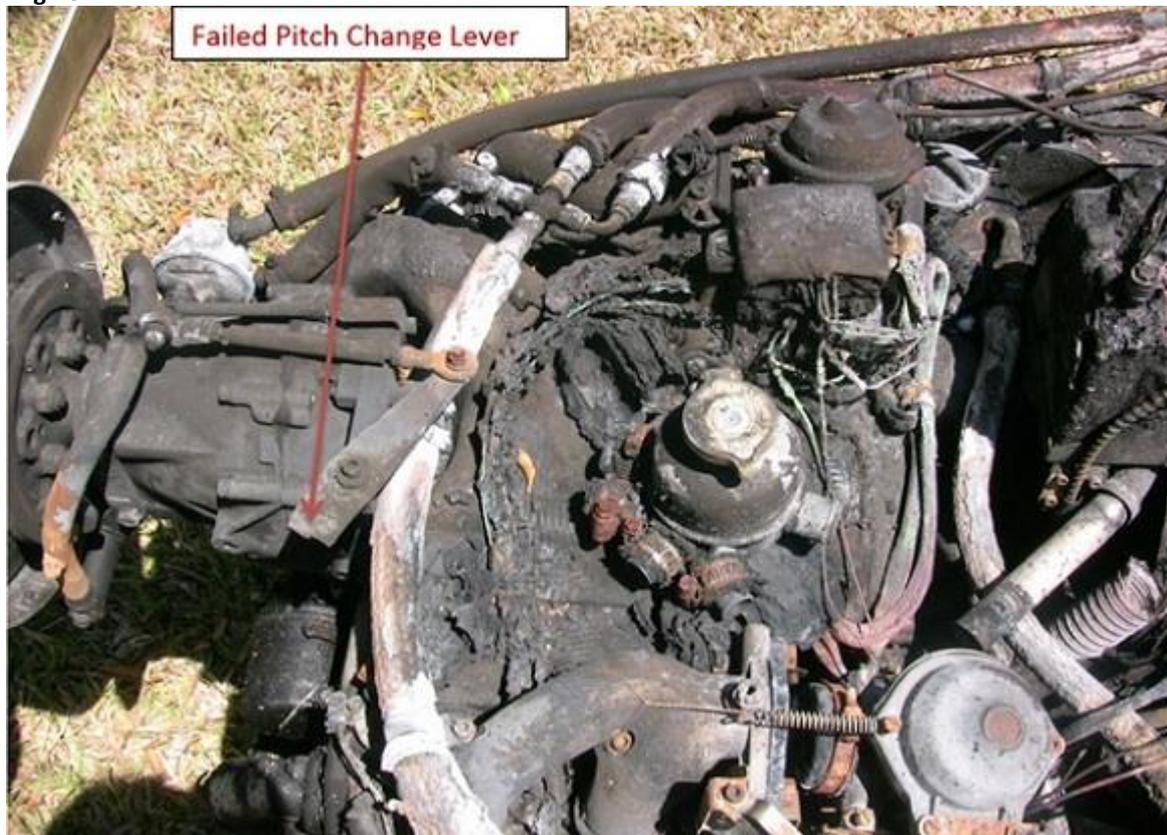
Damage to the engine and its systems was extensive. The four coolant hoses exiting the cylinder heads terminate at a small steel header tank situated centrally above the crankcase and this area sustained the worst of the damage. The return pipe to the radiator is also connected to this header tank. All five of these hoses were badly burned, the worst being the No. 2 cylinder head hose, which was completely destroyed. Hoses from numbers 1, 3 & 4 cylinders were burned to ash at the ends connecting to the header tank but were still intact nearer to the cylinder heads. The header tank, although not melted, had been subject to extreme heat, especially on the rear left adjacent to the left carburettor. There was no evidence of coolant in any of the upper hoses or the tank. The ignition coil packs and wiring to the right of the tank were severely damaged, as was the battery that is located centrally on the upper firewall behind the engine. The four hoses beneath the engine supplying coolant to the heads fared better and still contained coolant. Fire sleeving had been applied to these hoses to shield them from radiant exhaust heat and this protected them;

although their condition suggested that they had not been exposed to severe flame. The front left engine mounting rubber was severely damaged by the fire but the remaining three were still in good condition, suggesting they had received only minimal exposure to flames. All fuel and oil line connections were checked for tightness and, although the fuel line threaded connections at the fuel pump, carburettors and firewall showed signs of some torque loss due to heat/flame exposure, all were deemed to have remained fuel and oil tight.

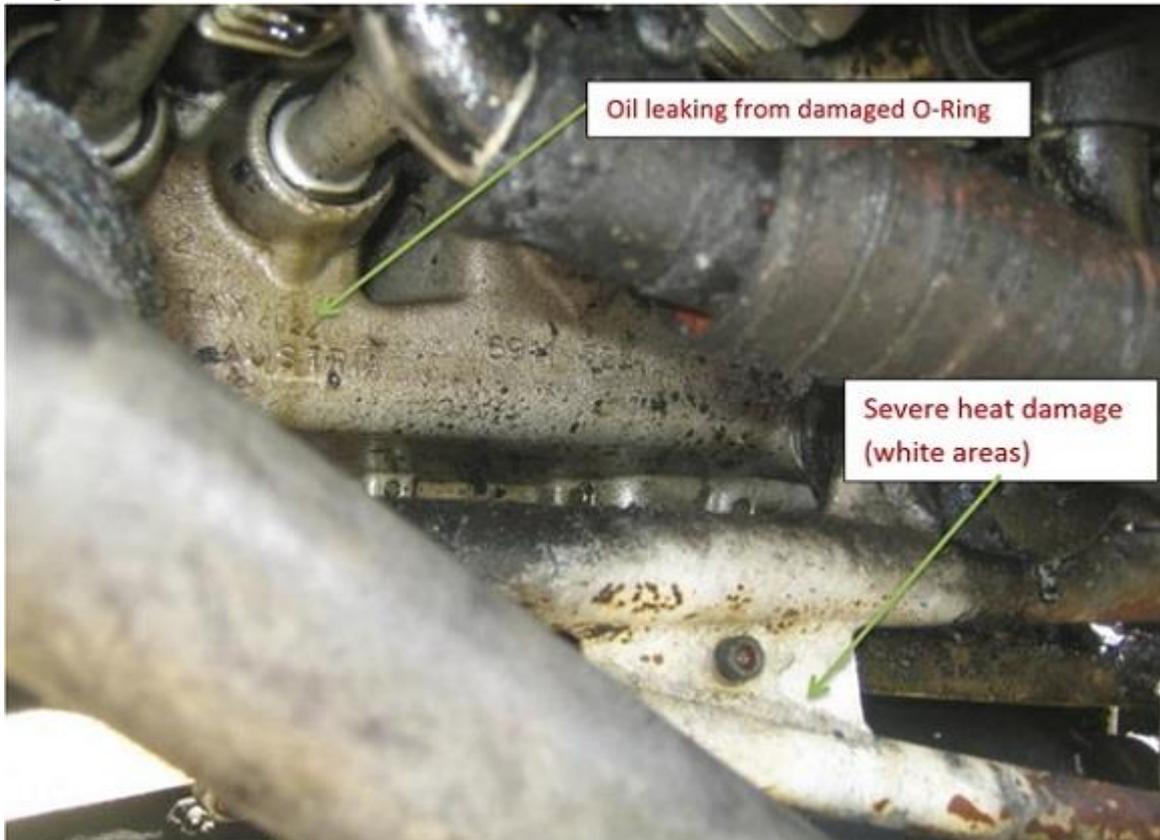
Despite severe exposure to heat and flame, especially visible on the fuel line fire sleeve where it crosses behind the gearbox, all the oil and fuel lines were intact and undamaged; the fire sleeving obviously performing its designed function. The remaining protective lagging was removed from each of the four exhaust pipes and the pipes examined for cracks or leaks but all were found to be in good condition. Likewise the muffler and all pipe joints were found to be sound. The lagging on numbers 2 & 4 pipes had been subject to flame, some of which had fallen away. The remainder was found to be very brittle and fell away when touched. The numbers 1 & 3 pipes had some lagging missing but was more intact and much less heat damaged. The oil pressure sensor, located at the front of the engine adjacent to the oil pump, was severely burned and was considered to be a potential oil leak source. However, upon removal and testing with compressed air to 80 psi the unit was found to have only the slightest air leak and was determined not to have contributed to the fire. The left carburettor had been involved in a very hot fire, with the fuel bowl melted and the air filter completely burned away. The rubber coupling between carburettor and intake manifold was also burned away. The safety retaining spring was still in place indicating that the carburettor had been properly located on the manifold prior to the fire. The float bowl retaining clip was also in its correct position, indicating that the float bowl was correctly installed. Although some of this fire impinged on the rear side of the coolant header tank and the upper left rear of the cowling the hottest area was below and to the rear of the carburettor. There was no fire at the right carburettor, although the right air filter was partially damaged. An examination of the electrical system, although badly burned with most of the insulation gone, revealed no sign of electrical fusion or overload. The spark plug attachments and ignition

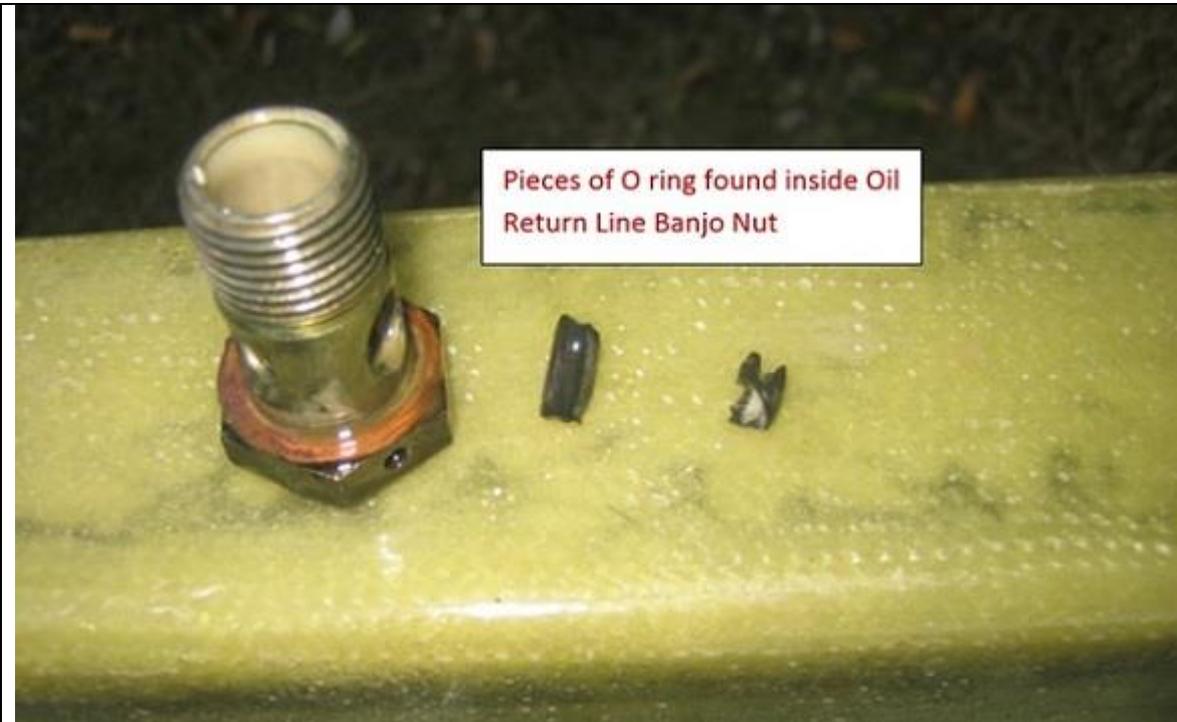
Investigation indicates the fire started near the front left of the engine, fuelled from the oil and mist leaking from the No. 2 cylinder inlet pushrod tube. The oil was most likely ignited by the adjacent hot exhaust pipe. Flames and heat were sucked upward and diagonally across the top of the engine, exiting initially via the gaps in the cowling around the oil tank inspection hatch and where the cowling attaches to firewall. Initially this fire was not severe but it intensified once the rubber components ignited. The pitch change relay lever was melted away at its outer end where it would have been in a direct path of the fire as it swept up past the front of the No. 2 cylinder. The failure of this lever prevented the pilot feathering the propeller, which resulted in the continuing rotation of the engine. This led to a continual flow of oil mist and petrol to the fire via crankcase pressurisation and the mechanical fuel pump. The cause of the oil leak was determined to be the incorrect assembly of the No, 2 cylinder head. During the process of aligning the pushrod tubes and the crankcase, the inlet side O-ring slipped out of position on the pushrod tube and was sheared off between the end of the pushrod tube and the crankcase aperture, thereby resulting in about one-third of the pushrod tube diameter remaining unsealed. The aircraft had flown on four occasions since the cylinder head installation but during this time no oil leaks or loss had been detected. The operator advised that he always removed the engine cowls when performing his Daily Inspection and that no evidence of oil leakage had been detected, nor was there any evidence of oil on the floor of the hangar where the aircraft was parked. Oil level in the tank was checked at each Daily Inspection and no oil usage/loss was seen. It is unclear why the oil leak did not become evident until after four flights, as the potential for the leak existed from the moment the O-ring was damaged on assembly.

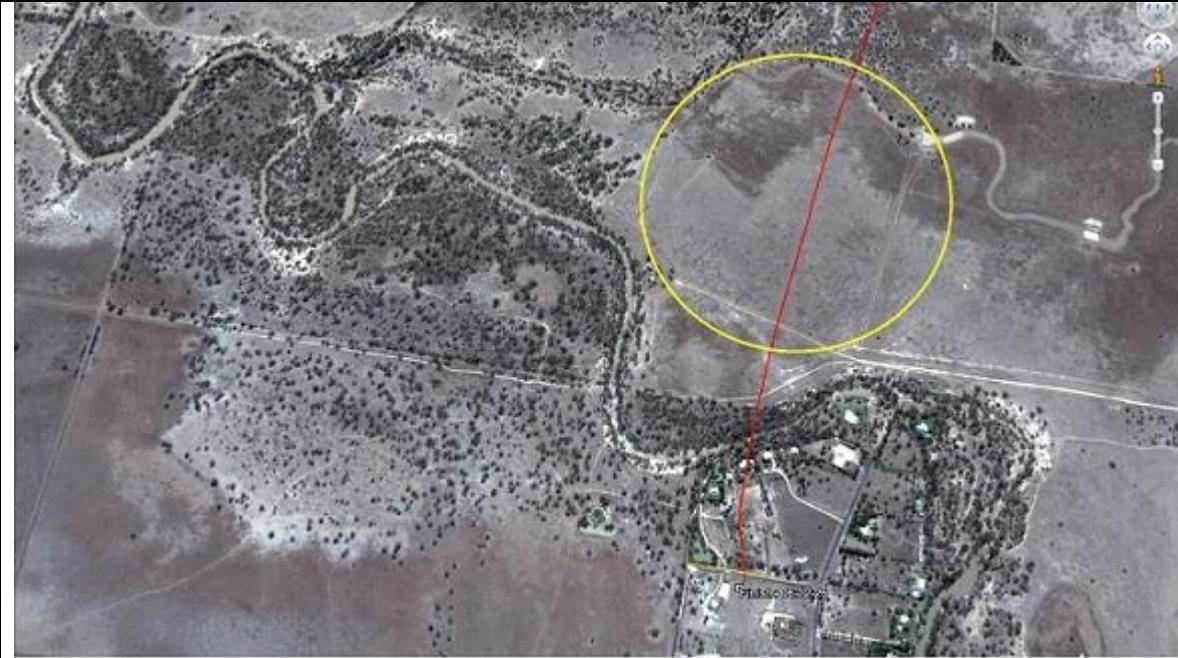
*The paddock in which the pilot intended to land is circled.*

The pilot arrived at his intended landing paddock at about 400ft AGL but realised the paddock was unsuitable. The pilot spotted an alternative small paddock some two kilometres further that he thought he would be able to reach but the glider continued to fly through descending air. The pilot flew the aircraft to very low level and initiated a pull-up over trees in order to land off a straight-in approach in the alternative paddock. After clearing the trees and while positioning for a landing, the glider's starboard wing struck a power line that the pilot had not sighted and the glider cartwheeled into the paddock tail first.

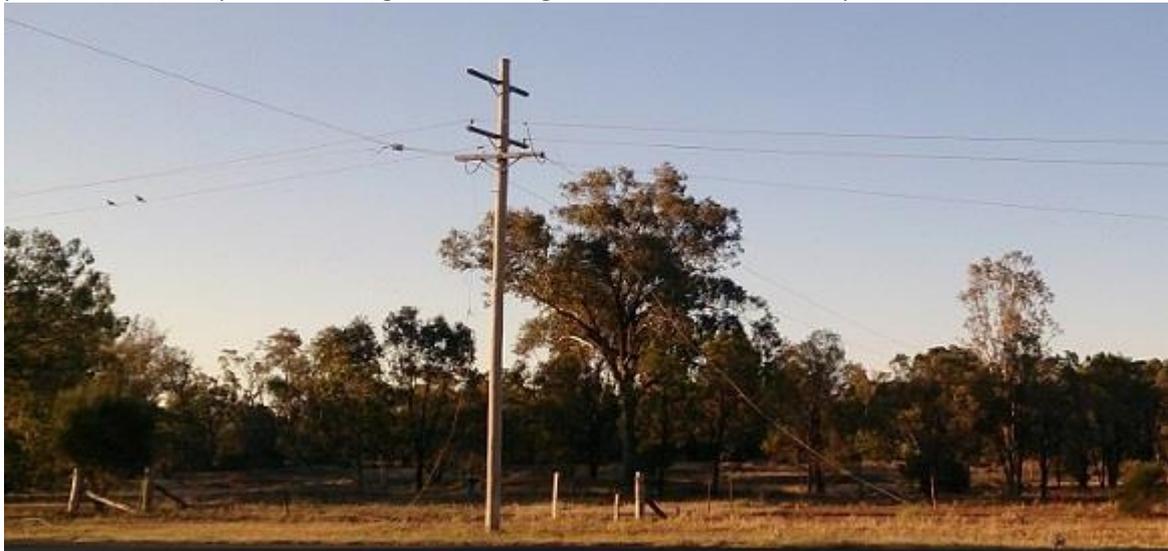
*Close-up of the Power pole showing broken line.*

The aircraft struck the power line with the right wing, midway between the fuselage and the airbrakes. This resulted in the aircraft turning through 180 degrees and impacting the ground tail-first, and then the fuselage taking an impact. This accident geometry led to the pilot suffering only minor injury.

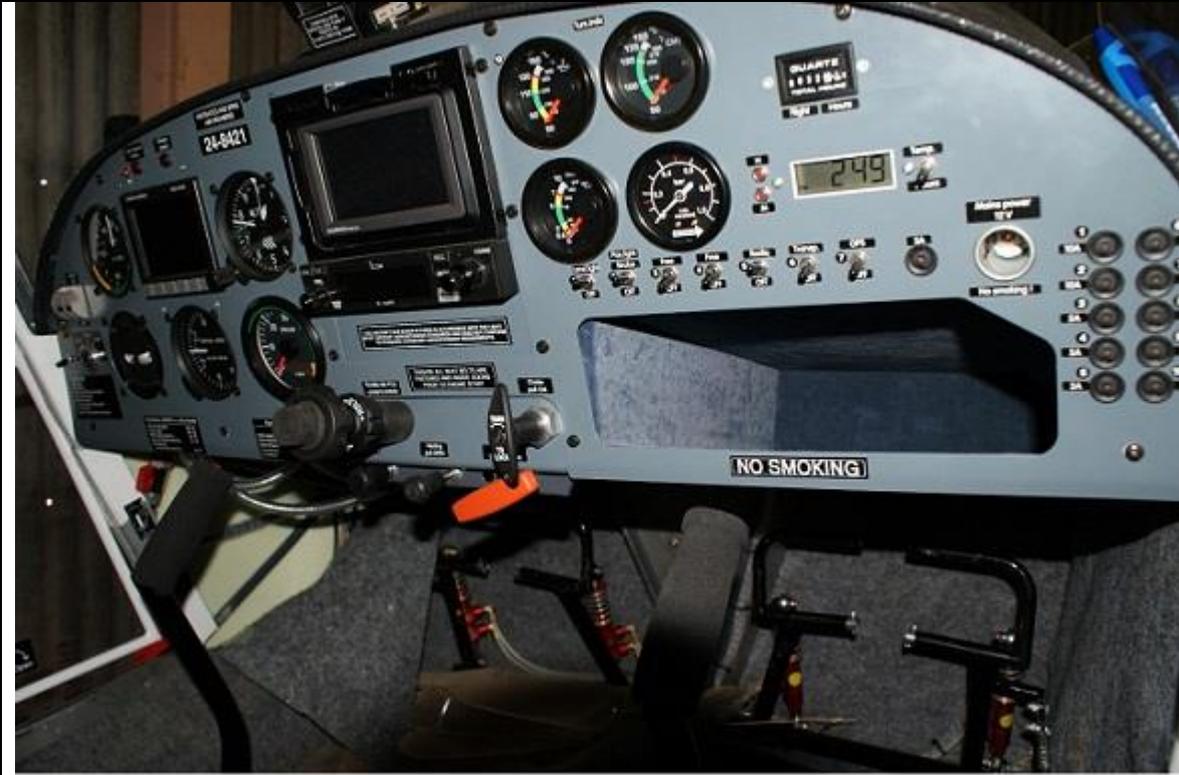
*Instrument panel showing control stick and centre throttle.*
