The Gliding Federation of Australia Inc

Occurrence Summaries

01/01/2015 to 31/12/2015

The Gliding Federation of Australia Inc
SOAR Accident and Incident Occurrences

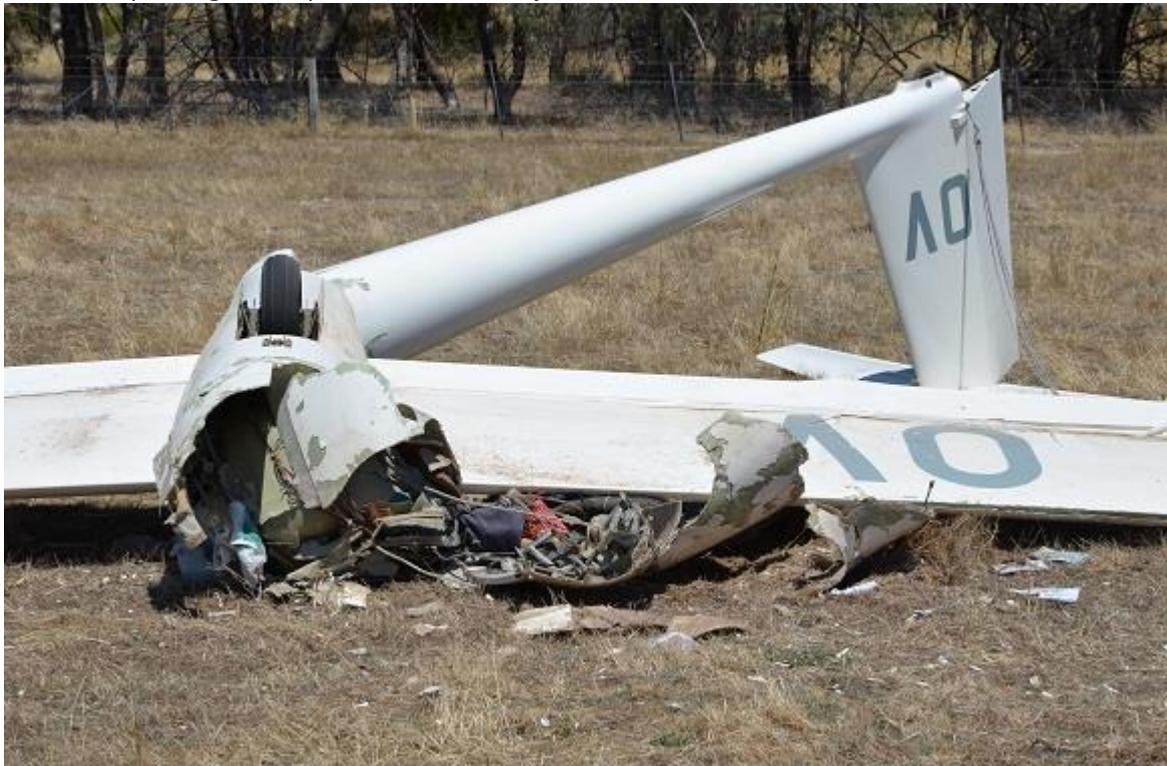
On 2 January 2015, at 1341 Eastern Daylight Savings Time, and while flying in the vicinity of Chesney Vale Victoria, a Schempp-Hirth Flugzeugbau Nimbus 2 glider departed controlled flight during a low-level right-hand turn and impacted the ground with the right wing and nose. The aircraft came to rest inverted and was substantially damaged. The pilot suffered fatal injuries.

The aircraft crashed in a rural paddock on the edge of a lake that was situated adjacent to a farmer's Airstrip. The Australian Transport Safety Bureau was notified shortly after, but declined to investigate. A Gliding Federation of Australia (GFA) Field Investigation was undertaken the following morning to assist the Police. Follow-up visits were conducted on later dates to gather more detailed information including flight data analysis, with ATSB assistance to extract data from a damaged data logger.

Examination of the occurrence site and wreckage indicated that the glider was in a right-hand turn when it struck the ground in a right-wing-low, very steep nose-down attitude. The aircraft came to rest inverted on a westerly heading. The leading edges of both wings left ground scars and the nose left a shallow indentation in the ground. The fuselage forward of the wing leading edge, which includes the cockpit, was mostly destroyed at impact. The wings remained attached to the fuselage and the tail boom was broken just behind the wings and displaced slightly to the South. The rudder remained intact but the drag chute and container had deployed due to impact loads. There was no evidence of any pre-existing airframe or control surface defect. All flight control surfaces were accounted for at the accident site. While there were multiple overload failures of the flight control system in the fuselage and cockpit areas, control continuity was established. There was little damage to the airbrake arms in the wings, which is indicative of them being in

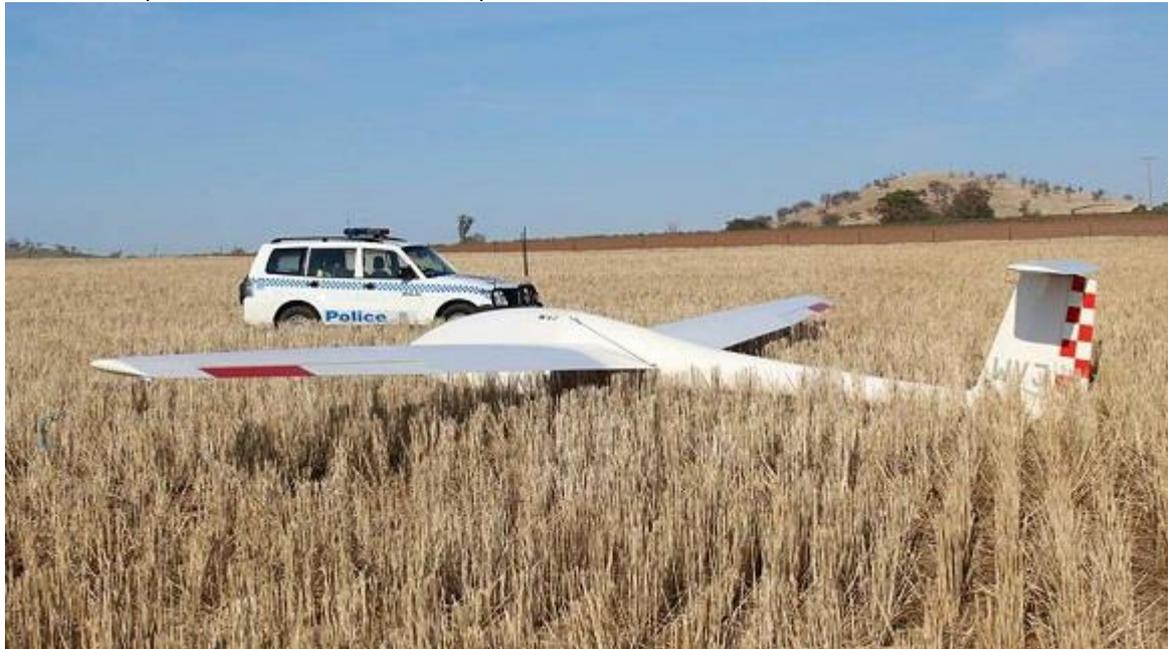
course of the flight the pilot noticed a squall developing under cumulus congestus some 10km east of the airfield. The pilot remained clear of the approaching squall but after about 4 hours the conditions began to deteriorate and the squall had developed into thunderstorms. When the squall reached the airfield the pilot radioed the Duty Instructor to advise his position and that return to the airfield was not possible. The pilot was unable to remain airborne and safely conducted an outlanding in a stubble paddock near a farmhouse some 15 kms from the airfield. After landing the pilot attempted to contact the Club by radio to no avail. As this was a local flight the pilot was not carrying his mobile phone, so he walked to the farm house to get assistance. Unfortunately the farmhouse was unoccupied, although it was evident that people were living there. Attempts to find another farmhouse proved fruitless.

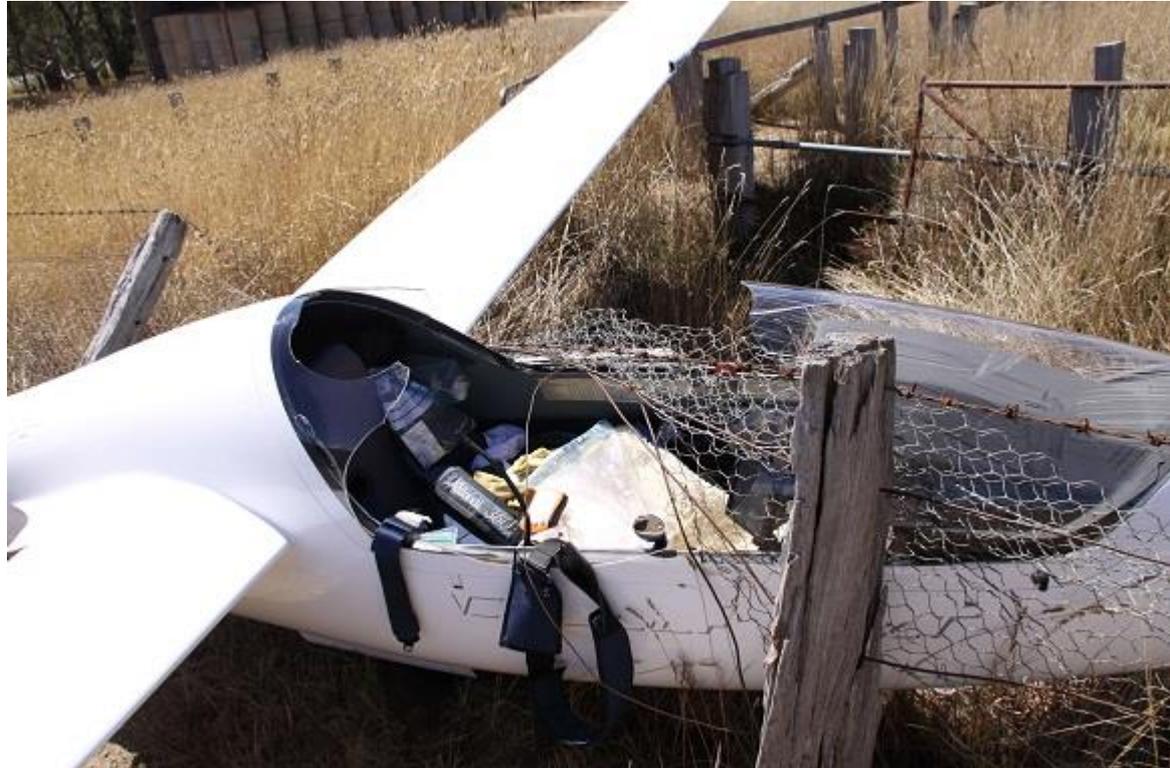
impacted a fence post rotating the glider's nose into the wire fence.

The aircraft was substantially damaged and the pilot suffered minor injury (the fencing wire coming very close to his body). This accident highlights the importance of good workload management and for pilots to focus on the right things at the right time. When flying cross-country it is important that pilots plan and think ahead so that they are always in a position to make a safe landing. At lower levels a pilot's priority will change from searching for lift to finding a suitable area in which to land. This requires good flight management and discipline. When landing in a strange paddock the pilot must ensure a proper survey is undertaken of the landing area so as to identify all hazards and ensure a safe landing can be accomplished. Starting the engine in the circuit is fraught with danger and should not be attempted. Furthermore, landing with the motor extended but not operating often results in a steep reduction in performance, which can be comparable to flying with the airbrakes extended. High workload situations during the landing phase often lead to poorly executed landings, sometimes with serious outcomes. Well-developed and fundamentally sound landing procedures and techniques will safeguard against these outcomes.

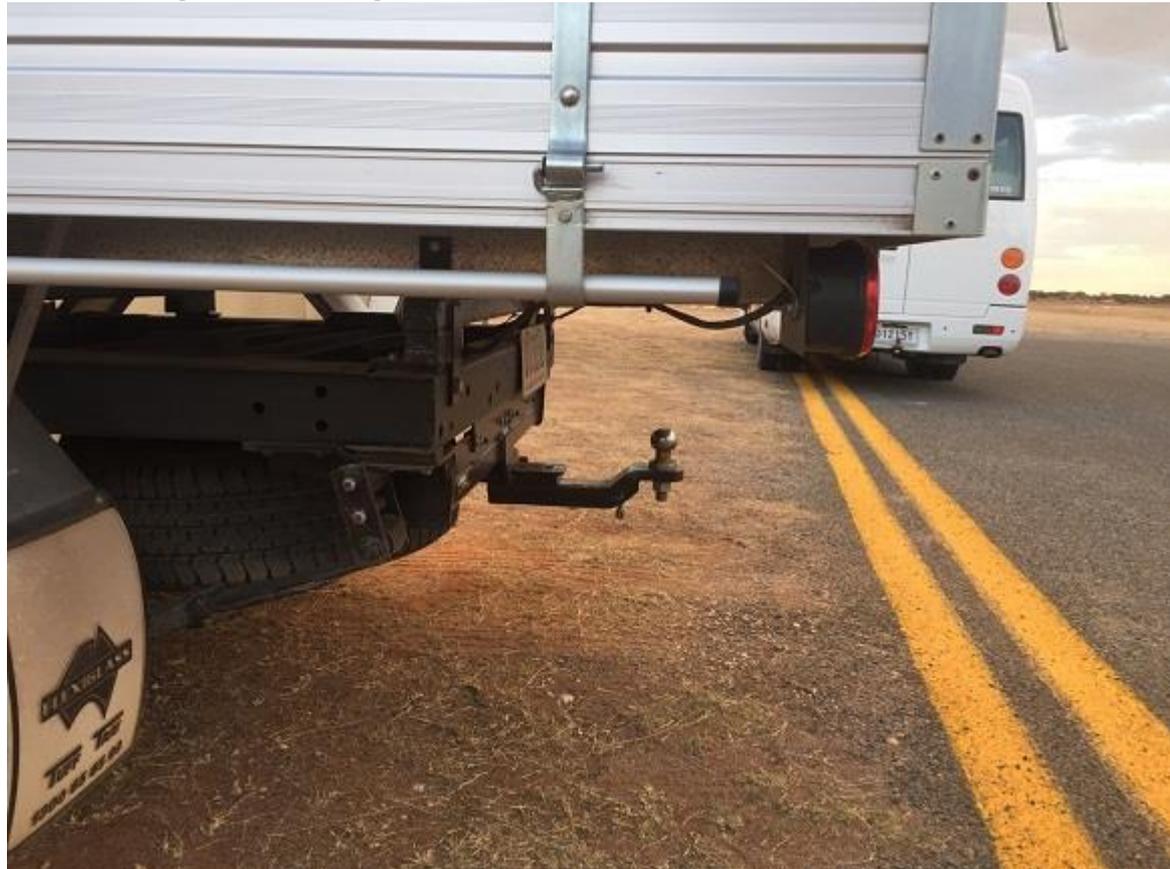
While towing the glider back to the tie-down area at end of days flying activity, the rudder came into contact with the rear of the towing vehicle during a turn causing minor damage. The vehicle had previously been identified as unsuitable for towing this glider because its tow bar was too short. Driver fatigue was assessed as a contributing factor in deciding to use this vehicle.

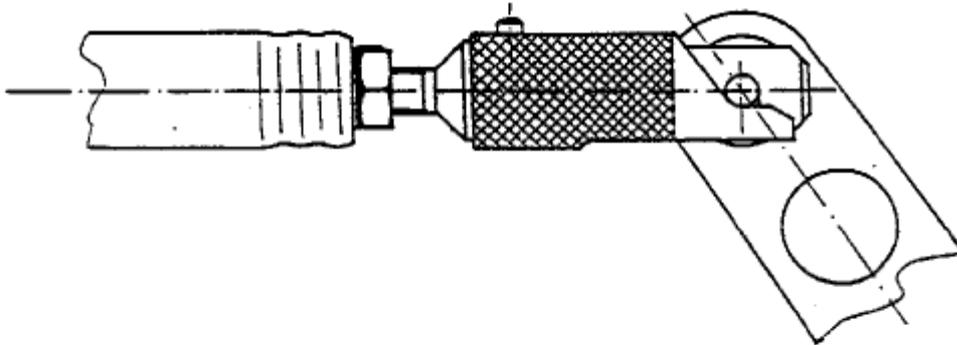
A) Joint Connected and Secured

Date	5-Dec-2015	Region	VSA	SOAR Report Nbr	S-0633		
Level 1	Operational	Level 2	Airframe	Level 3	Other Airframe Issues		
A/C Model 1	PW-5 "Smyk"		A/C Model 2	N/A			
Injury	Nil	Damage	Nil	Phase	Ground Ops	PIC Age	55
