THE GLIDING FEDERATION OF AUSTRALIA INC.

AIRWORTHINESS ALERT 2010-1

ASK-21 Sailplanes & ASK-21 Mi Powered Sailplanes

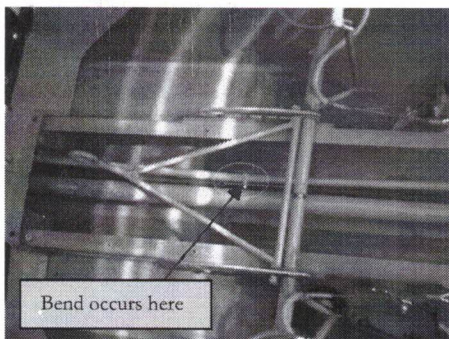
On Monday 12 July, during the performance of the Pre Take-off checks, an ASK-21 sailplane was found to have restricted movement of the controls. The restriction was caused by a bend in the pushrod connecting the front & rear trim levers. This resulted in the pushrod being displaced downwards into an area normally occupied by the aileron/elevator control tube, preventing it from moving left towards the wooden stop shown in the picture to the right. This caused blocking of right aileron travel and could have led to loss of control had it occurred during flight. Discovery of this problem while on the ground proves the value & importance of a properly conducted Pre Take-off check.

It is highly recommended that the trim pushrod be inspected for damage before further flight.

Inspection requires removal of the cockpit flooring panel forward of the rear seat. A 300 mm straight edge held against the pushrod underside will show any bend. Bear in mind that there may be a slight bend from new, but with the straight edge held centrally beneath the welded stud this should not exceed 1 mm at one end of the straight edge while the other end is in contact with the tube. With the trim in full forward, full rear and mid range positions, check throughout the full movement range of elevator & aileron controls that the trim pushrod does not contact the aileron/elevator control tube or the wooden aileron stop.

If excessive bending of the trim pushrod, or interference to the travel of the aileron/elevator tube is found, the aircraft is to be immediately withdrawn from service and this office notified.

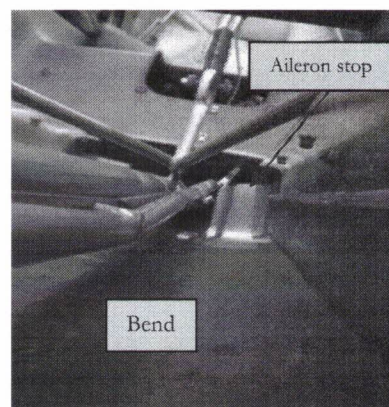
is not known for certain how the damage occurred, but high compressive loads could be generated in the pushrod by overtravel of the front trim lever once the trim has reached its forward limit, as the stops are incorporated at the rear. The pushrod has a stud welded on the top side for attachment of the trim springs. Shrinkage caused by the welding process will result in a slight downward bow and probably some local softening of the tube. Excessive compression loads would result in distortion at this focal point.

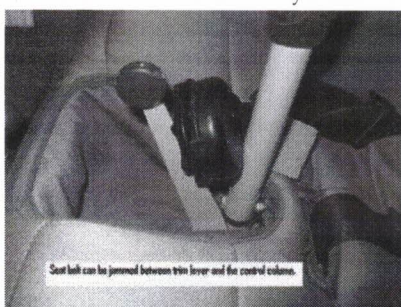
There are at least two ways that excessive load could be applied to the trim lever. The picture to the left shows how it is possible for the front harness buckle to lodge between the front stick and the trim lever. Forward movement of the stick, or more likely the rear stick, would exert significant pressure on the trim lever, resulting in very high compression loads in the pushrod connecting the two trim levers. Similar loads could also be applied if an occupant entering the front cockpit in an awkward manner accidentally put a foot on the front trim lever.
