## THE GLIDING FEDERATION OF AUSTRALIA INC

### Airworthiness Alert 2015-2

### Premature release ASK21mi VH-NQM

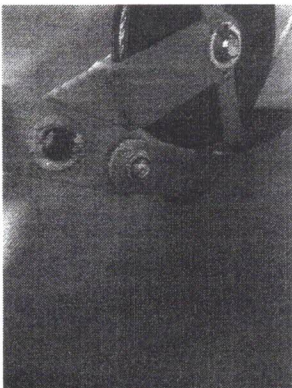
The fault was the over-tightening of a nut and bolt in the release circuit. The design unfortunately requires the nylock nut not to be tight. Being tight can stop the release closing over-centre.

The hook was removed and tested. The over centre readings were all within the normal range. The hook was reinstalled and pull back measurements were then taken at the front release knob. It was found that the pullback force reduced markedly just prior to the full closed position. The knob did retract fully. It was found that the release had not reached the fully closed position with the arm still 1-2mm from the over centre stop. Letting go of the release knob from the fully open position (allowing rapid closing) allowed the release to fully close. With normal controlled operation of the release, the stop was not reached.

It was found that the bolt attaching the pulley system to the Tost lever (shown in photo) was too tight causing binding just prior to the fully closed position. Loosening the nut slightly allowed normal operation. The fault and remedy was repeatable. The aircraft has completed 7 flights since rectification without further occurrences.

Perform a functional check of the system ensuring free and a non-restricted actuation throughout the full control range. Ensure that the nut described in the attached report is free to rotate without restricting the movement of the mechanism. Further, inspectors must be diligent and understand the mechanics of the mechanism when performing maintenance and inspections. The slightest overtightening or binding even in a secondary control system has safety implications.
