26 May 2009

CANCELLED 14 OCT 2022
REFER GFA AN 0170
AIRWORTHINESS ALERT 2009-2. SZD-50-3 PUCHACZ

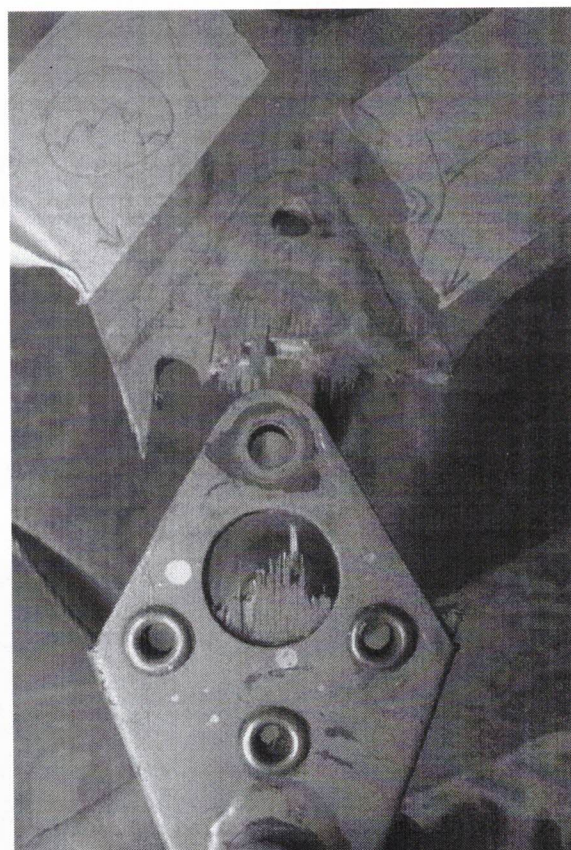
During an Annual Inspection the ply plate in the base of the fin which supports the rudder drive quadrant mounting bracket was found to be broken. Inspection of a second aircraft revealed similar damage.

The drive quadrant pivots on a steel bracket fabricated from two diamond shaped plates with side gussets & is attached to the plywood by three tubular rivets and an 8 mm bolt at the forward end. A nylon bush attached by this bolt serves as a rudder overtravel stop by limiting rotation of the drive quadrant. There are lightening holes in the upper & lower metal plates, through which the ply is visible.

The failures occurred spanwise between the tubular rivets on the left & right of the bracket, and may be visible in the lightening holes. It could be difficult to detect during a Form II and would be virtually impossible to detect during a normal DI.

When the rudder cable circuit & pedal stops are correctly adjusted the quadrant does not contact the rear stop, but incorrectly set pedal stops could permit significant foot loads to be applied to the rear stop. Violent deflection of the rudder in strong wind could also cause the quadrant to come in contact with the rear stop. This would be exacerbated by loose rear cables.

Before further flight the integrity of the plywood within the metal bracket must be checked.

1. Remove the rudder.
2. Slacken the rudder cables and remove from the drive quadrant. It is not necessary to remove the drive quadrant.
3. Remove the 8 mm bolt and the rudder stop, but **do not** remove the tubular rivets.

4. Check the ply for damage by gentle up & down movement of the bracket while observing in the area of the lightening holes above & below. Also apply a firm rearward pulling load (by hand). Cracks may be visible in the edges of the ply, but these could well be hidden by the gussets on the sides of the bracket too. (See diagrams on Page 1)

5. If damage is detected in the ply the aircraft is not to be flown until repairs have been carried out. Contact the GFA Airworthiness office for repair instructions.

6. If no damage is found the aircraft may be returned to service. When adjusting cables ensure correct tension is applied & check rudder deflections after refitting. Deflection limits are adjusted at the pedals & if correct the rudder drive quadrant will not contact the rear stop.
