THE GLIDING FEDERATION OF AUSTRALIA INC.

ELEVATOR HINGE PIN FAILURE IS-28B2 & IS-28M2.

30 January 2008

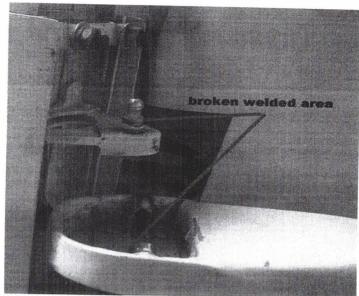
An Australian club has found a broken elevator hinge pin in the left elevator of their IS-28B2 glider. On closer inspection the hinge pin in the right elevator was also found to be cracked. The hinge pins in question are the inner ones which also serve as a locating pin for the elevator connecting yoke which couples the left & right elevator root ribs together during rigging and transmits the drive from the elevator push rod. It is not possible to detect the failure unless the tailplanes are in the folded position and the connecting yoke separated from the elevator root ribs. The attached sheet shows photos of the damaged components.

Left Elevator hinge & root area showing Hinge Pin completely detached from bracket on root rib

BEFORE FURTHER FLIGHT:- Derig the tailplanes and move the yoke aside. Thoroughly clean the area around the pins & inspect the flange area of the pin for cracks with a X10 magnifying glass. A digital camera set at high resolution & image viewing on a computer screen using the magnifying tool is also an effective inspection technique.

If a crack is found the aircraft may continue in service provided the crack does not extend for more than 25% of the pin circumference. If cracks longer than this are found the aircraft should be grounded and this office contacted for further advice.

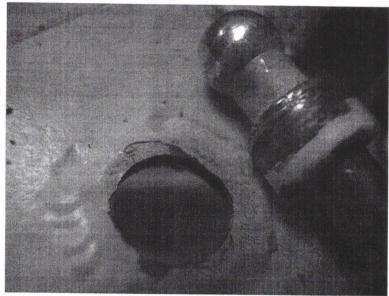
Left hinge pin failure area

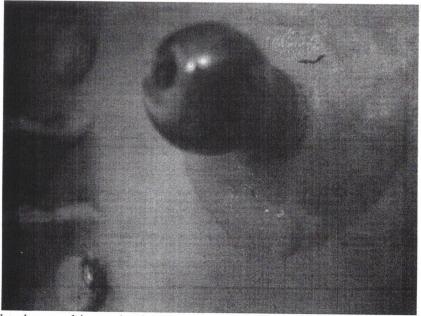
Right elevator hinge pin showing cracking around 40% of circumference
