THE GLIDING FEDERATION OF AUSTRALIA INC.

AIRWORTHINESS ALERT A2007-2

TOW RELEASE CABLE FAILURE:- DUO DISCUS / JANUS.

07 August 2007.

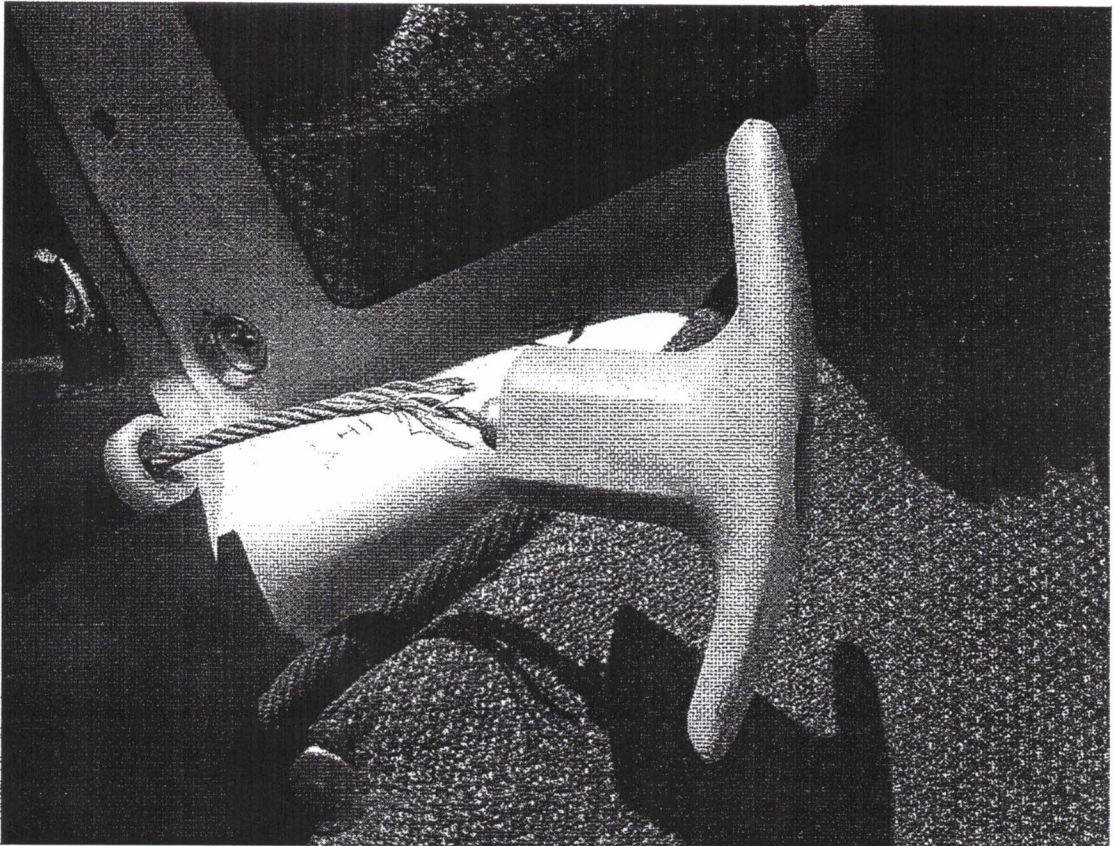
An Australian Duo Discus operator has found a near total failure of the Tow release cable at its exit point from the "Tee" shaped release handle in the front cockpit. The failure was not easy to detect as the broken wires were effectively shielded from easy view by the protruding steel swage at the base of the release handle (see photos on reverse). There was no cable damage at the rear cockpit release handle. The damage appears to have been initiated by a sharp edge on the inside of the steel swage.

Cable damage at exit of Tee handle (Front Cockpit)

BEFORE FURTHER FLIGHT:- Carefully examine the cable for broken strands at the exit of the release handles in both cockpits. If damaged strands are found repairs must be carried out before returning the aircraft to service. Note: locally available 1/8" cable may be safely used in place of the 3.2 mm cable now being used by Schempp-Hirth. Please detail your findings on the tear off strip below & return to the GFA secretariat by 28 August if possible.

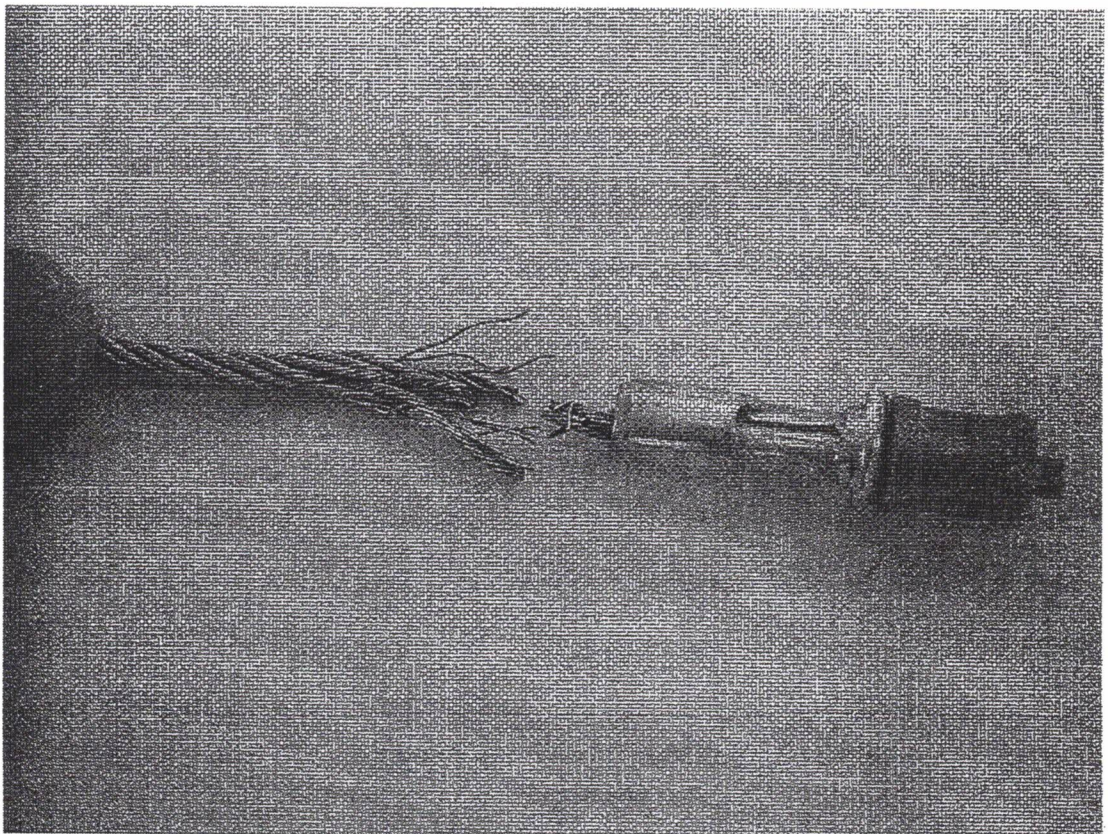
Three remaining strands of the cable protruding from the swage were cut to remove the tee handle.
Note: all fatigued strands are broken exactly at the opening to the steel ferrule/swage.
