The Gliding Federation of Australia Inc

Occurrence Summaries

01/01/2018 to 31/12/2018

The Gliding Federation of Australia Inc Accident and Incident Occurrences

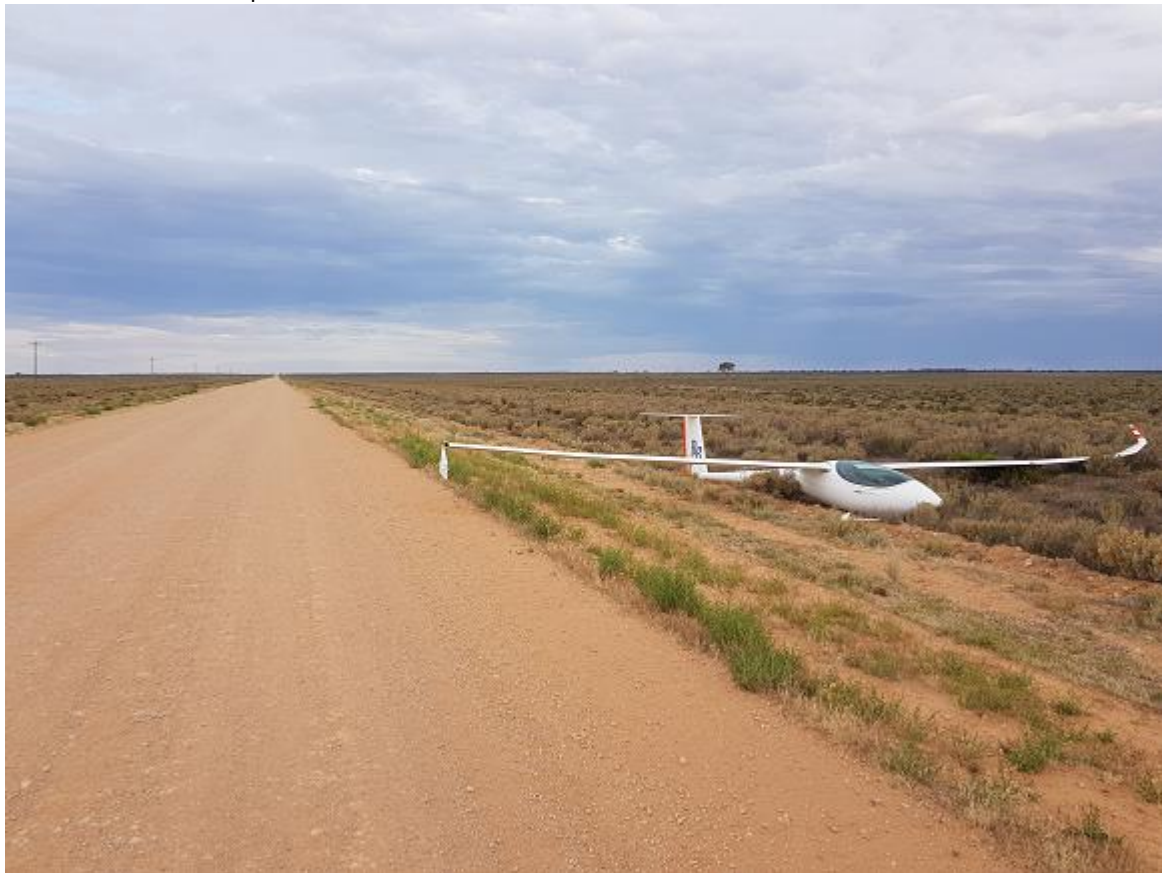
The aircraft suffered significant damage to the lower fuselage, the undercarriage box and to the main frame immediately behind which carries the rear wing lift pins. The uncommanded retraction of the main gear also resulted in the tailwheel retracting as they are interconnected. The tailwheel retracted with vigor, over rotating the frame and punching two holes into the base plate of the tail tank. After the flight the pilot noted *"there is no question of my hydration state as I super hydrate prior to takeoff, connect myself to a catheter for flight, and pee about 1½ to 2 litres during the flight as a result of very regular drinking in flight. I also eat mixed nuts, and fruit in flight very regularly. I do believe that I was pretty peeved off with the glider – and to a lesser extent myself for letting it distract me during an unexpected out landing."* The pilot also noted that they spent the 2 weeks prior to the competition rectifying problems to get the glider ready, which eliminated planned practice and familiarity flying with the glider.

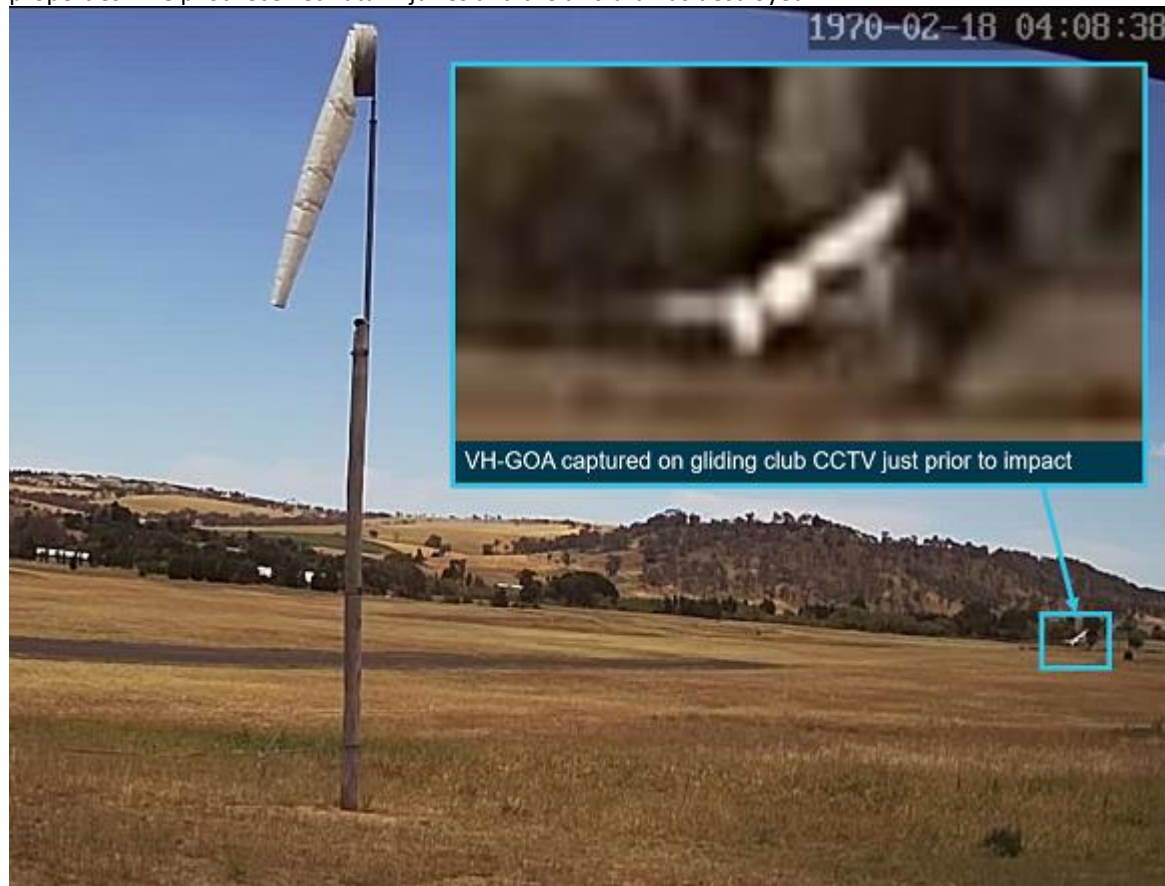
Figure 4: The glider immediately before impact. Source: CCTV camera still image, modified by ATSB

canopy was jettisoned and by the time the glider descended to about 500 ft AGL, more of the fuselage was engulfed in fire. At about this time, at least one of them called emergency services. The soaring club's closed-circuit television camera recorded that the glider banked left just prior to impact (Figure 4). A witness similarly reported that the glider's left wing tip impacted the ground first, before it came to rest in an inverted position. The wreckage continued to burn after impact, and a fire spread to the surrounding grass. Some witnesses moved to the accident site with handheld fire extinguishers to control the fire. About 10 minutes later, fire services arrived on the scene and extinguished the fire before it spread to neighbouring properties. The pilot received fatal injuries and the aircraft was destroyed.

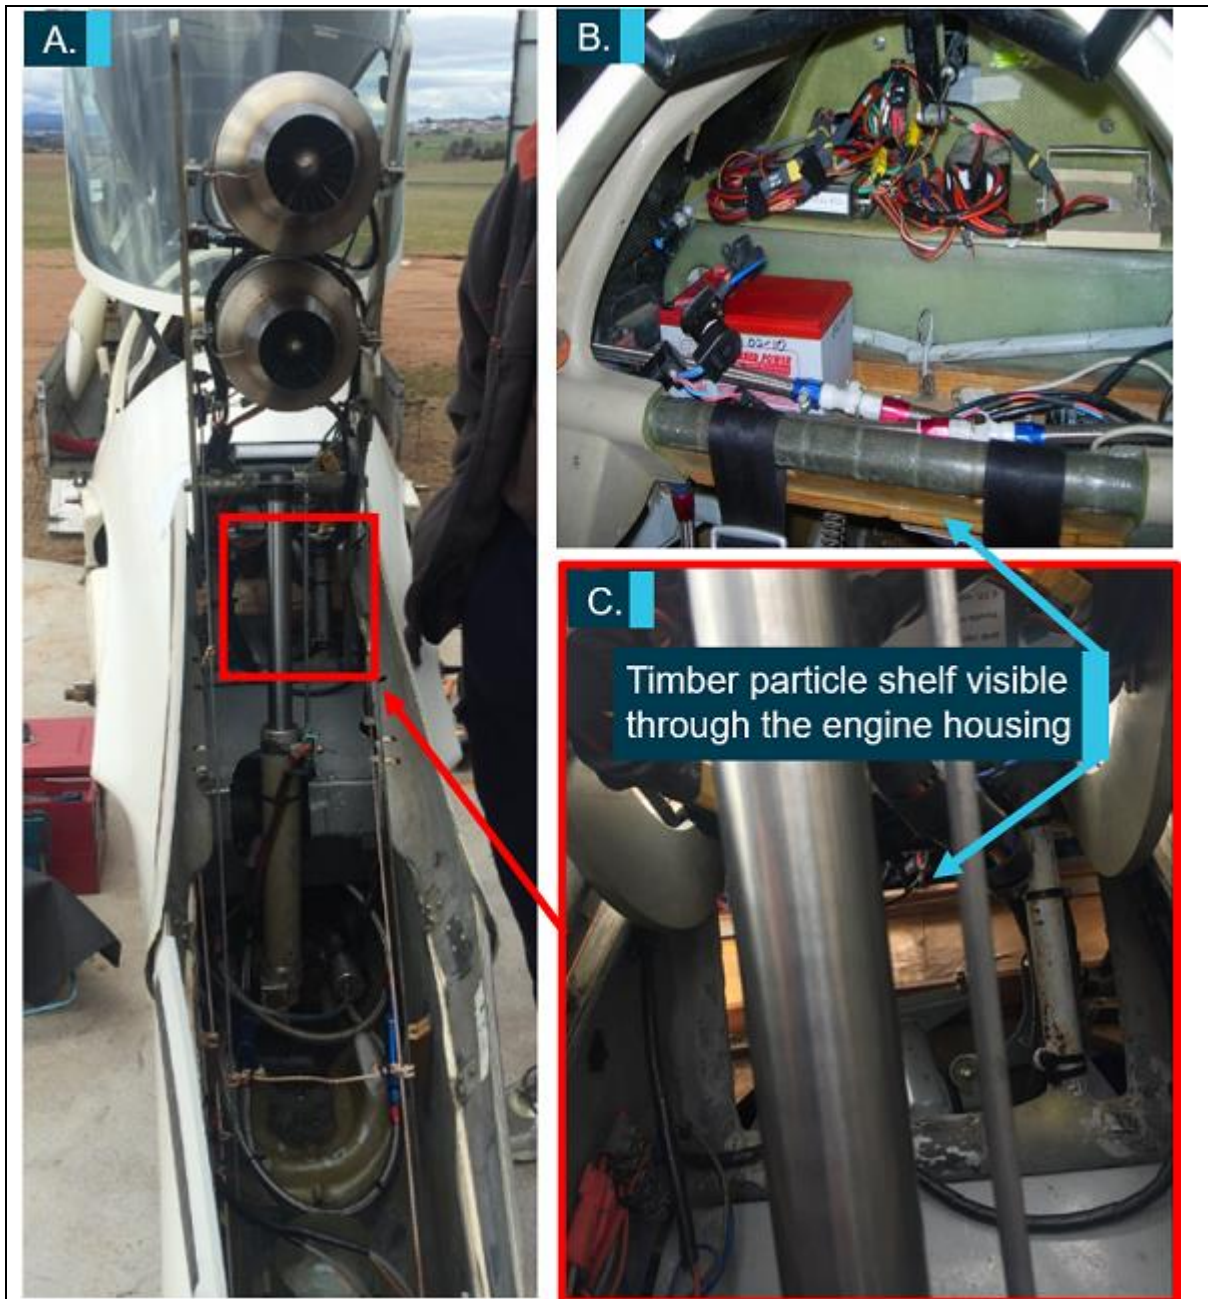
Figure 7: Engine housing and cockpit (A. Engines – rear view, B. Cockpit area – rear view, C. Area between engine housing and particle shelf). Source: Gliding Federation of Australia, with permission.

Sealed firewalls reduce the spread of fire and prevent the leakage of flammable substances, like propane gas or diesel, reaching the cockpit. When lowered, the engines were accommodated within the fuselage tail boom (Figure 7, item A). Regarding the aircraft design, Schleicher confirmed that the 'ASH-25E was not [originally] equipped with a forward firewall' and it appeared that during the subsequent modification, one was not added. Schleicher also confirmed that 'the factory-made engine compartment was primed with a fire protection paint'. Between the engine housing and the shelf in the cockpit, there was an unobstructed opening through to the timber particle shelf (Figure 7, item B and C). In their investigation report, GFA stated that "it is likely that when the two stroke engine removal [was done], the electronic shroud cover and carbon fibre electronics bay were removed from the aircraft and not refitted." An inspection of the images of the particle shelf, and remnants of fuel lines, indicated that there did not appear to be any heat protective sleeves used.

Following the occurrence, the Gliding Federation of Australia published an Airworthiness Directive and Airworthiness Advice Notice, both entitled Engine Compartment Fire Containment and Retardation, which provide guidance regarding fire safety. The Airworthiness Directive requires all powered glider operators to inspect and repair fire retardant paint, fit 'in case of engine fire' cockpit placards, and ensure there is no flammable material on the cockpit side of any firewalls.

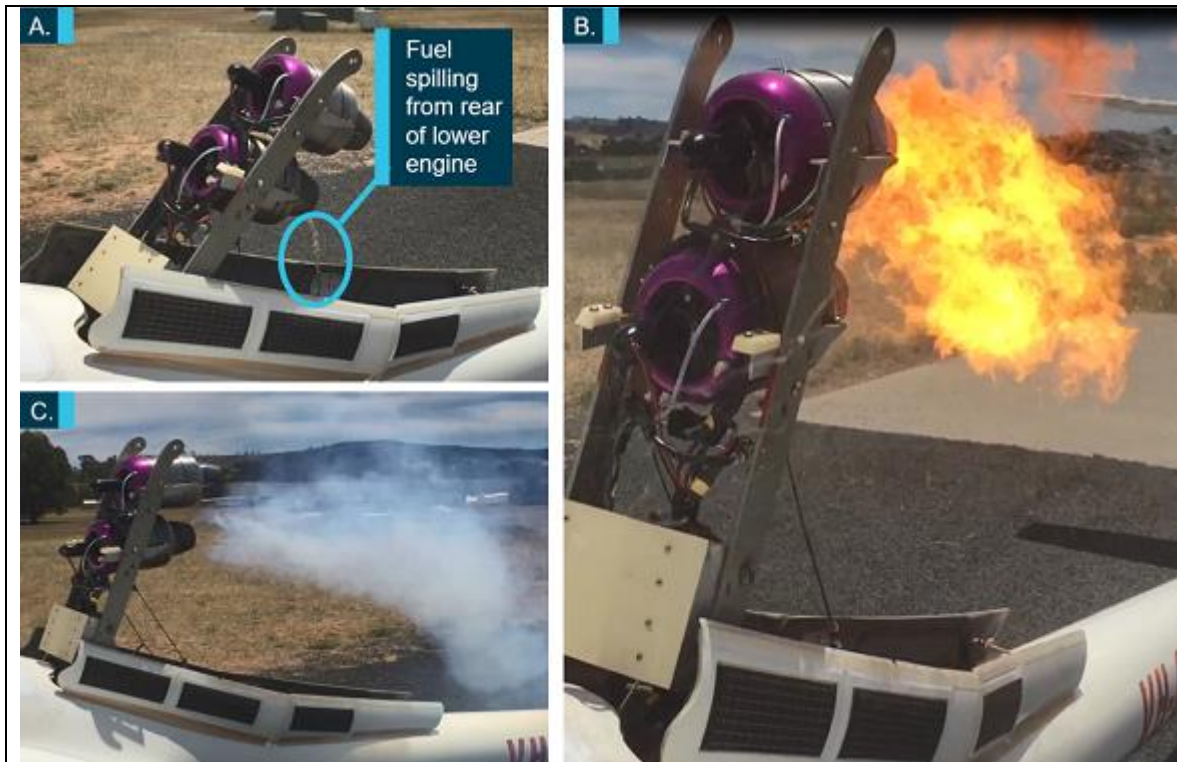
Figure 8: Photographs from engine testing. Source: witness, with permission

On the day before the occurrence, the pilot was observed performing ground testing on the glider's engines. A video was also taken of the tests. Significant observations included:

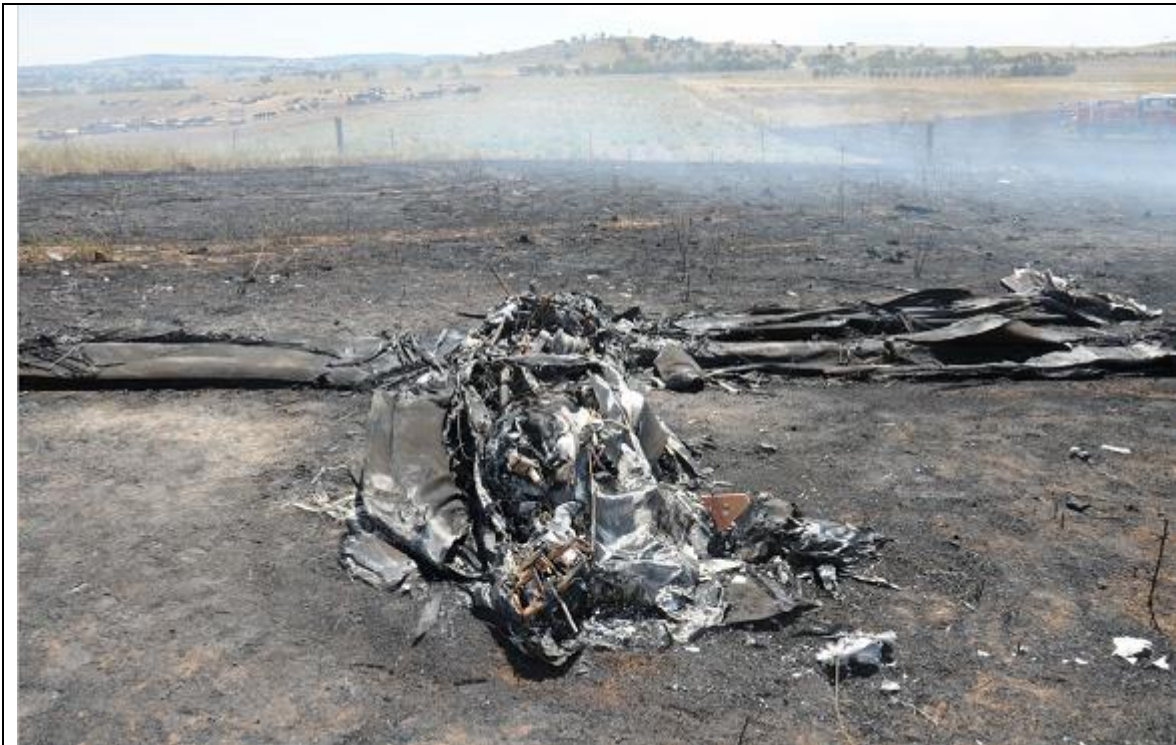
Figure 11: Wreckage of VH-GOA. Source: NSW Police

The glider caught fire in-flight, with flames seen near the engine housing. However, due to the severe post-impact fire damage, the ignition source of the fire could not be determined. The pilot was probably attempting to return the burning glider to the airfield when it departed controlled flight and collided with terrain. The loss of control was probably due to the effects of fire incapacitating the pilot and/or affecting the aircraft's flight controls. The ATSB found that the pilot had the necessary equipment to make an emergency egress from the glider to escape the effects of the fire. He jettisoned the glider's canopy but possibly due to incapacitation, did not exit. Finally, the glider's cockpit and engine housing were not separated by a firewall. That resulted in limited containment of smoke and fire, and reduced the available time to make an emergency exit.

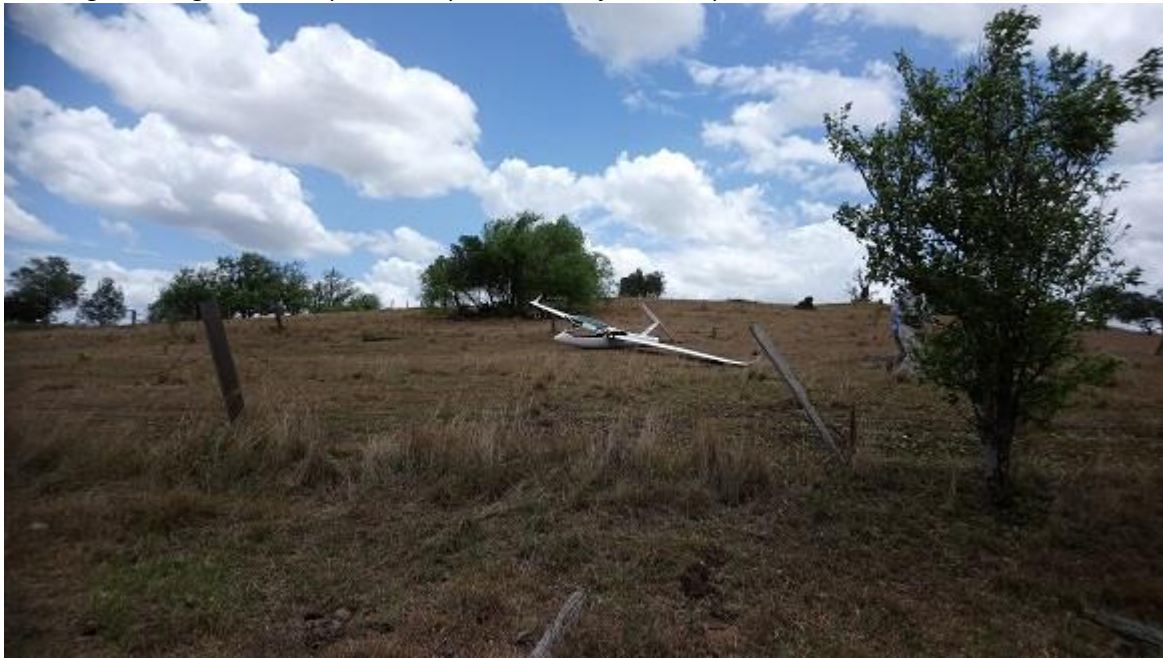
Fig 1. Wreckage looking in direction of travel.

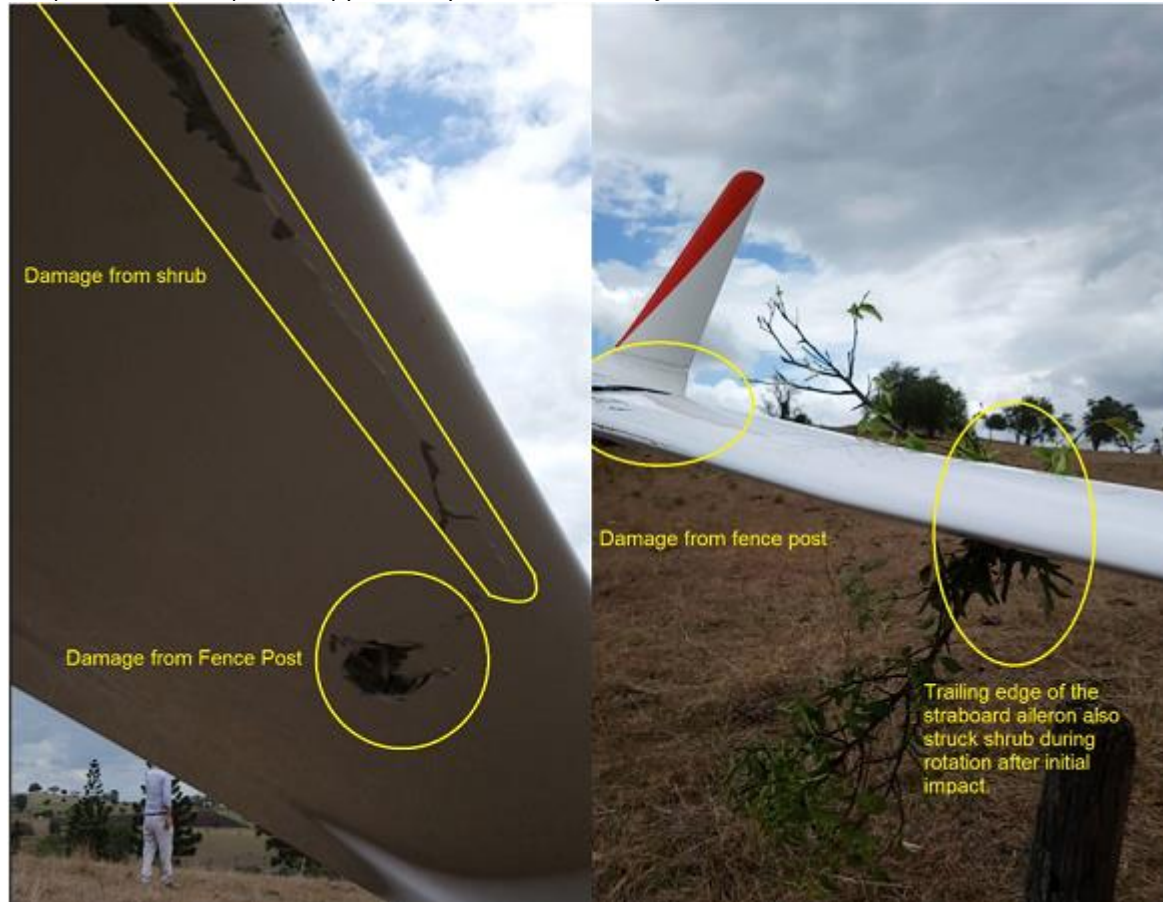
Fig 3. Starboard wing damage

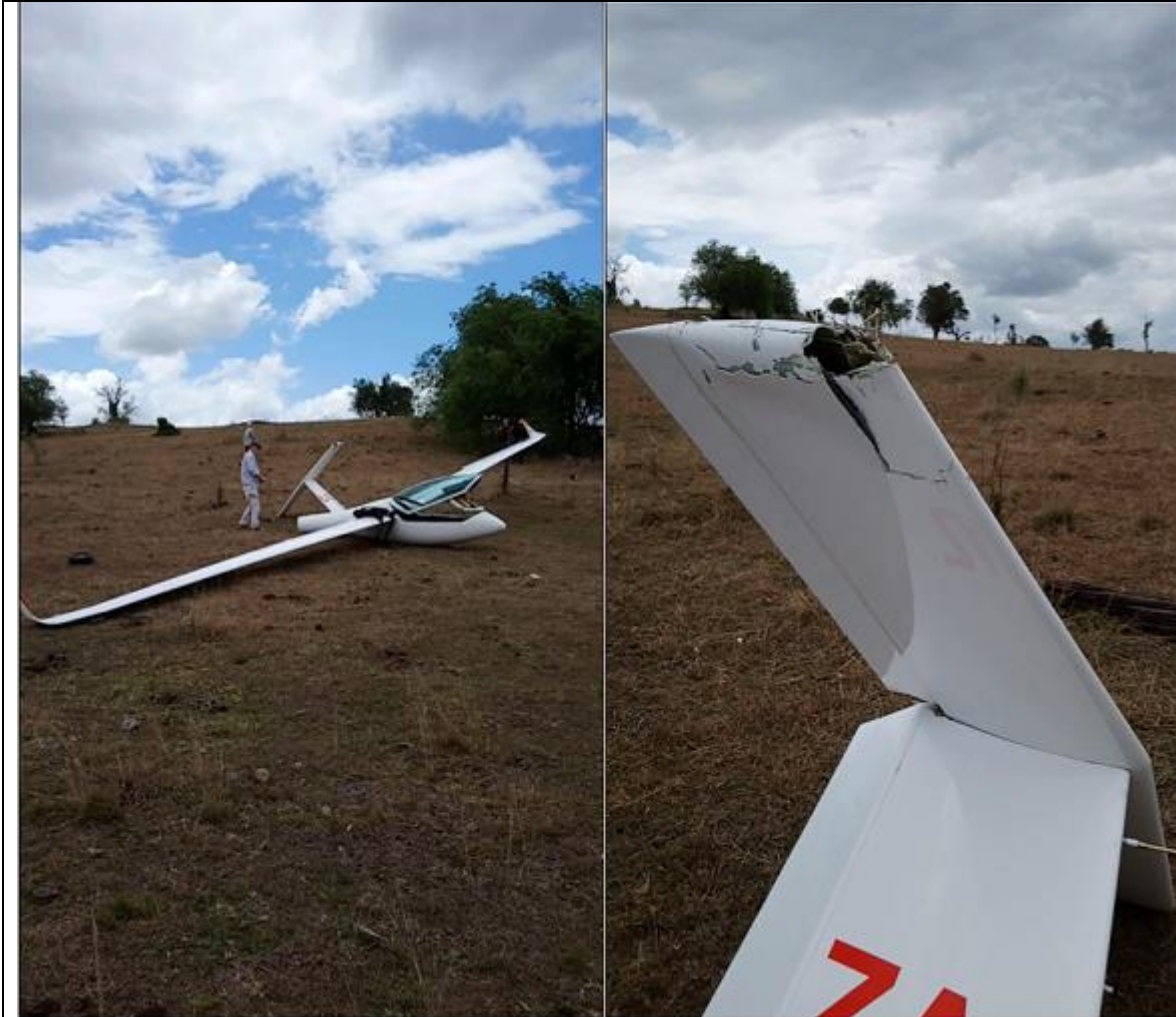
Fig 4. Fuselage and tailplane damage

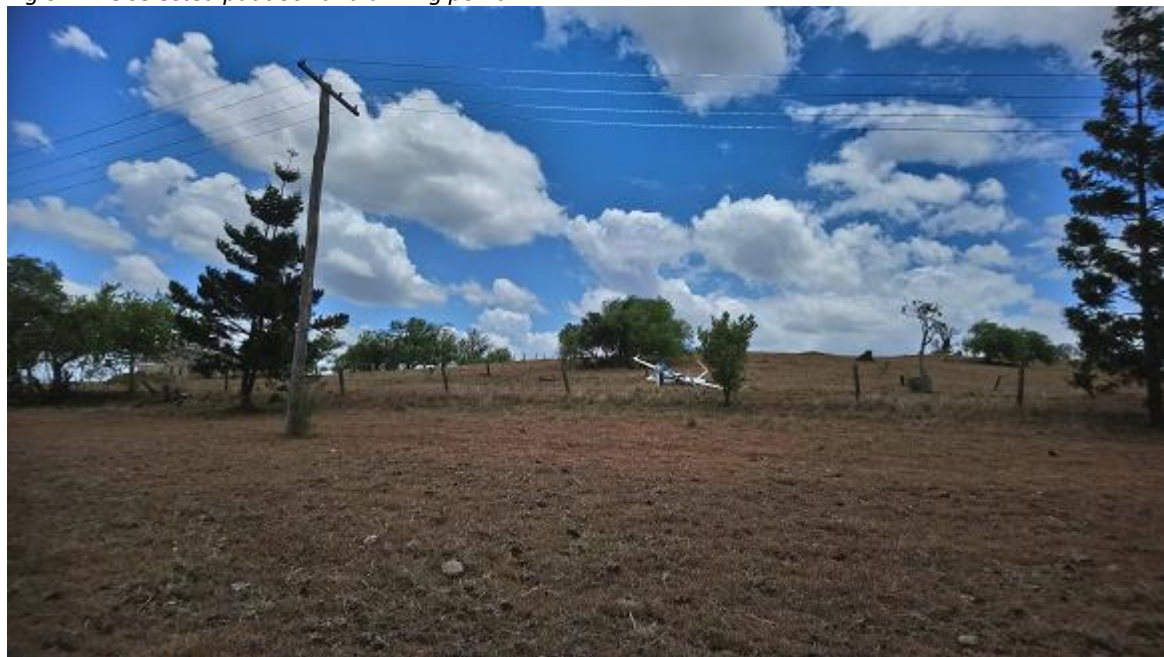
Fig 7. The glider passed between power pole (left) and tree (right), and under the powerlines.
