## AIRWORTHINESS ADVICE NOTICE.

**SUBJECT:** ENGINE COMPARTMENT FIRE CONTAINMENT AND RETARDATION.

**TYPES AFFECTED:** All self launching and power assisted sailplanes, fitted with 2 stroke, 4 stroke, rotary and jet engines. This includes Experimental and Light Sports Aircraft.

## ENGINEERING ORDER ..... MB18-12-1

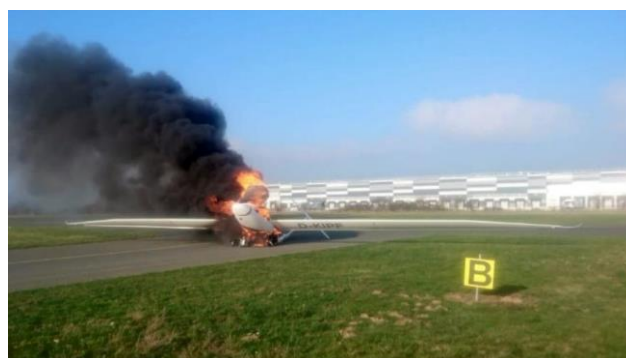
**(1-1) GERMANY 2018** This Stemme suffered an in-flight fire in the circuit, managing to land on the aerodrome before the fire rendered the sailplane uncontrollable.

The fire started in the engine bay and eventually spread to the rear fuselage burning it through, collapsing the structure after landing. If that had occurred while negotiating a landing, all or part rudder and elevator control would have been lost.

In this case the fire had not spread forward, into the cockpit area before landing.

The crew were unharmed, having sufficient time to land and exit the sailplane. A similar occurrence with a Stemme in Australia in 2006 was unfortunately fatal to 2.

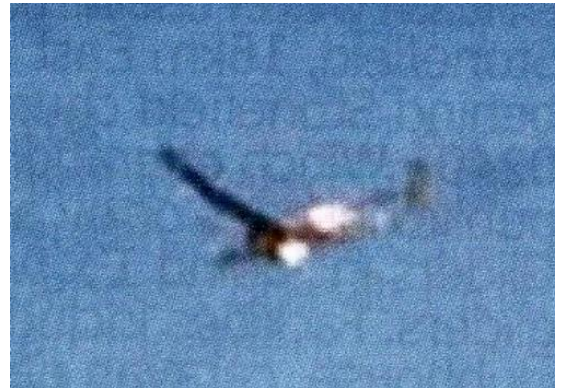
**(1-2) AUSTRALIA 2018** This ASH25E is seen in flight with fire coming from the wheel bay and the rear end of the engine compartment. It is probable, but not proven, that the rear fuselage burnt through, causing loss of control, prior to ground impact. Fatal to one.

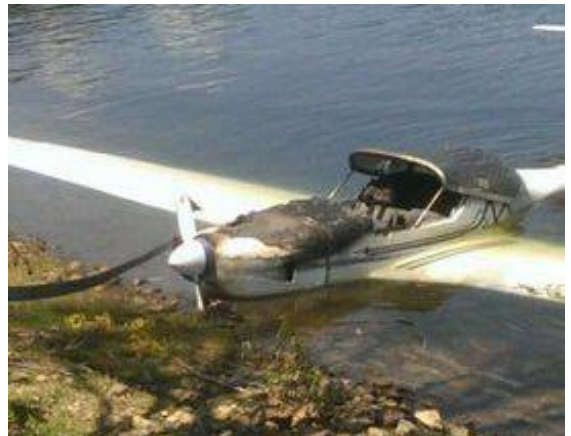
**(1-3) AUSTRALIA 2014** This Ximango suffered an engine oil leak, resulting in an engine compartment fire which was able to spread to the fuselage and cockpit. The pilot was fortunate to ditch into a lake suffering minor injuries.

*“Shutting down the engine had no appreciable effect on the fire, which by now had started to breach the cowling on the upper right rear where the oil tank inspection hatch is located.”*

Had the fire been better retarded and contained in the engine compartment the pilot may have had more time and less drama to resolve the situation. The fire also badly burnt the underside of the fuselage back to well behind the wing root.

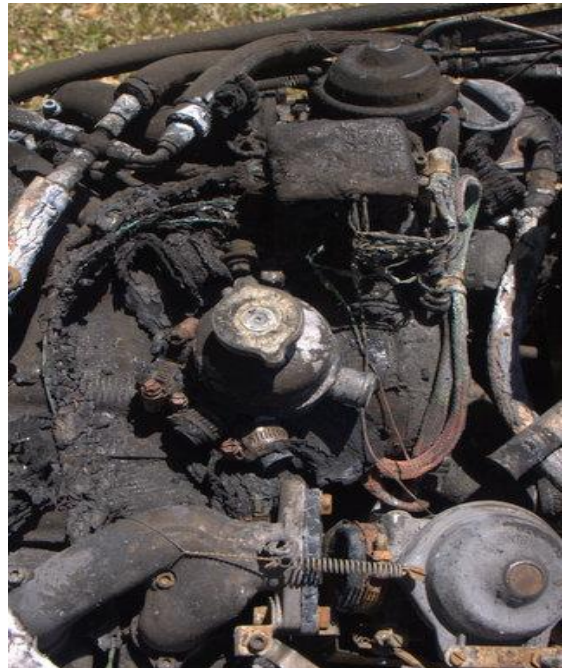
This photo of the burnt engine compartment shows the extent of the damage. The Rotax 912 engine coolant hoses totally burnt, but the fire-resistant sleeving over the fuel hoses stopped them burning.

With some of the aluminium parts in the engine compartment melted the temperatures would have exceeded 700 C.

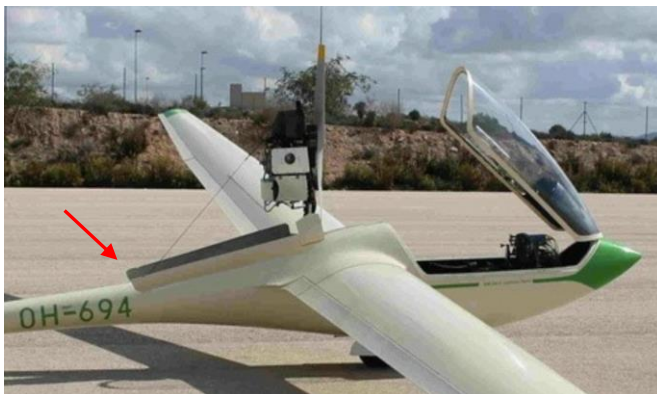
**TYPE A:** Engine fully extended. The engine bay can be saturated with oil and fuel over time. Fire retarding paint is needed over all internal surfaces, including the insides of the access doors. Possible penetration of fire into the rear boom should also be considered. Small jet engines are known to spit fuel unburnt and burning, during failed starts, which can be a major fire hazard.

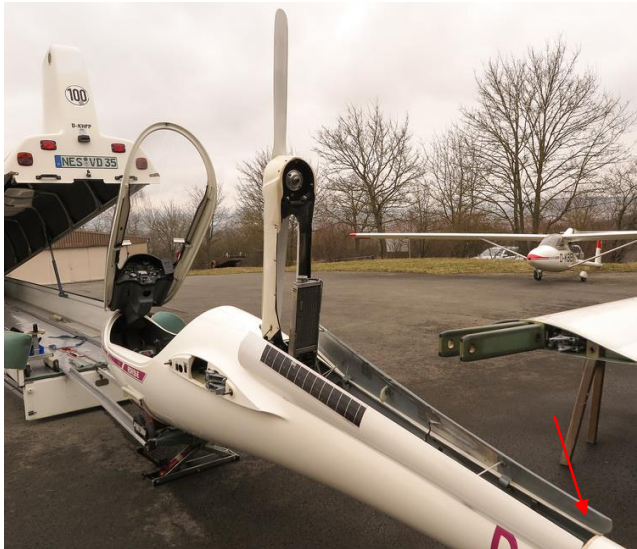
#### TYPE B: A fully buried engine.

History shows that this installation will be subject to more fuel, oil and radiator fluid saturation over time and more likely to have a fire event. Full internal coverage is needed, including the inside of the access doors. Cleaning the soaked internal structure can be extremely difficult.

Possible penetration of fire into the inside of the fuselage rear boom should also be considered.

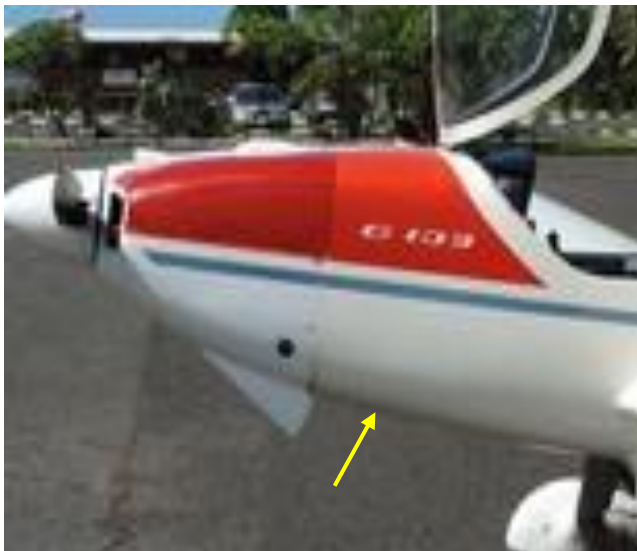
#### TYPE C: Touring Motor Glider (fiberglass).

A fire in this compartment is an immediate threat to the cabin occupants from both heat and noxious fumes, which will be exacerbated if raw FRP and internal upholstery become ignited. The engine cowls must be internally treated to stop the cowls igniting. The firewall must be fireproof and the external surface of the fuselage immediately behind the cowl flap exit should be coated to prevent ignition by flames exiting through the cooling exit duct. The underside of the fuselages of these types of powered sailplanes are notorious for being left with uncleaned layers of oil and dirt.

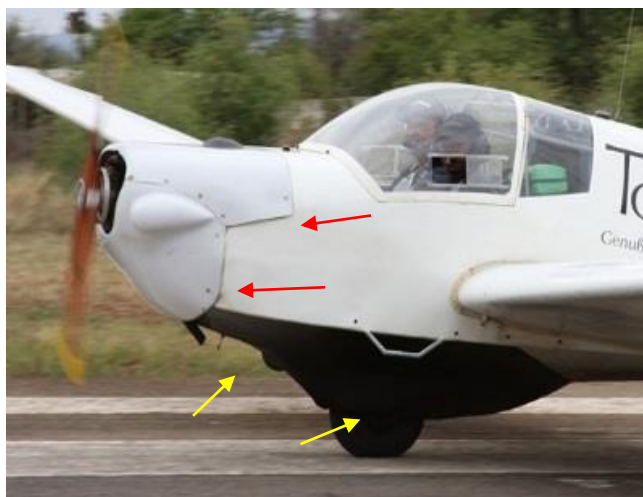
#### TYPE D: Motorfalke / RF4 / RF5 / Ask 14 and similar types. (Fabric covered fuselages)

This family of powered sailplanes are fabric covered timber and tube steel structures. The area indicated by yellow arrows behind the bottom cowl cooling air outlet is fabric covered, including the wheel fairing.

All of that fabric area can become fuel, and oil saturated and exhaust damaged making it highly flammable.

The fabric covered areas marked by the red arrows are vulnerable to fire spreading from the cowls. The standard of: "600 mm rear of cowl openings" for the application of fire retardant paint should be followed here and is one of the ORIGINAL configurations prompting the standard.

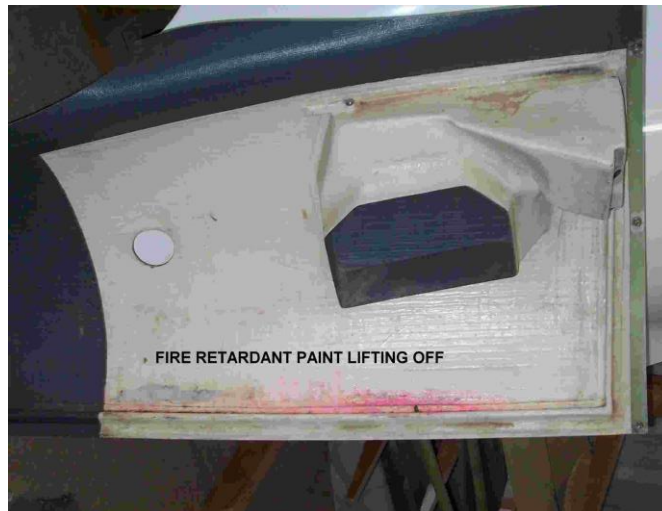
##### STEMME COWL DETERIORATION.

This is an example of deteriorated paint, which would be ineffective in the event of a fire:

This photo shows a Stemme engine cowl with peeling fire retarding paint, leaving the composite structure exposed to flame should a fire occur. The fire would spread behind the fire retarding paint to burn the structure. This typical deterioration can be found on the cowls and in rear fuselage compartments of all sailplane types.

**NOTE:** The only way this problem can be rectified is to remove the flaking paint **completely** and re-paint with an **approved intumescent paint** product. “Repairing” by overcoating the flaking paint will not ensure protection. The new Intumescent paint must be securely attached to the surface it is protecting.

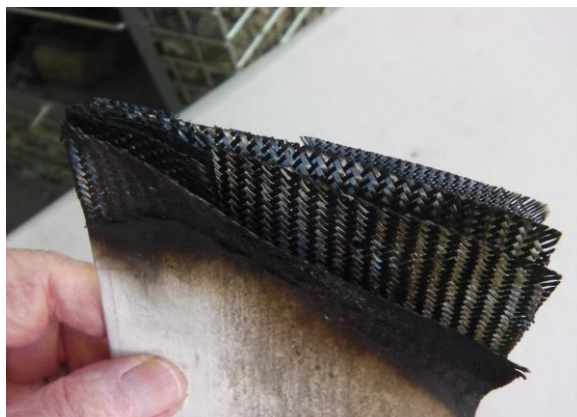
This photo shows how our composites burn. The Epoxy resin is totally burned out, leaving the glass fabric (or carbon) intact. The structure has no strength and no stiffness. The paint under the thumb is original “Fire Resistant,” applied by the German manufacturer. The fire has worked itself behind the paint to burn the resin.

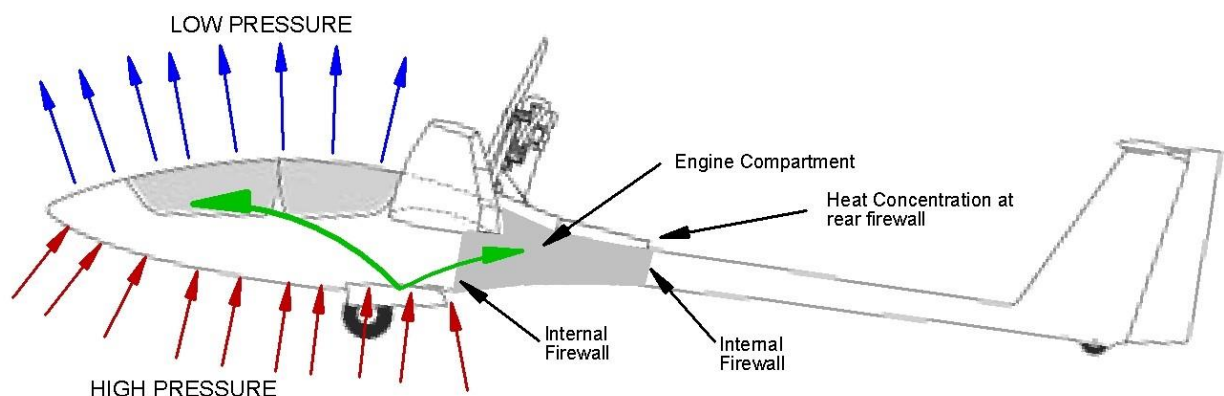
### (7-1) TYPICAL REAR ENGINE

This diagram shows an ASH 25E in roughly a thermalling attitude.

- (1) The high pressure air under the fuselage will tend to be drawn towards the cockpit by the low pressure along the top of the canopy.
- (2) There is low pressure over the engine compartment tending to also draw air from the high pressure area.
- (3) The front firewall stops air flow into the engine compartment.
- (4) IF the front firewall is not fitted or is not sealed, the movement of air will create a "blow Torch" affect on any fire in the engine compartment.

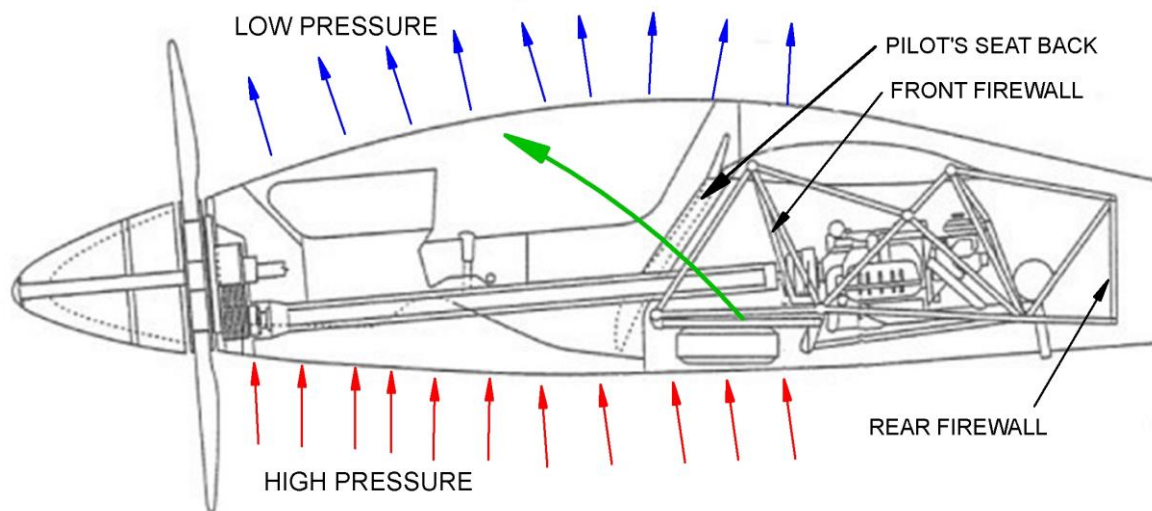
### (7-1) STEMME AIRFLOW

The Stemme fuel system is entirely located in the undercarriage bay ahead of the engine. Any fuel leak has the potential of spreading rearwards into the engine compartment resulting in fire. The pressure differential induces airflow from the undercarriage bay **forward** into the cockpit taking with it any fumes, smoke, even fire, should it occur in the undercarriage bay.

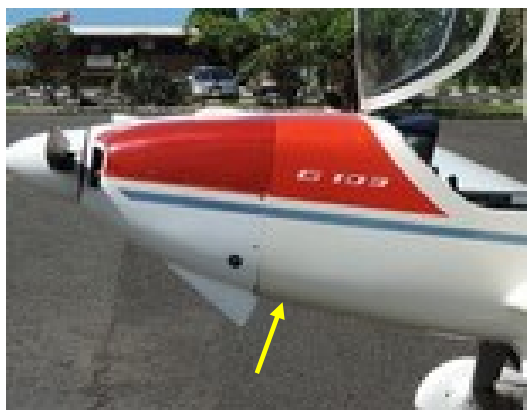
This photo shows a typical engine cooling air outlet on the bottom engine cowl. These can be either adjustable cowl flaps or fixed outlets.

To protect the bottom of the fuselage from ignition, **IFRP** is to be applied to the surface aft of cowl outlets for at least 600 mm aft and 100 mm wider than the outlet opening, each side, to cover the contingency of Side Slipping as part of pilot emergency procedures. (Ref: Appendix D and Appendix B (D))

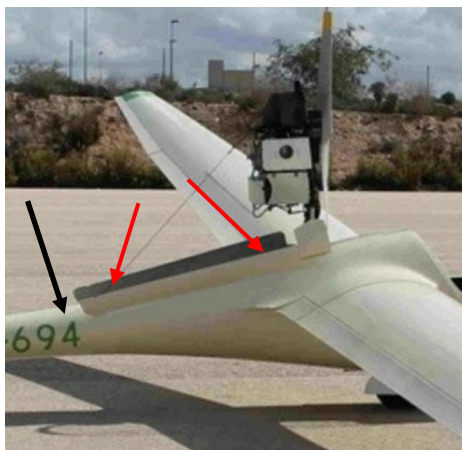
- (D) **A firewall at the front and back of a rear, buried, or pop up, engine compartment,**

The front wall and rear wall of these compartments are classified as a **Firewall**. They must be Fireproof and sealed around the edges with heat resistant putty to stop fire and fumes moving into either the forward fuselage or the rear fuselage boom. If not made from mild or stainless steel they must be coated on the engine side with **IFRP**.

The area behind the engine compartment shown by the **black arrow** must be considered for **IFRP** coverage as discussed in Section (6)

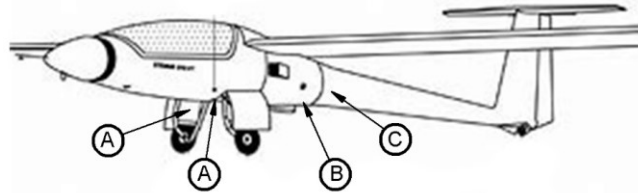
### C-1 STEMME series.

History shows that the Stemme series has several potential “fire fronts” making the need for more widespread use of Intumescent paint to protect the cockpit and rear fuselage boom.

- (A) The entire undercarriage bay, including the inside of the undercarriage doors to be coated, with particular attention to the front wall isolating the cockpit. The front face of the firewall need not be coated.
- (B) Consideration should be given to extending Intumescent coating into the rear fuselage boom.

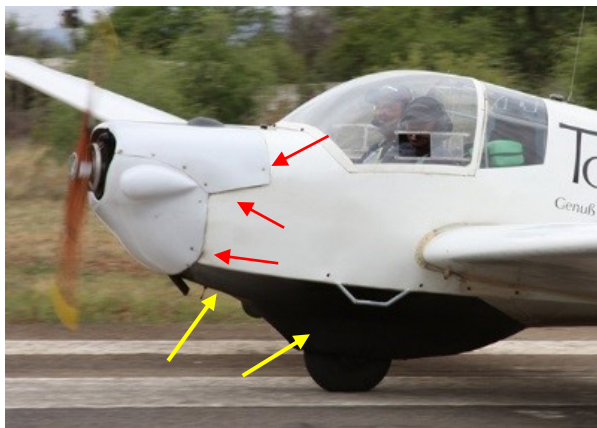
### C-2 MOTORFALKE / RF4 / RF5 / Ask 14 and similar series. (Fabric covered fuselages)

This family of powered sailplanes are fabric covered timber and tube steel structures. The area behind the bottom cowl cooling air outlet is fabric covered, including the wheel fairing. All of that fabric area can become fuel, oil and exhaust saturated making it highly flammable.

**IFRP** should be applied at least back to the centerline of the wheel and span sideways to each bottom longeron.

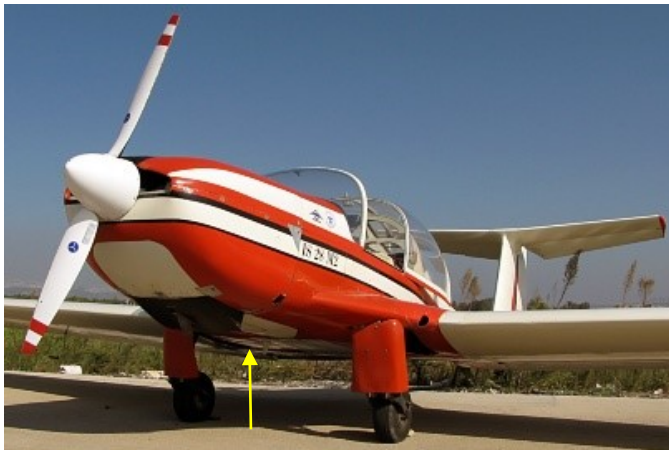
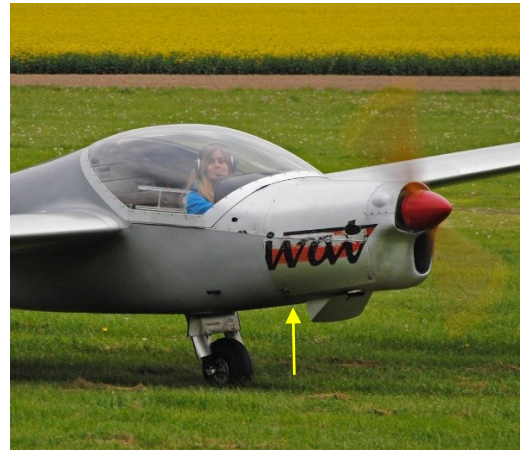
### C-3 IS28M2 / Vivat (Powered sailplanes with Alclad fuselage structures)

The underside of the fuselage immediately aft of the engine cowl flap is sheet Alclad which is not Fire Retardant, needing Intumescent paint coverage for protection.

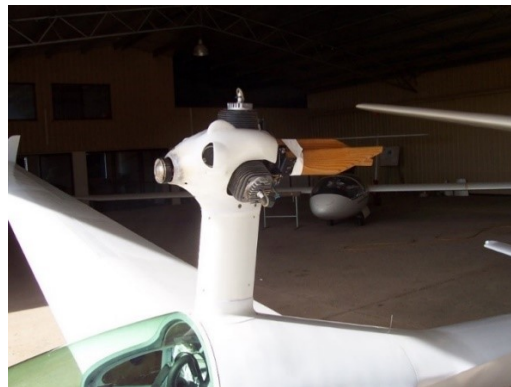
### C-4 POWERED SAILPLANES WITH PYLON MOUNTED ENGINES.

The engine is capable of dripping fuel and oil onto the fuselage structure at the base of the pylon. The inside of any engine cowling can be contaminated. This could be ignited. Each installation needs to be evaluated and if the application of Ff88 or other approved Intumescent paint can be applied to offset an event, then action should be taken.
