AIRWORTHINESS ADVISORY NOTICE

GFA/AN 29 GENERAL 4

Glider Types Affected:

All gliders with quick connect ball joint control connections including

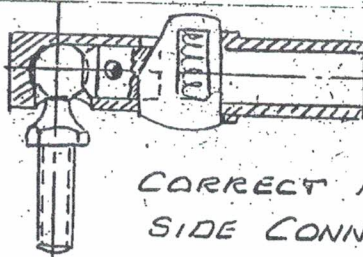
The attached illustrations show the difference between correct and incorrect assembly of the ball joint coupling.

CORRECT ASSEMBLY  
SIDE CONNECTION

Even when visual inspection of the connection is readily carried out the following physical check should also be carried out.

After engaging the coupling apply a pressure of about 5 kilograms (10 - 11 pounds) in the opposite direction to that necessary to engage; that is in the direction to effect disconnection, also check by feel the position of the spring loaded locking wedge to ensure that it is in the fully engaged position.
