## AIRWORTHINESS ADVICE NOTICE

TYPE AFFECTED: Standard Libelle 201 and  
Standard Libelle 201B.

SUBJECT: Miscellaneous airworthiness information.

<b>GFA AN 009</b>	<b>ISSUE: 5</b>	<b>29/03/2023</b>	<b>Page 2 of 6</b>
-------------------	-----------------	-------------------	--------------------

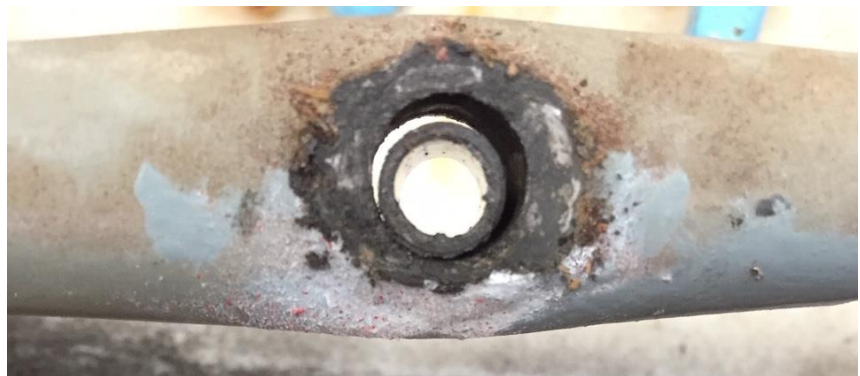
3.2. When dismantling the air brake drive arms note the centre arm is supposed to have an oval hole (on initial disassembly it looked horribly worn - see photo below). If we had "fixed" this (as was my initial reaction) we would have caused ourselves untold pain!

#### **THIS CENTRE HOLE IS MEANT TO BE LOSE!**

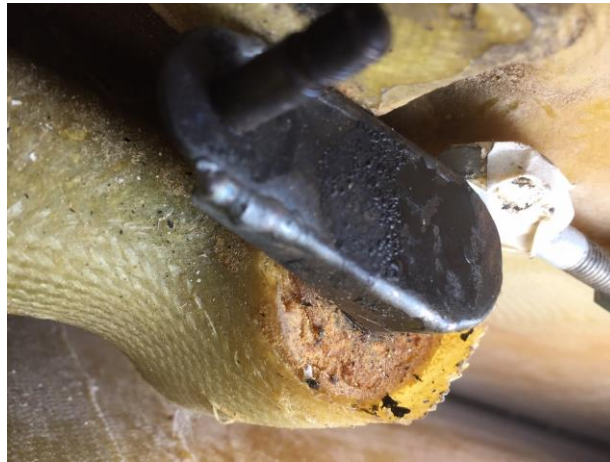
3.3 The actuator arm on one gearbox was found to be bent and cracked (too much over-center). The arm is integral with the gearbox and only accessible through a hole in the root rib. With advice from Streifeneder we were successful in welding the arm in situ. A botched outcome would have been catastrophic as it would entail replacement of the gearbox requiring it be cut out and glassed back into the wing. I comment that Streifeneder was familiar with this problem....suggesting it isn't unknown and perhaps needs looking at regularly. When derigged it isn't difficult to inspect. Make sure the overcentre is correctly set all the time.

Beware the gearbox has plastic gears and the assembly is in FRP. It was very technical to weld it in place without causing damage.

#### NEWLY RE-WELDED ACTUATOR ARM INSIDE THE WING

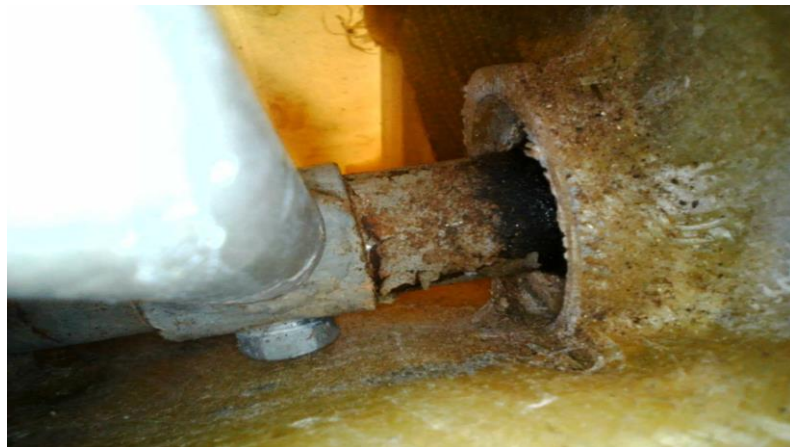
**3. Pushrods in the fin.** As per GFA AD688 inspection showed significant corrosion in the lateral tailplane mount/elevator actuator axle and supporting bearings of a Libelle 201B. These were extremely difficult to access. Probably cause was a pee tube in the past. Good photographs of the corrosion were obtained using an endoscope camera inserted and maneuvered through the rudder pushrod cut out in the lower fin web. Holes will need cutting in the FRP to gain access and repair. Eg photo:
