THE GLIDING FEDERATION OF AUSTRALIA INC

Airworthiness Alert 2021-1 **PIK-20 Cracking of Chrome Plated Flaperon** **Spigots**

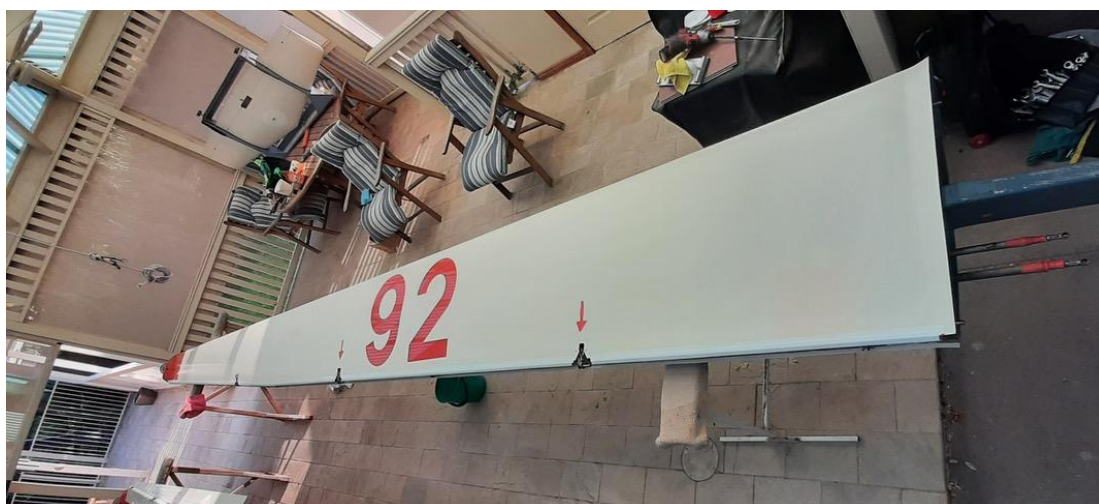
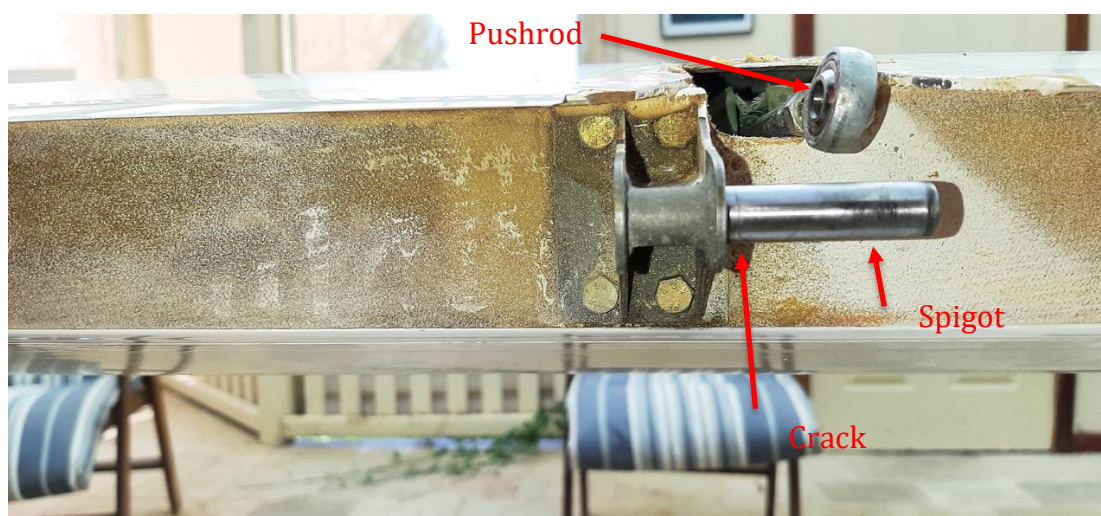
A Service Difficulty Report has been received detailing circumferential cracking of two chrome plated flaperon pivot pin spigots on the right wing of a PIK-20E, this defect was found whilst performing an annual inspection. The PIK-20 flaperon has three actuating pushrods with a corresponding spigot that forms part of the hinge. Two of these spigots on the right hand wing adjacent to the flaperon push rods were found with circumferential cracking (see red arrows on wing below). It is not known at this time if the circumferential crack is only in the chrome coating or if it extends into the chrome molybdenum tubing.

If a survey or deeper inspection has not been carried out recently, the GFA recommends a detailed inspection is performed at the next annual inspection.

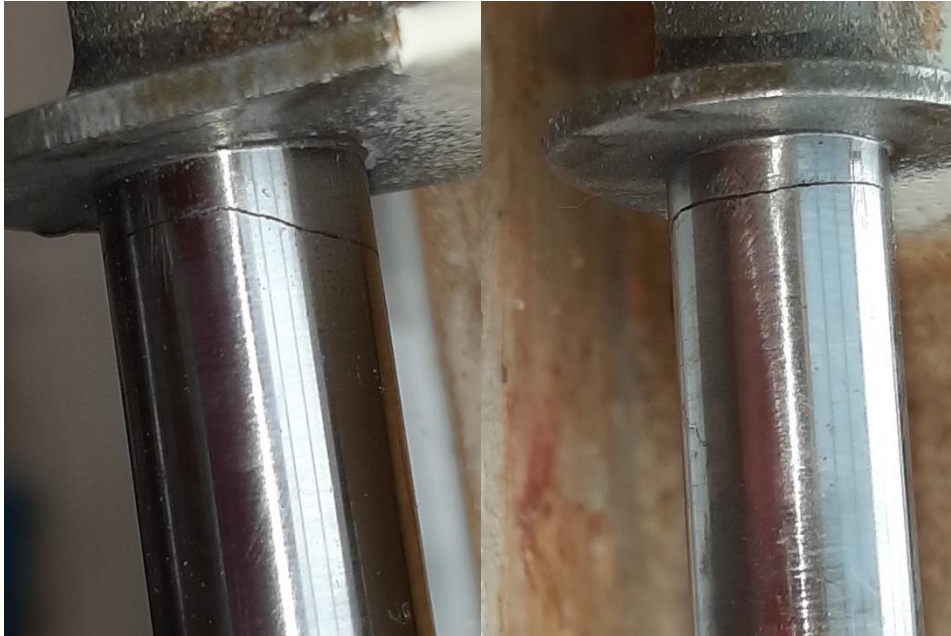
The cracking appears to encircle the entire spigot, but a residual strength test has demonstrated a very large amount of strength remaining. At present, it appears the crack may only be to the depth of the chrome plating but the cause and mechanism driving the crack is yet to be determined.

Circumferential cracking of the chrome plating near base of spigot

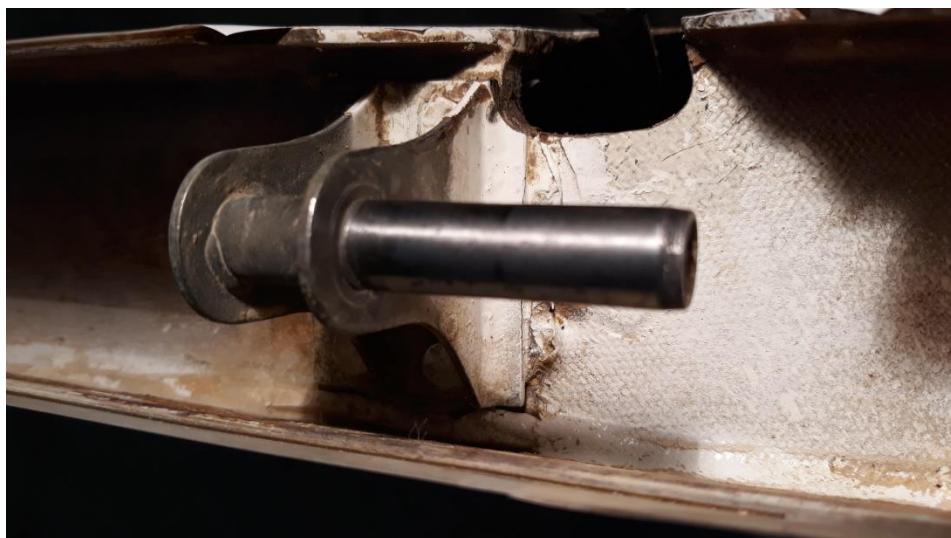
Spigot without chrome plating
