**Civil Aviation Authority**  
**SAFETY NOTICE**  
**Number: SN-2020/003**

**Version 2: Issued: 30 April 2021**

## **Carbon Monoxide Contamination Minimisation and Detection in General Aviation Aircraft**

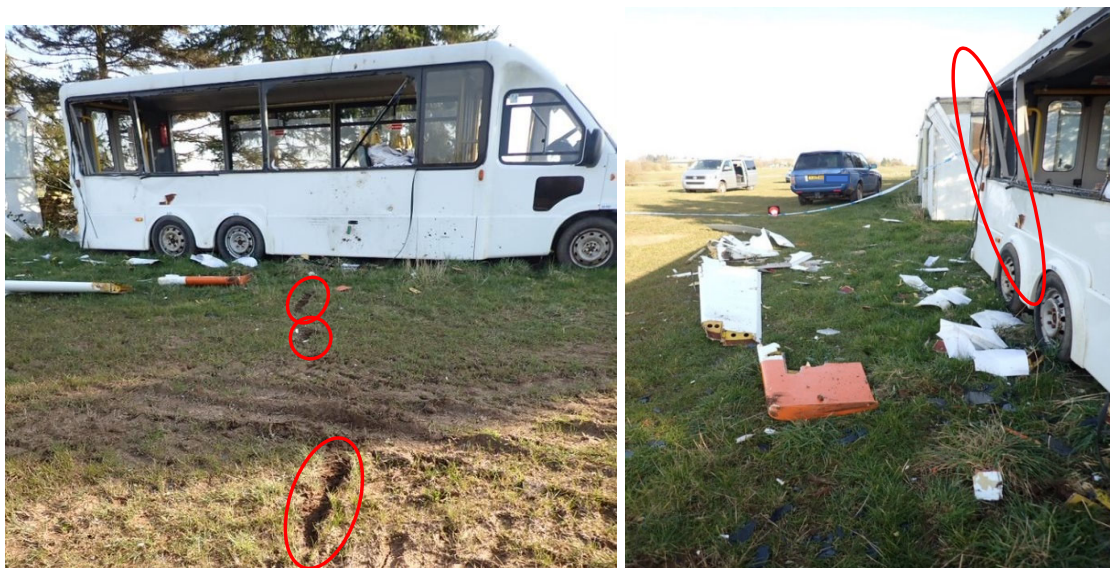
**Figure 2**

From the ground marks it was evident the aircraft was heading east towards the airfield at the time of the accident. The first impact marks were made by the right wing tip, which touched the ground three times before the leading edge of the wing hit a small bus parked along the treeline of the west field (Figure 2).

Ground impact marks, detached right wing and impact angle on the bus

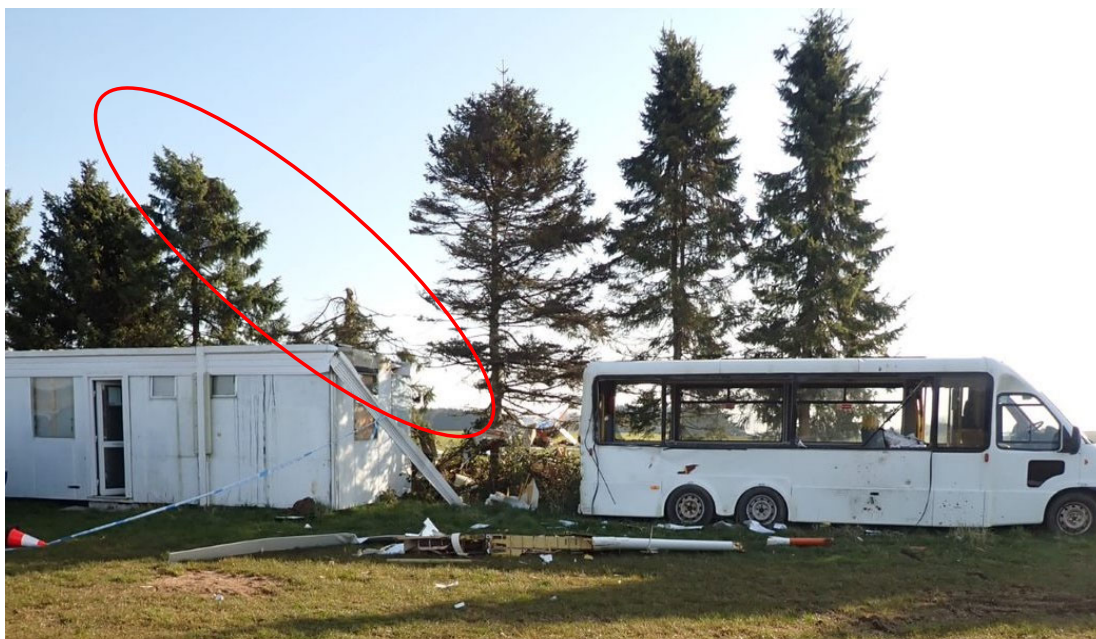
**Figure 3**

Damage to the cabin roof and the angle sliced through the tree line

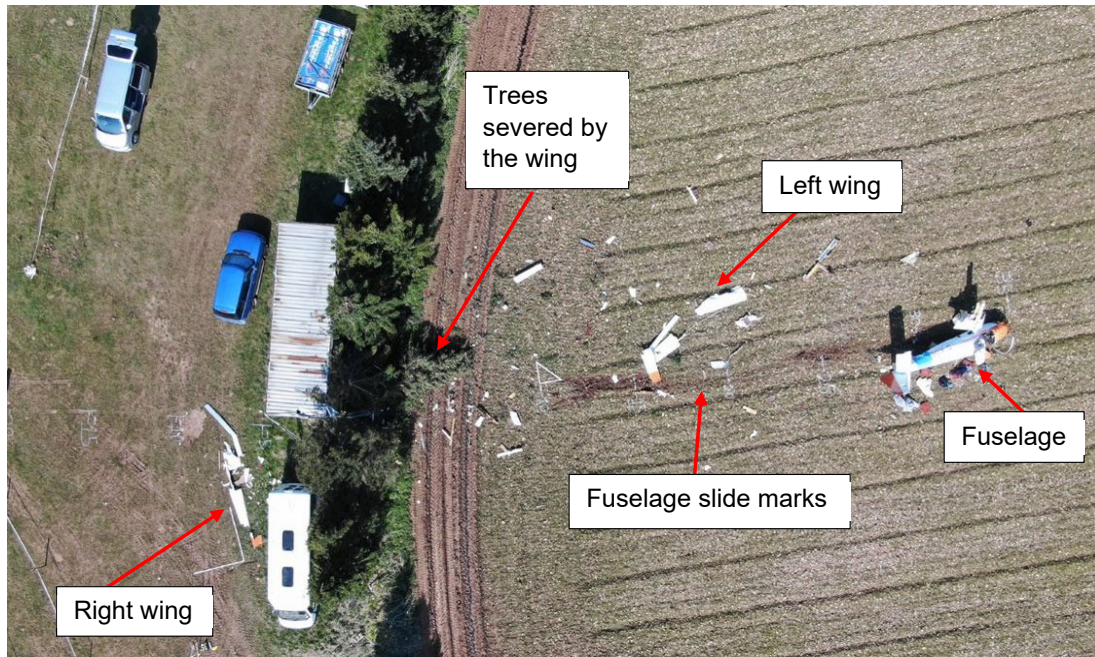
**Figure 4**

The remaining wing detached and landed to the left of the aircraft's path. The fuselage continued sliding along the ground before finally stopping in a slightly right nose down attitude pointing towards the airfield (Figure 4). One of the propeller blades broke away from the hub between hitting the trees and the ground in the east field and the remains were found under the left wing.

Overhead view of the final positions of the fuselage and wings

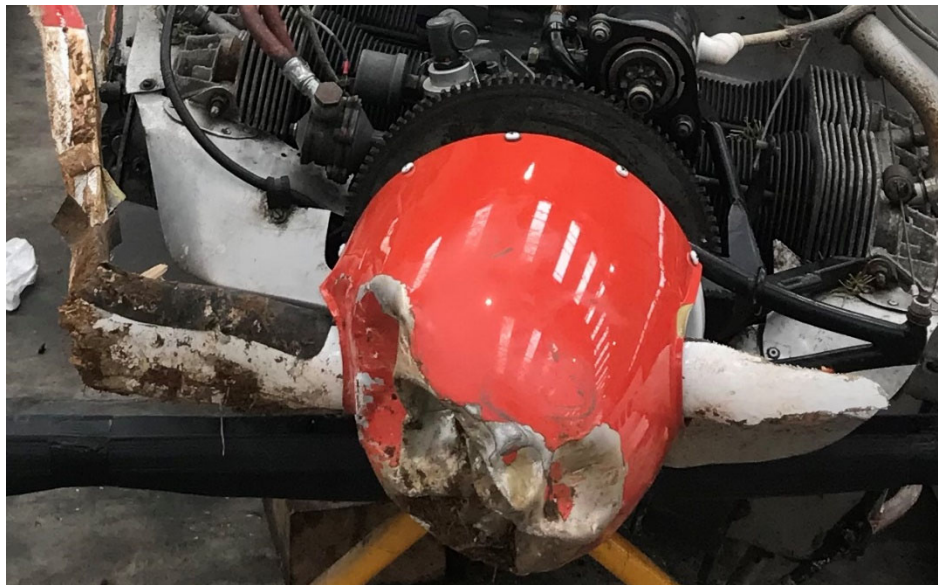
**Figure 5**

The propeller's spinner had large impact dents but there were no radial score marks to indicate the propeller was rotating under power when it hit the ground (Figure 5). The tail and fuselage behind the cockpit were largely intact, with minor damage to the leading edges of the fin and left tailplane.

Remains of the propeller blades and the dented spinner

Examination of the engine, the propeller and the spinner indicated that the engine was not producing power when the aircraft struck the ground. However, the remains of branches were lodged in the engine bay and propeller from the trees that were damaged in the tree line between the east and west fields. It is likely the engine stopped when the propeller sliced through the trees, causing one blade to separate near the root and land in the east field, while the other was bent backwards but remained attached to the hub.

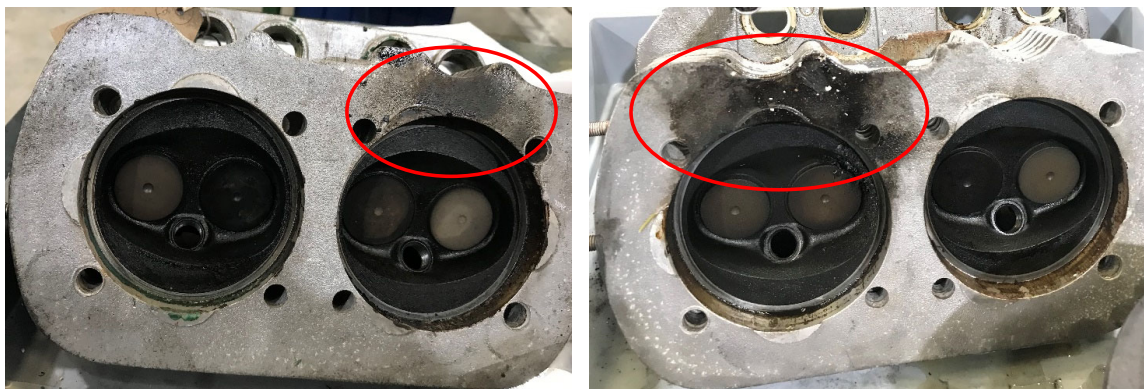
**Figure 7**

When the cylinder heads were unbolted from the crankcase, thin layers of black combustion deposits were found covering the piston crowns, combustion chambers and valve heads. There were signs of staining between Nos 3 and 4 cylinder heads and their respective cylinders (Figure 7). Records show that cylinder pressures were only 10% below their maximum when they were tested in December 2019.

No 3 and 4 cylinder heads showing signs of staining

The engine manufacturer stated that the staining visible on the cylinder heads was condensation mixed with soot and may contain traces of fuel and oil. On engines that have been overheated, a slight deformation of the cylinders and cylinder heads occurs as operating time increases. For the Limbach 1700 engine, deformation only occurs at the cylinder head and the cylinders are made of grey cast iron. This means that during cold

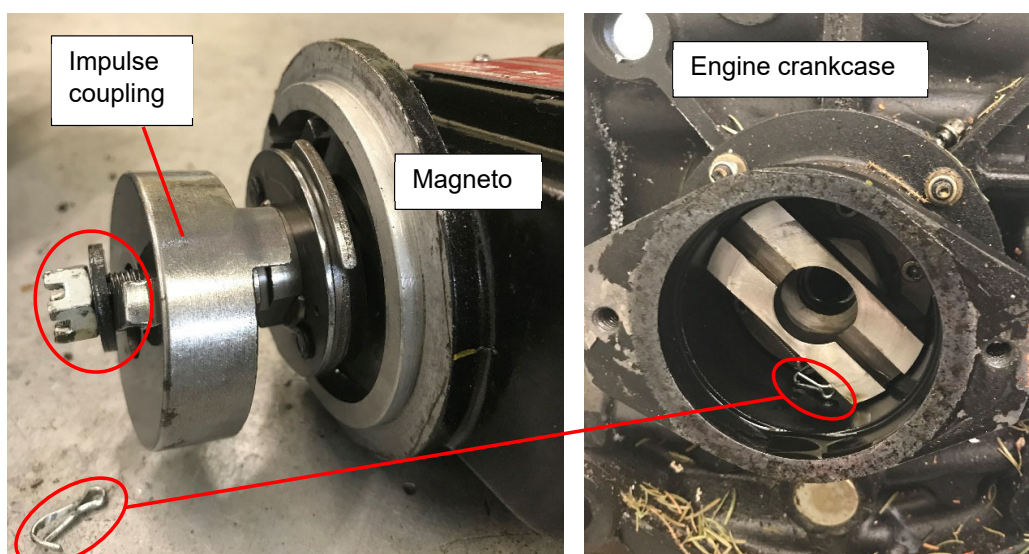
**Figure 8**

While the ignition system was being removed from the engine, the castellated nut and washer holding the magneto's impulse coupling onto the drive shaft was found to be held on only by the last few threads of the shaft. The split-pin that should have prevented the nut and washer from unwinding was found in the engine's magneto housing with one leg bent and the other leg broken in half (Figure 8). The magneto had been overhauled in 2017.

Magneto impulse coupling, nut, washer, split-pin and engine magneto housing

The magneto impulse coupling securing-nut and washer were found partially unwound but still on the shaft, and the split pin not fitted. It is likely the nut and washer would have unwound completely in time, although the magneto's impulse coupling would not have disconnected from the magneto. This did not contribute to the accident.

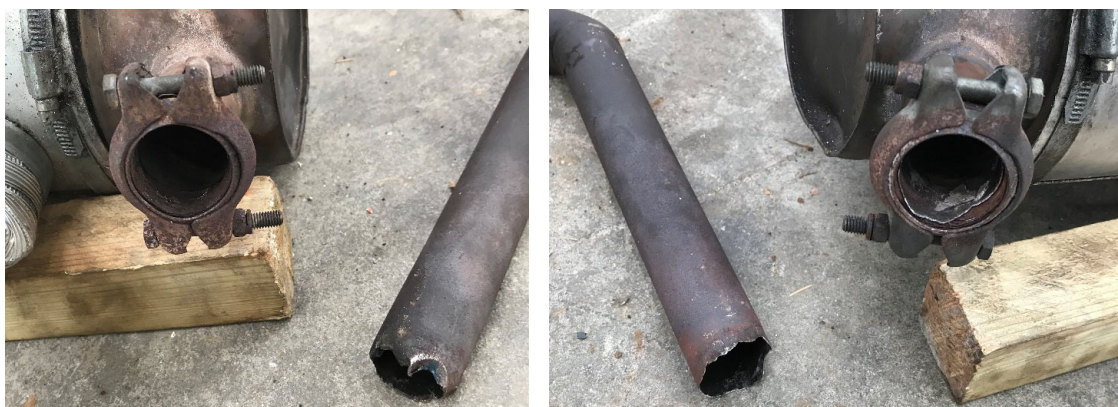
**Figure 9**

On dismantling the remaining exhaust system, the down pipes from No 1 and 2 cylinders were easily removed by hand from the silencer despite their securing clamps and sealing rings remaining in place. Visual examination revealed the ends of both pipes had corroded and fractured completely around their diameter. The detached ends of the pipes were still fitted in the silencer. The jagged edge of No 1 cylinder's down pipe had bent inwards as the pipe was pushed further into the silencer during the accident (Figure 9). The two exhaust down pipes from No 3 and 4 cylinders were removed and visually inspected but only minor surface corrosion was evident.

Forensic analysis found that although the exhaust down pipe from No 2 cylinder was corroded and the wall thickness had reduced, it had fractured during ground impact. The down pipe from No 1 cylinder was severely corroded and forensic analysis found that it had already failed some time before the accident. Both the pipe and its sealing ring showed traces of exhaust gas leakage. The evidence was very difficult to detect visually with the exhaust still fitted to the engine and in the engine bay. The signs of leakage were not easily discernable even with the system dismantled and required forensic examination to confirm that leaks had occurred.

No 1 and 2 cylinders' exhaust down pipes and silencer pipes showing failures

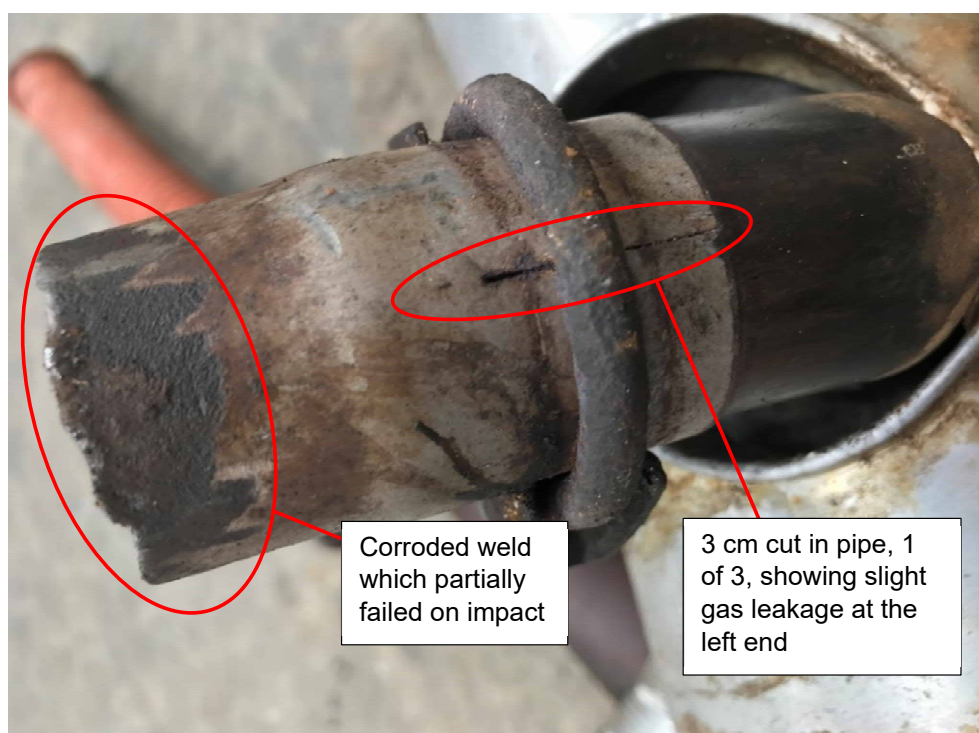
**Figure 10**

Whilst the partial failure of the exhaust tail pipe at the weld was due to ground impact, there was evidence that gas leakage had also occurred at the connection of the tail pipe to the silencer. The tail pipe had three, 3 cm cuts along the length of the pipe from the end to enable it to expand to fit over the silencer connection. A clamp was placed over the cut end of the pipe to secure it in place. As the pipe had not been fully pushed over the connection, the cuts were not completely blanked by the silencer pipe, which allowed gas to escape when the engine was running (Figure 10). The aircraft manufacturer stated that the tail pipe fitted was not an approved design.

Partially fractured tail pipe attached to the silencer

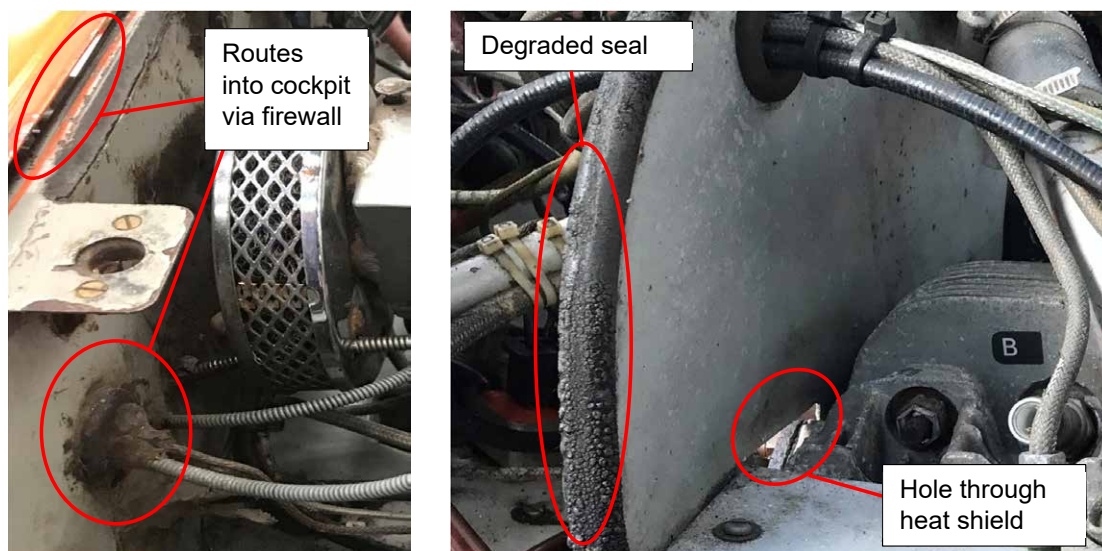
**Figure 11**

During engine removal, it was evident that the seals and grommets used in the engine firewall to protect the cockpit from engine bay gases had deteriorated and perished. It was likely that gases in the engine compartment could flow into the cockpit through the firewall (Figure 11).

Exhaust gas routes into the cockpit through bulkheads and firewalls

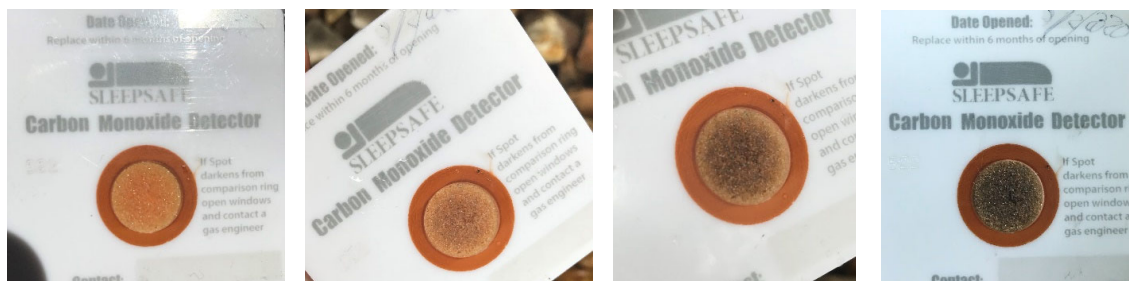
**Figure 13**

A CO spot detector was fitted to the centre of G-KDEY's instrument panel to warn the pilot if CO entered the cockpit. The detector's tan coloured spot turns black in the presence of CO. It was purchased from a non-aviation specific store in February 2020. The detector was removed and placed in front of a petrol mower exhaust to check its operation. The spot had to be held directly in the exhaust flow for 4 to 5 minutes before it started to discolour and approximately 7 minutes to turn it black (Figure 13). After an hour in fresh air, the spot reverted to its original colour.

Spot detector colour change when exposed to CO

The inspecting BGA engineer observed that following this accident he did not consider “dark spot” detectors to be an adequate means of alerting pilots to the presence of hazardous CO levels.
