AIRWORTHINESS ADVICE NOTICE

TYPE AFFECTED: Jonker Sailplanes JS3

SUBJECT: Miscellaneous Airworthiness Information

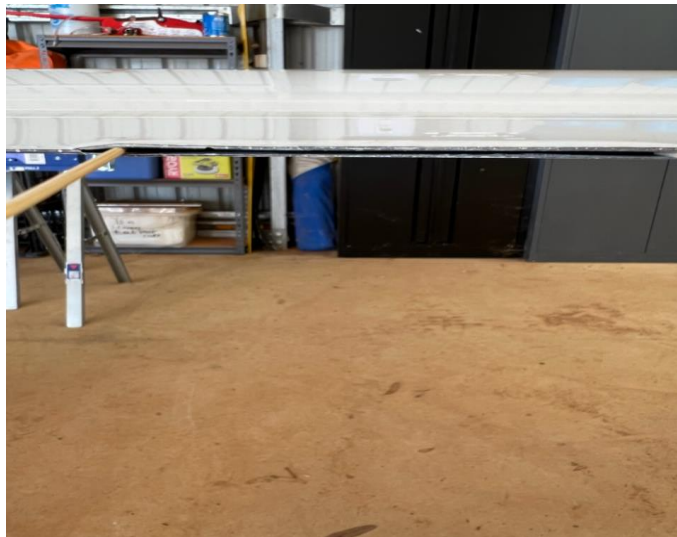
1. A defect report detailing a flaperon delamination has been received on an early serial number JS3. During the annual inspection, the LH side 18-metre outboard wing flaperon was found to have an 80mm delamination at the trailing edge. This resulted in a loss of torsional stiffness. The defect was identified by applying a small amount of torque to the control surface.

When performing maintenance, inspect the flaperon control surfaces for delamination by applying a small torque. A healthy integral control will resist flexing. Any control surface with delamination or disbond will suffer a loss of torsional stiffness and open. Jonker Sailplanes has been advised.

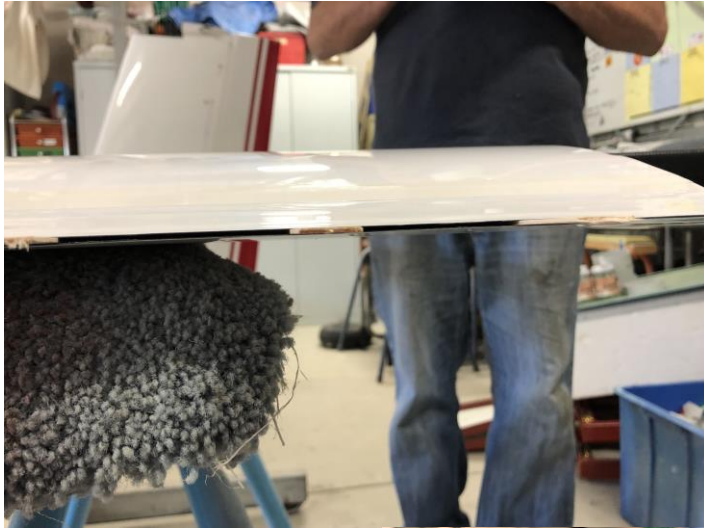
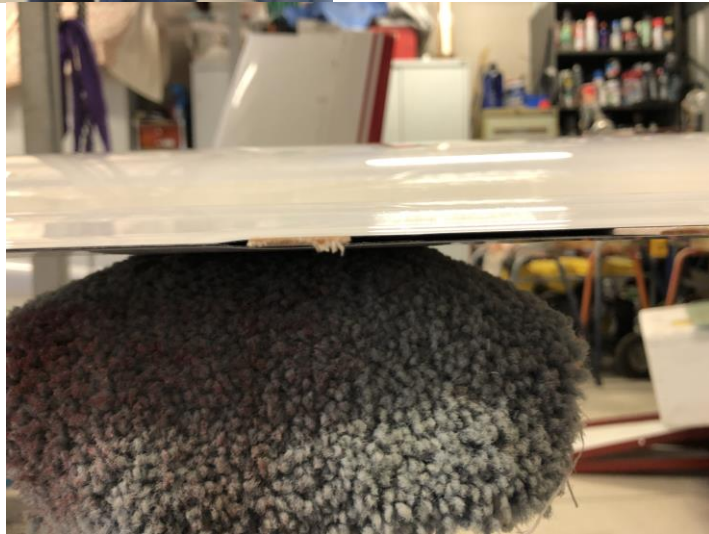
Within one month of receiving the first report, a second was received detailing a similar defect. The second aircraft being produced six later on the production line. Whilst also performing an annual inspection, the LH side 18-metre outboard wing was also

found to have a delaminated flaperon trailing edge 130mm in from the root and 190mm in length. It appeared to have never been bonded at the failure point as the surface was clean, devoid of resin. The fault was almost impossible to see as the trailing edge appeared normal. The defect was found when polishing the wing.
