AIRWORTHINESS ADVICE NOTICE

- TYPE AFFECTED:** STEMME S-10, ALL MODELS, ALL SERIAL NUMBERS.
- SUBJECT:** Miscellaneous airworthiness information.
- MODIFICATIONS:** Copies of Service Bulletins may be obtained from Type Certificate Holders website.

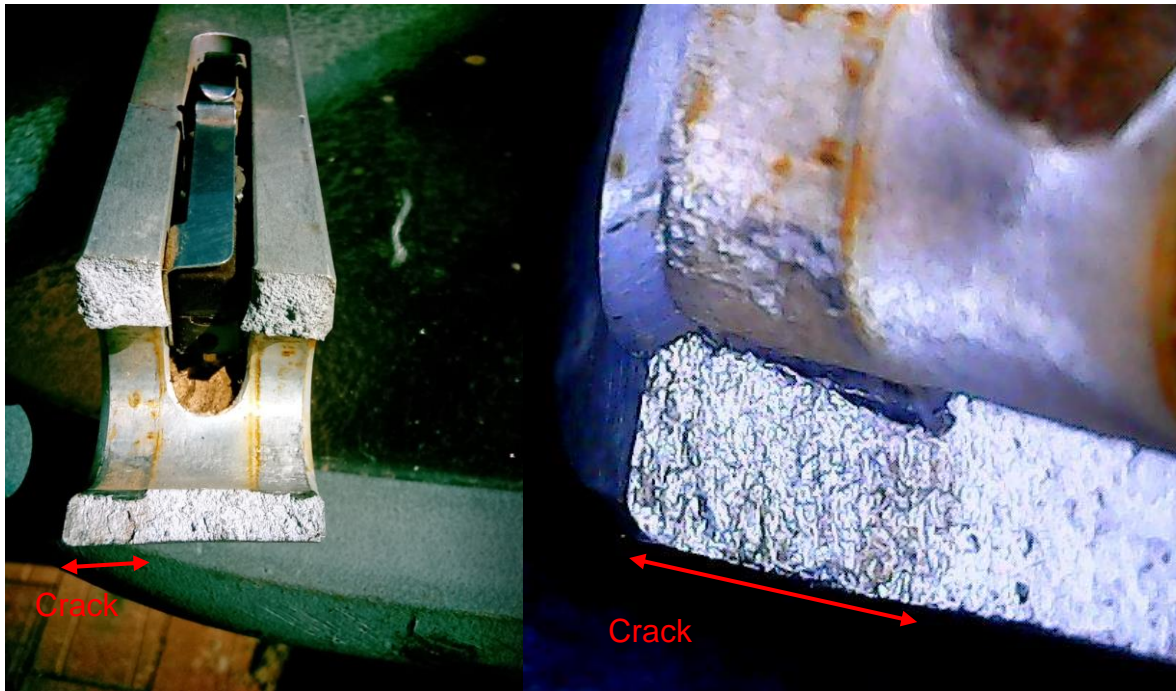
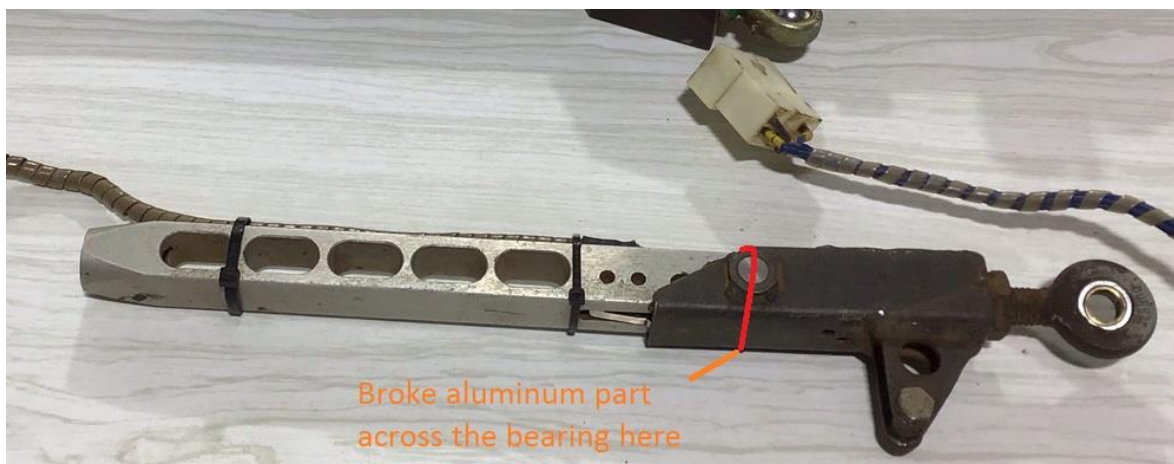
- A recent reported failure was from a failed over-centre linkage which caused the undercarriage to over extend. The crack had started to progress well before the gear failure with stress corrosion

likely to have progressed the crack. The gear failed when taxiing off the runway after landing.

Be aware that it is difficult to inspect all undercarriage components without disassembly.

- A thorough visual inspection of the undercarriage is recommended looking for cracking and deformed undercarriage components after the aircraft is subjected to any abnormal load. Inspect at annual inspections, after hard landings, ground loops or poorly executed cross wind take-off or landings. Nondestructive testing methods should be employed on any component which has visual indications.
