AIRWORTHINESS ADVICE NOTICE

TYPE AFFECTED: DG-1000

SUBJECT: Miscellaneous airworthiness information.

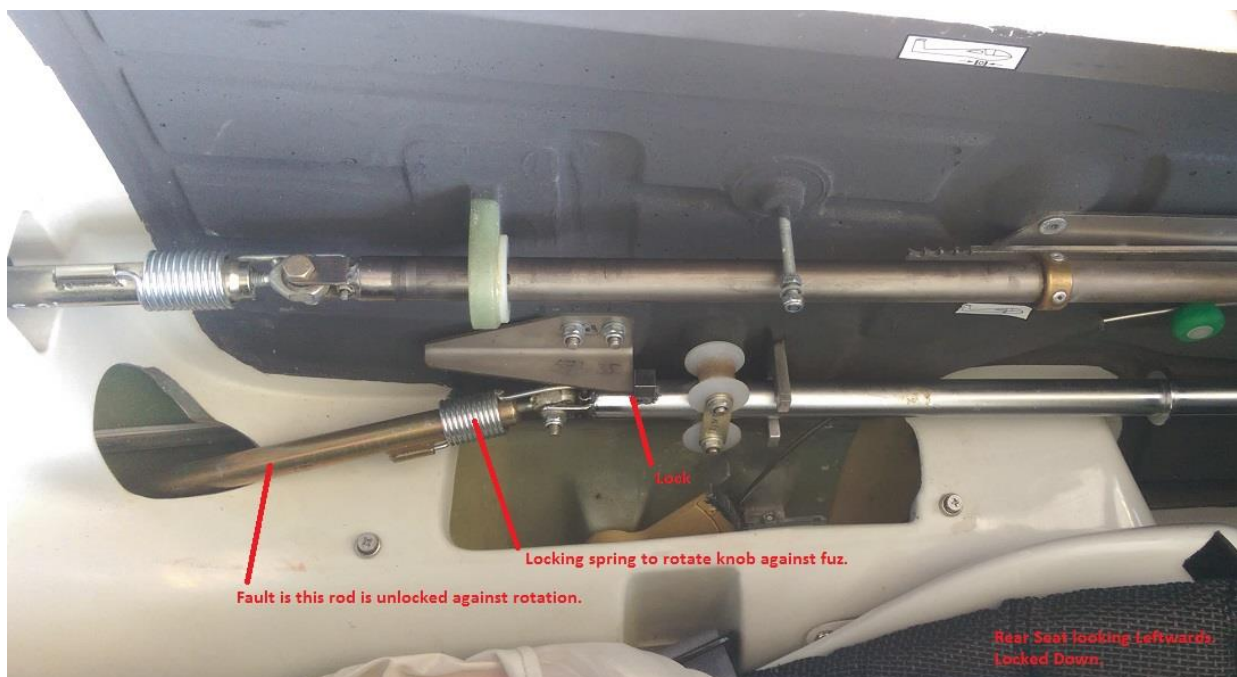
4. UNDERCARRIAGE CONTROL KNOB NOT REMAINING IN LOCKED POSITION: (Previously AWA 2018-3) The DG 500 and DG1000 are subject to the undercarriage control knob not remaining rotationally locked. The control push rod is subject to spring forces which 'breaks' the torque on the jam nut / lock washer combination permitting the rod to rotate on the end fitting threads.

Figure 1: Undercarriage push rod in left rear cockpit

Access is gained through the left rear seat control cover. Loctite stud locker high strength is recommended to supplement the lock washer and hold the fitting in correct orientation.

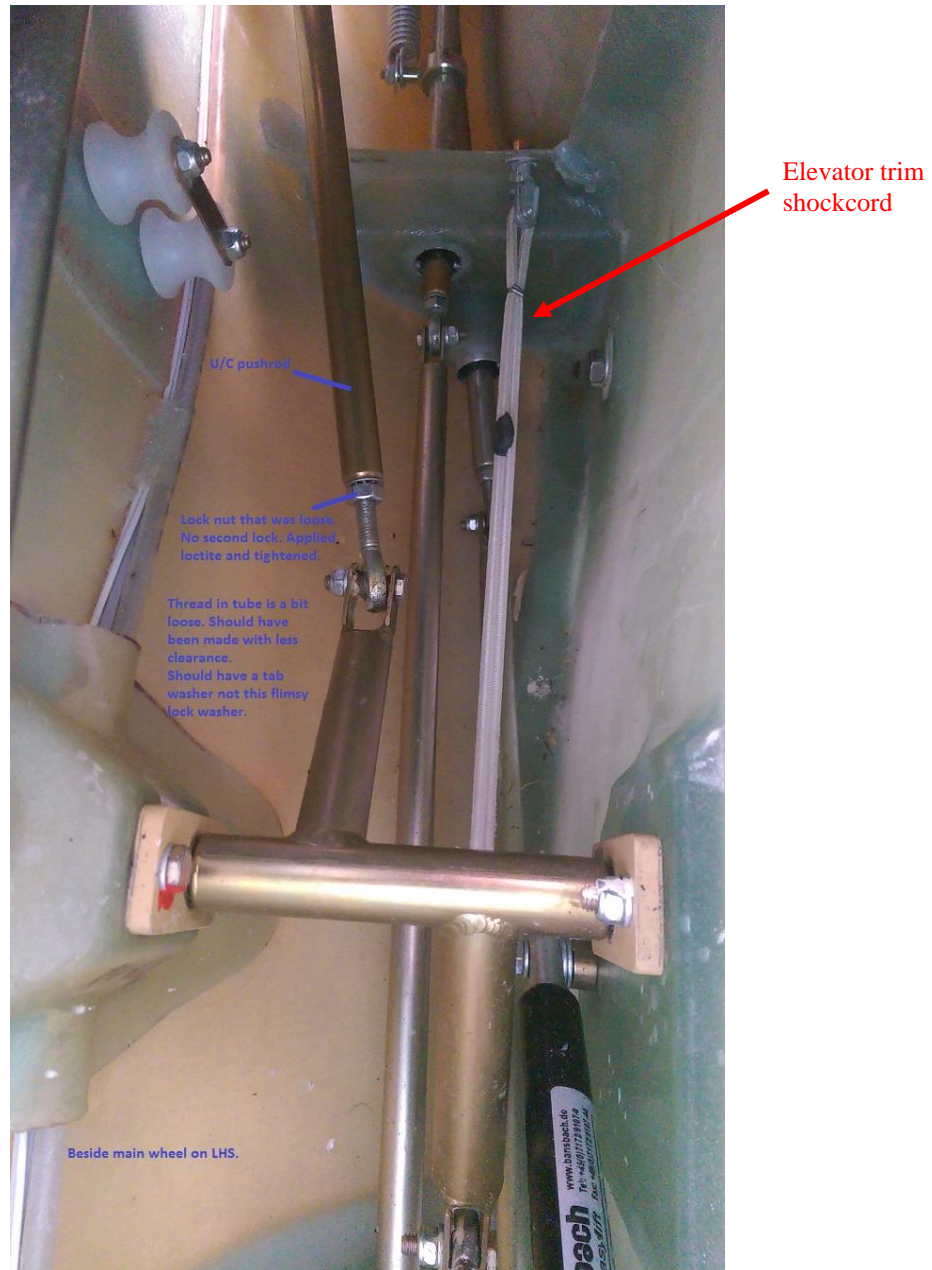
Figure 2: Undercarriage push rod in centre fuselage. Elevator trim shockcords are on right hand side

5. SHOCKCORDS: The DG-500 and DG-1000 variants use shock cords to apply added trim tension and apply tension to tow release cables when not under load. See example in Figure 2 above. The trim control will lose effectiveness if tension is lost, or the release cable could snag or foul if not kept under tension. The release knob hanging down is an indicator that the shock cord is losing effectiveness.

All shock cords used on these types will need replacement with time. They should be checked for effectiveness at each annual inspection. The trim mechanism is located beside the main wheel well. The release cables under the rear seat instrument binnacle.

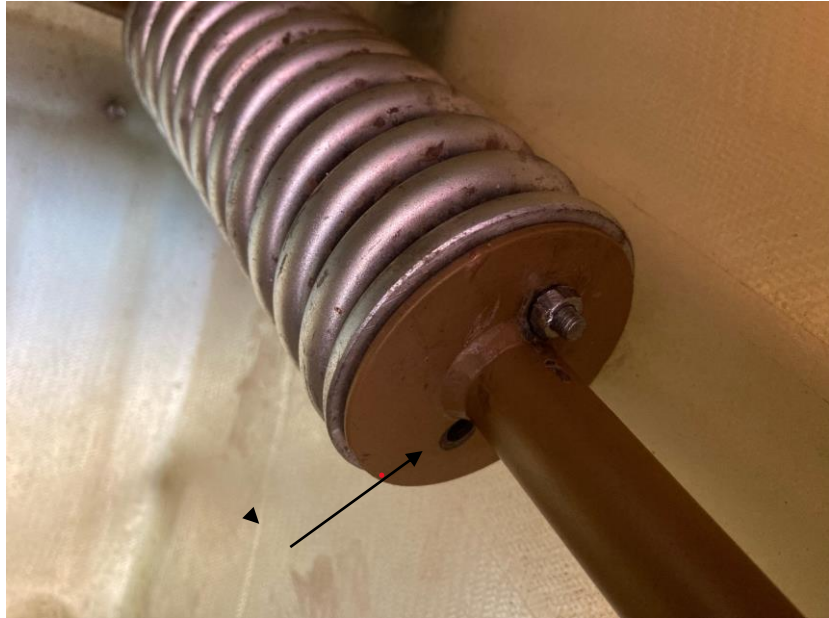
6. The DG-1000S has three undercarriage options, two are retractable and one non-retractable. All three have a sprung undercarriage. These spring units are known to suffer failure of the bottom aligning bolts. The spring unit can be repaired by a CASA approved licensed welder. This notice is to make pilots and maintainers aware of the potential failure point.

Welded alignment bolt failed, one alignment bolt with nut remaining.
