THE GLIDING FEDERATION OF AUSTRALIA

GFA AN 184

AIRWORTHINESS ADVICE NOTICE

TYPE AFFECTED: PW-6U

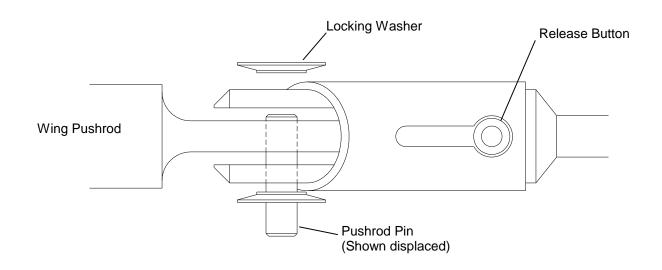
Figure 1 aileron and airbrake connector

Experience has shown that the locking washer on the connecting pin in the connectors may work loose allowing the control to be connected incorrectly as shown in figure 1.

Should the locking washer be loose then the defect must be rectified before next flight.

The defect may be rectified by either replacing the washer with a new part (the best option) or by cold forming the washer until the hole is between 5.980 and 5.990 mm diameter.

Cold forming should be done by either pressing flat between plates or by placing a steel ball (~ 20 mm ø) on the hole and then tapping with a hammer. If using the steel ball method the washer should be turned over and the process repeated.

Before pressing the washer on, the pin diameter should be checked for the correct size of 5.992 to 6.000 mm diameter.

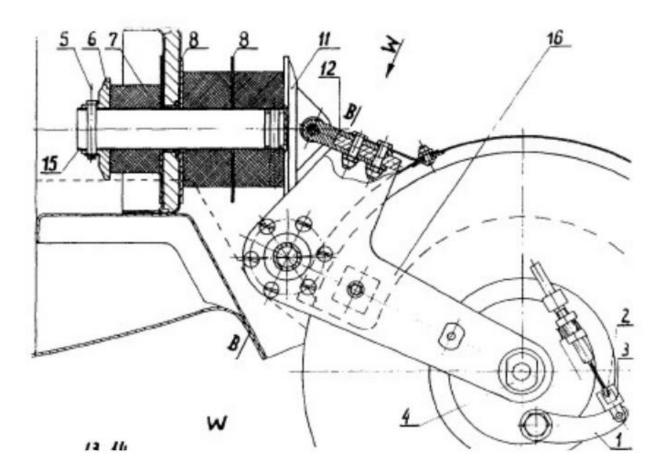
A PW-6 undercarriage was found badly worn and suffering component failure during an annual inspection. The sliding tube connecting the undercarriage swing arm to the main bulkhead, and which supports the cushion rubbers, had failed at the aft end. The pin connecting the tube to the swing arm had torn out of the tube.

The failure appears to be as a result of poor design combined with wear and tear. Failure of the sliding tube is a result of loads imposed by a wheel and its supporting structure swinging down after having been compressed. The failure is not able to be identified at daily inspection, as it only becomes apparent when the weight is off the wheel. This case was found at annual inspection. The rough strip from which the aircraft operated likely significantly contributed to the failure.

See diagram and photo below.

It is highly recommended that the aft pin and sliding tube be closely inspected at each annual inspection. This will unfortunately require extensive disassembly.

To check for the problem raise the aircraft in its cradle and gain access to the aft pin. This will unfortunately require extensive disassembly of the undercarriage so that the rubber blocks can be slid away to reveal the aft pin and the hole through which it fits in the sliding tube.

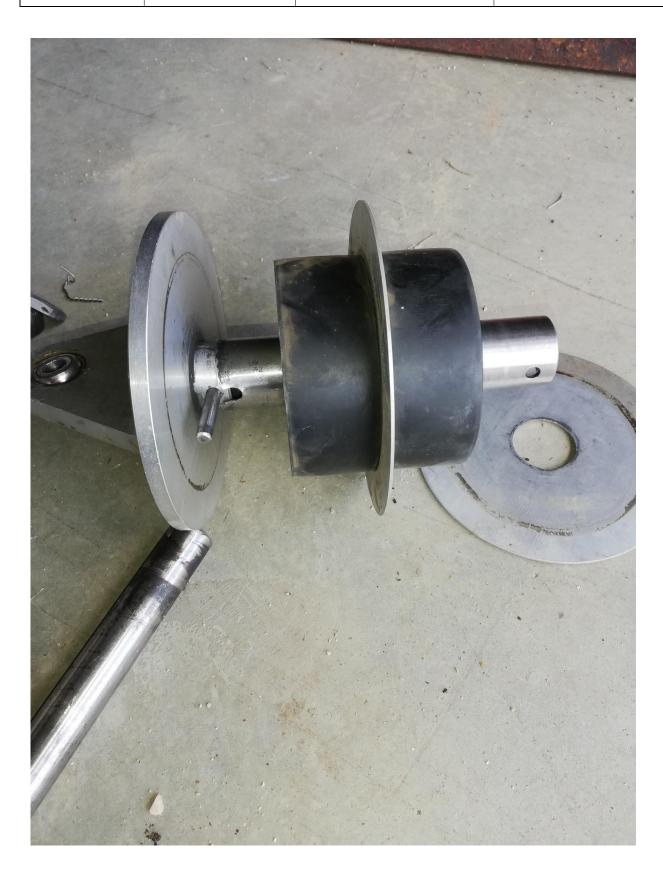
The photograph below shows the damaged sliding tube. The displacement of the pin is likely the result of the damage rather than the cause of it. (In other words, the pin hole was damaged and torn allowing the fitting (P/N 11) to move relative to the sliding tube (P/N 15), and then the pin fell out.)
