THE GLIDING FEDERATION OF AUSTRALIA INC

Airworthiness Alert 2021-2 **PIK-20E Engine Stay (Safety) Wire** **Turnbuckle Failure**

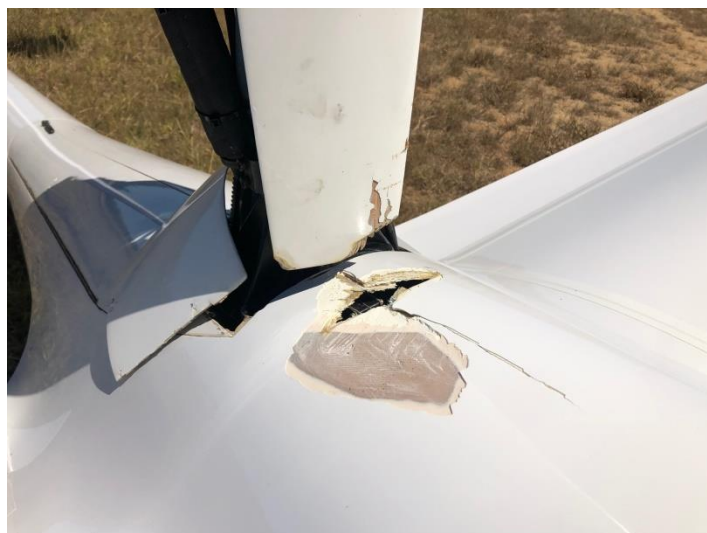
A PIK-20EII has suffered a failure of the engine thrust stay wire resulting in the pylon and propeller moving forward and contacting the fuselage. The failure occurred at full power and during the initial take off roll. The pilot reacted quickly bringing the aircraft safely to a stop.

On inspection, the upper steel fitting of the turnbuckle assembly failed due to fatigue. The part has been sent for further analysis. The airframe had logged 1813 hours time in service, the engine and propeller 178 hours.

The GFA recommends that the engine stay turnbuckle be visually inspected for cracks during the Daily Inspection process. Any visual indications require further NDT investigation or turnbuckle replacement. The GFA further recommends that the turnbuckle is replaced prior to the engine reaching 150 hours time in service.

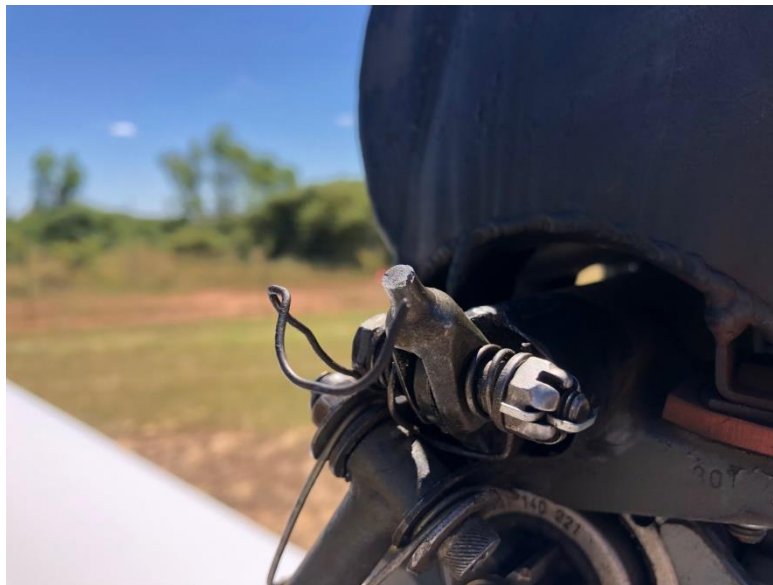
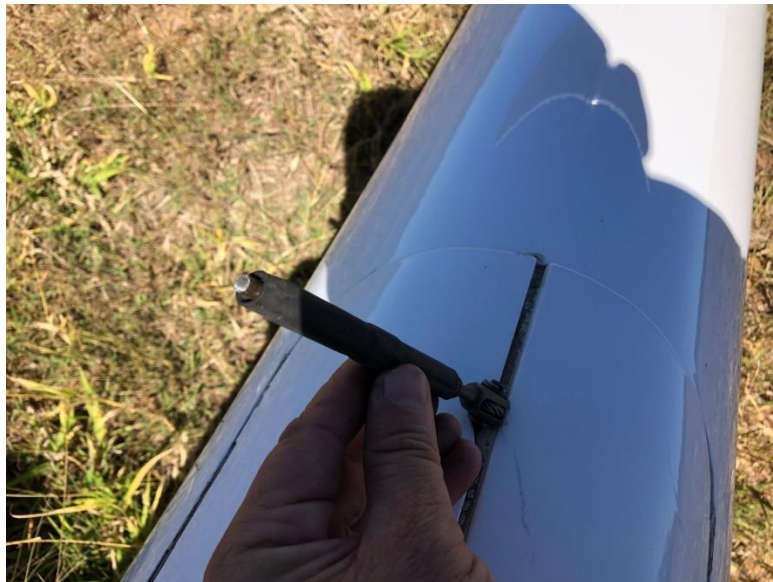
Some operators place a safety cable around the turnbuckle to mitigate any damage experienced with such a failure.
