THE GLIDING FEDERATION OF AUSTRALIA INC

Airworthiness Alert 2021-3 **IS-28B2 Wing Rigging Failure**

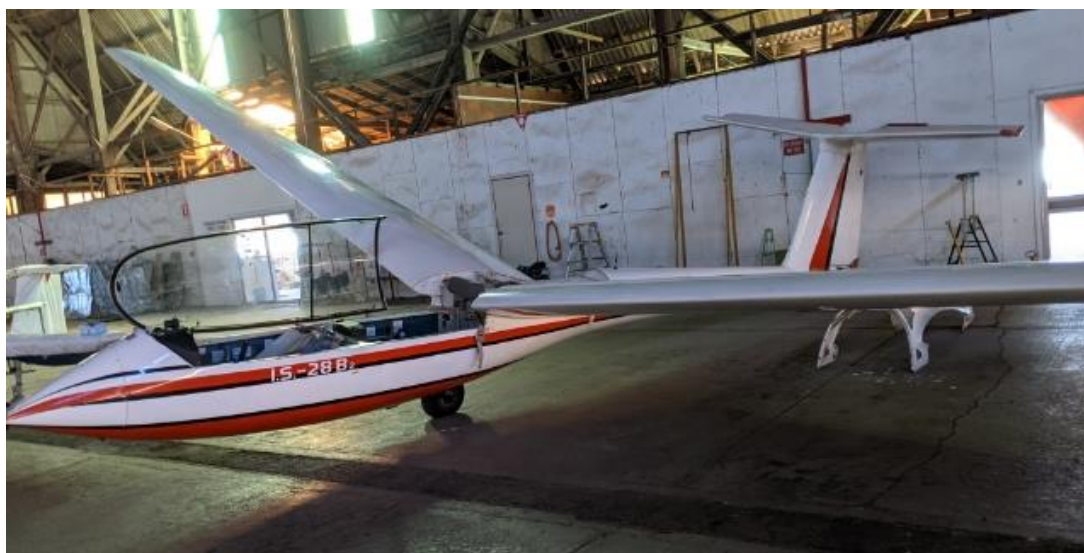
An IS-28B2 sailplane had recently completed an annual inspection for the issue of a maintenance release and was performing a post maintenance evaluation flight. The glider was on aerotow flying just above the ground when a loud cracking noise was heard. The flight was terminated and a landing straight ahead was successfully carried out. After landing, the glider exhibited an exaggerated dihedral. On inspection, the connection between the lower wing spar attachment fittings had failed.

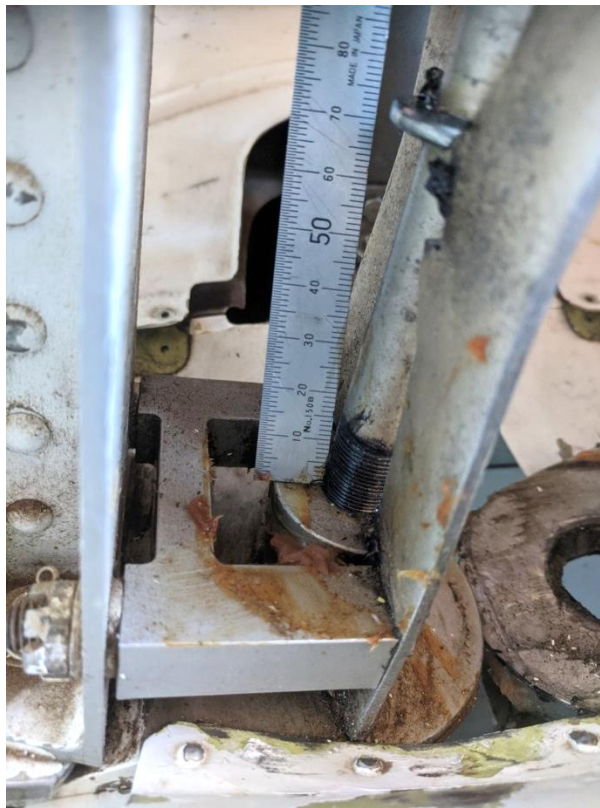
The initial inspection suggested the upper tapered bolt had engaged correctly during rigging, but the lower tapered bolt had not engaged correctly. There were less than 14 mm of thread exposed on the bottom tapered bolt. A comparison with another IS-28B2 revealed that correctly engaged tapered bolts had approximately 25 mm of threads exposed on upper and lower threads when both tapered bolts were fully engaged.

Incorrect rigging - 13 mm thread exposed, collar not retained in slots, wear / contact surfaces visible on tapered bolt. Centre collar is above slot in guide plates

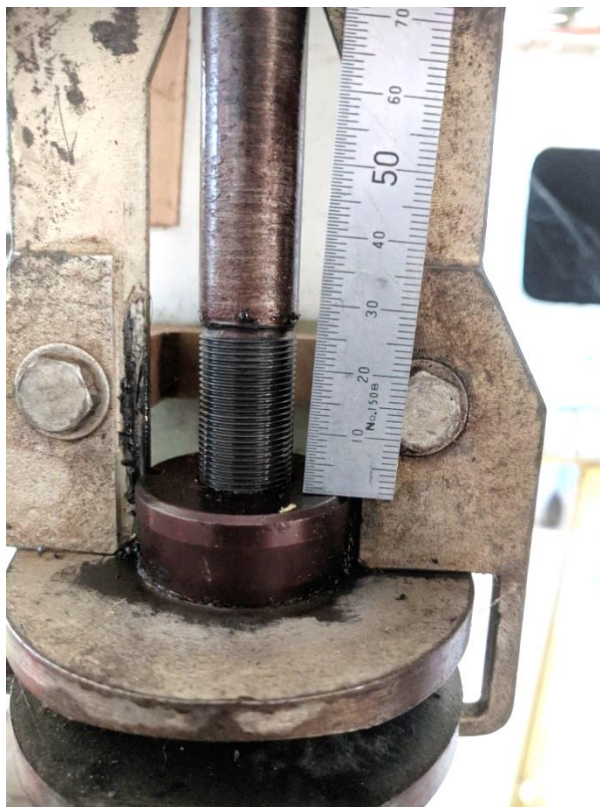
Correct rigging - aligned spar fittings and 25 mm thread, no wear / contact surfaces on tapered bolt exposed, collar housed in retainer.

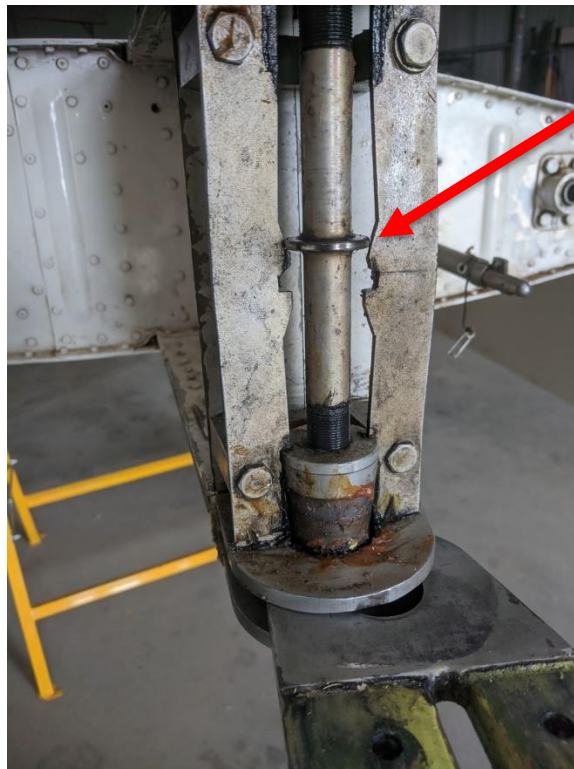
After the preliminary inspection, the glider was derigged and it was able to recreate the sequence of events. During the initial rigging, the lower spar fittings were mis-aligned causing the lower tapered bolt to jam. An extension handle was being used on the T handle

rigging tool. The additional force provided by the extension caused the collar to force itself free of the retaining slots. It is likely the slots were quite worn prior to the event.

The upper tapered bolt was then free to extend into the upper fitting. The lower tapered bolt was still jammed and winding the T handle simply moved the collar and upper pin upwards.

**Collar free of slots.
Retaining plates deformed.**

Recreation of event. The lower spar tongue is jamming the lower tapered bolt with wear / contact surfaces exposed, the collar is 10-15mm above the slots and the collar retaining slots are worn and rounded. The upper tapered bolt is fully engaged.

Prior to rigging, the slot in the guide plates for the collar should be inspected for undue wear.

Prior to rigging, the tapered bolt assembly must be inspected and confirmed to be in good condition, fully functional and serviceable. Worn bolt assemblies must be replaced.

After rigging, the collar should be inspected to ensure it is still in the retaining slots.

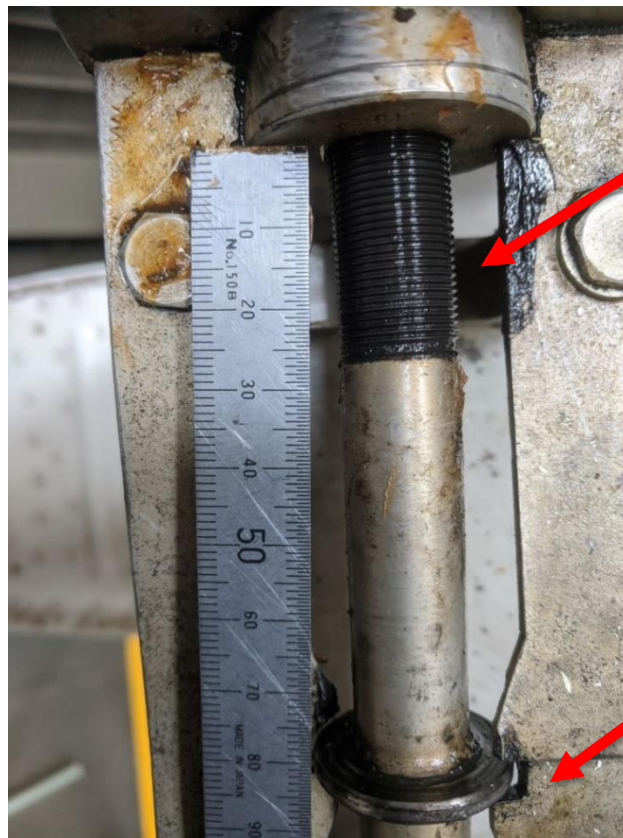
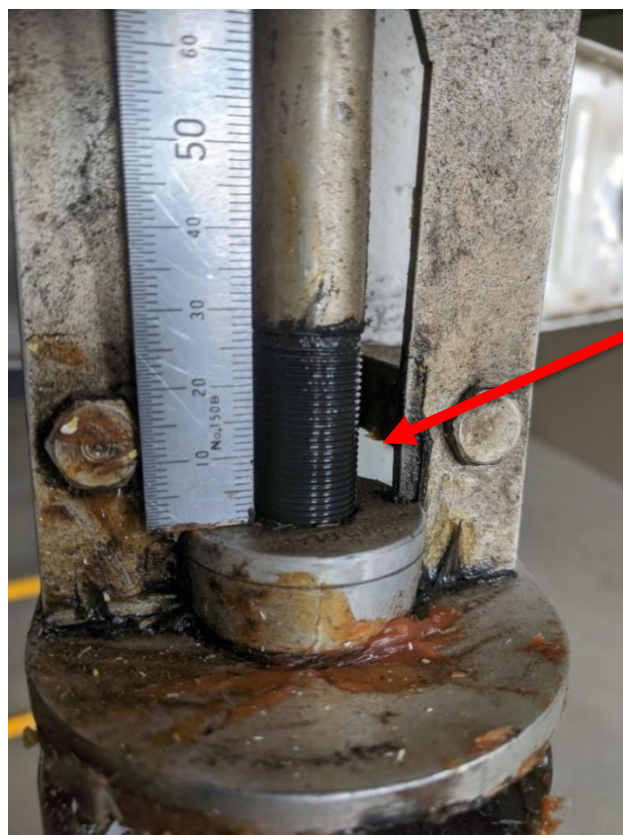
Approx 25 mm thread showing

Collar in slot

The tapered bolts and collar should be visually inspected after rigging (including using a torch and mirror) to ensure upper and lower tapered bolts are fully engaged and collar is retained in its slot. Check the exposed threads are roughly equal on the upper and lower surface and approximately 25 mm of thread is exposed. Wear / contact surfaces on both tapered bolts should not be visible.
