AIRWORTHINESS ALERT 2022-2

Corrosion

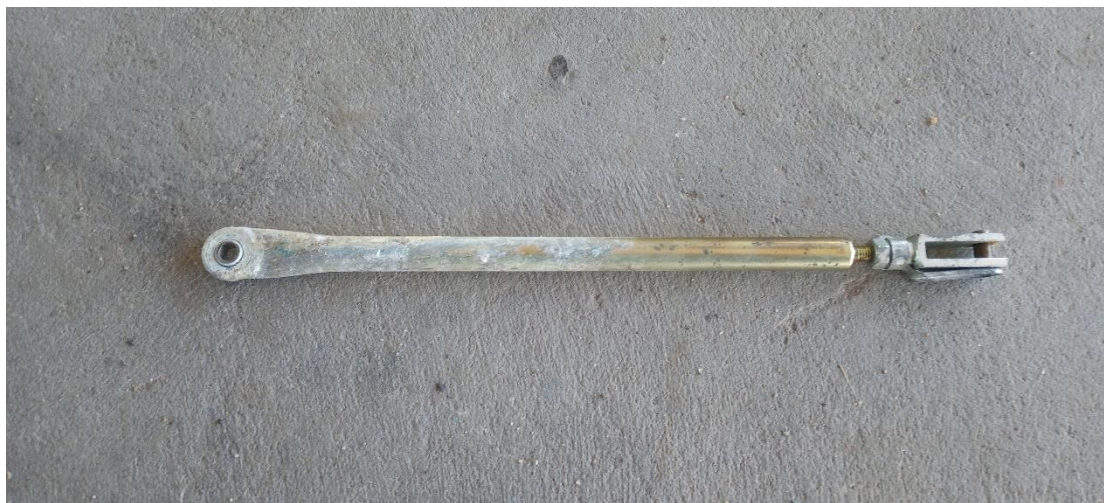
A recent defect report detailed widespread corrosion on metal components under the cockpit floor of a DG-1000. It was reported that an incident involving leaking water ballast bags had flooded the area under the cockpit. This water unfortunately remained trapped in situ for weeks due to no drains in the immediate area under the cockpit. A one-off loss of bladder control event also reportedly contributed. This scenario most likely exacerbated by an unprecedented wet season and resultant high humidity delaying the area drying out through evaporation.

On inspection, it was identified there were no drain holes in the immediate area under the cockpit.

Figure 1: Corroded rear release pushrod resulting from water and urine exposure.

The report stated that water ballast leak in the wings was caused by bad connections at installation, these are now rectified. The lack of any drain holes played a significant part in allowing the water to remain trapped under the floor for a significant time.

All affected components were washed, cleaned, and treated as applicable with lanolin. Washing and drying the metal components and under floor area in the DG-1000 was difficult. All affected components will be reinspected at future maintenance and further treatment carried out as required.

The under floor area should be inspected at the end of the day after known liquid spills or other mishaps in the cockpit.

Inspectors need to be vigilant when performing annual maintenance identifying and rectifying damage caused by urine, battery leakage and general water ingress. Drain holes must be clear and capable of performing their function.
