# The Gliding Federation of Australia Inc

## Occurrence Summaries

01/01/2022 to 31/12/2022

**The Gliding Federation of Australia Inc**  
**SOAR Accident and Incident Occurrences**

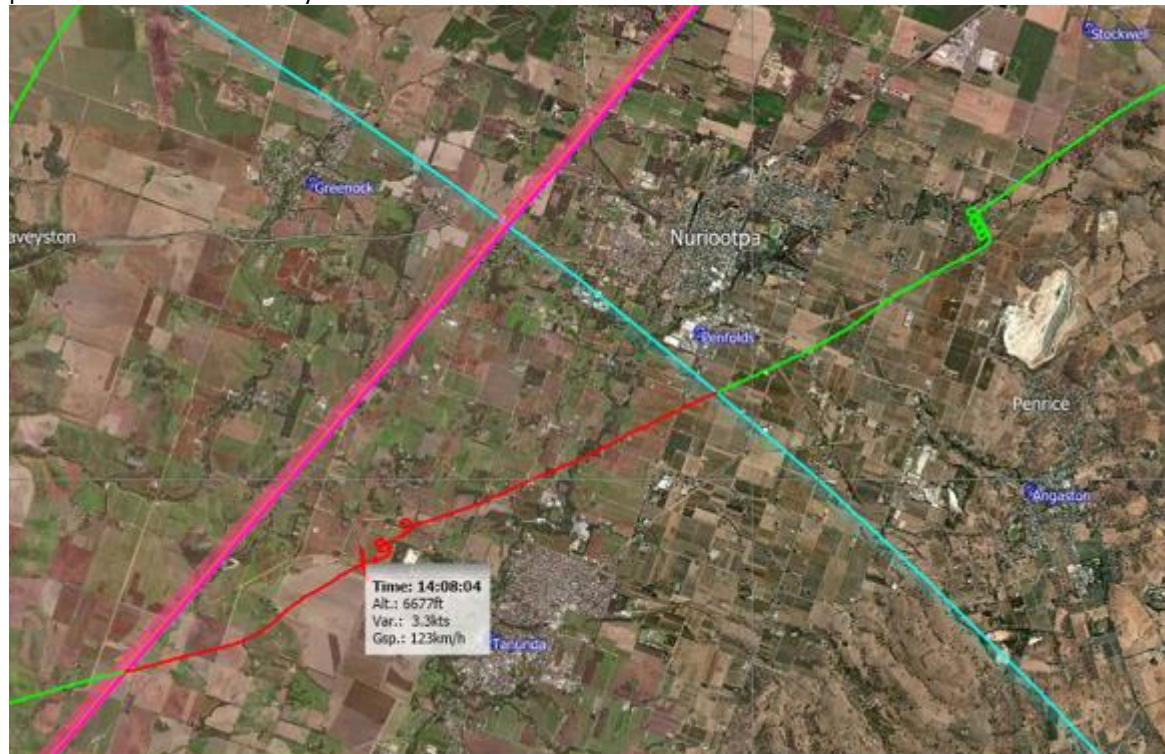
Investigation revealed the pilot traversed through Class C airspace about 2.7km laterally and 2300 feet vertically (See image below). The area to the west of the pink line was released to 6500ft, and east of the pink line and south of the cyan line is class C LL 4500ft.

The CFI reported that the pilot participated in a comprehensive briefing from the Club's Airspace officer and now has a much better understanding of the airspace and the CTA steps around the aerodrome.

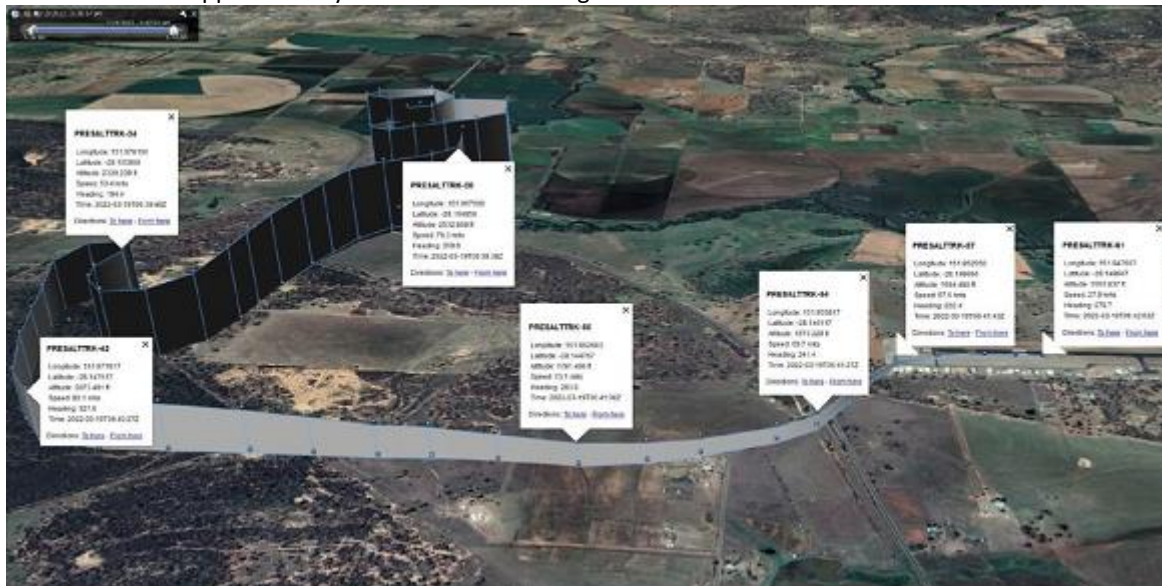
- The PIC conducted a low altitude turn through approximately 50° and touched down on RWY 27R, just beyond the runway 27 taxiway, moving at a slight diagonal across the grass. The aircraft came to a halt approximately abeam the AAFC hangar.

VH-NDQ return to Warwick airfield flight path overview (courtesy GFA flight trace analysis).

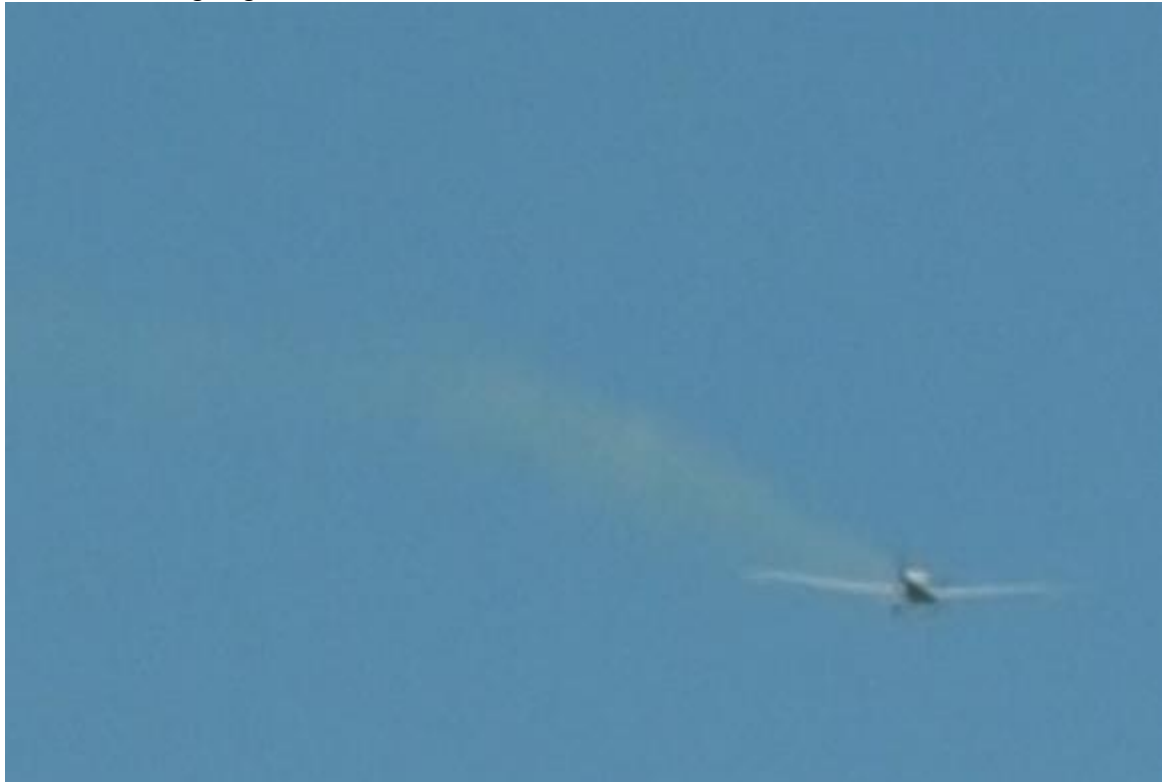
Just after take-off a witness observed white smoke streaming from the glider and called emergency services. The command pilot reported the smell of oil coming from the air vent and decided to return to the aerodrome for an engine-off landing. After exiting the glider, the command pilot reported seeing oil on right-hand undercarriage leg below the oil reservoir overflow.

The pilot reported that at about 1,200 ft, on climb to the East they noticed the smell of oil coming through the right air vent. A check all engine gauges showed the engine to be operating normally. The pilot slowly closed the throttle and performed the engine failure procedure while turning back towards the aerodrome. During this time the oil smell had stopped, and the circuit entry was normal. The pilot made the circuit radio calls and during mid downwind stopped the engine and turned off the master switch. The pilot completed a normal landing and rolled to a stop just before a taxiway. The pilot then turned the master switch back on, and then the fuel pumps. The engine started and instantly had oil pressure. The pilot taxied back to the parking area and switched off. Upon exiting the glider, the pilot observed oil on the right-hand undercarriage leg below the oil reservoir overflow. Shortly afterwards the emergency services arrived on scene but there was no emergency. The engine was inspected by an authorised maintenance organisation. The engine was test run and the oil and filter were replaced. A test flight established the engine was performing normally.

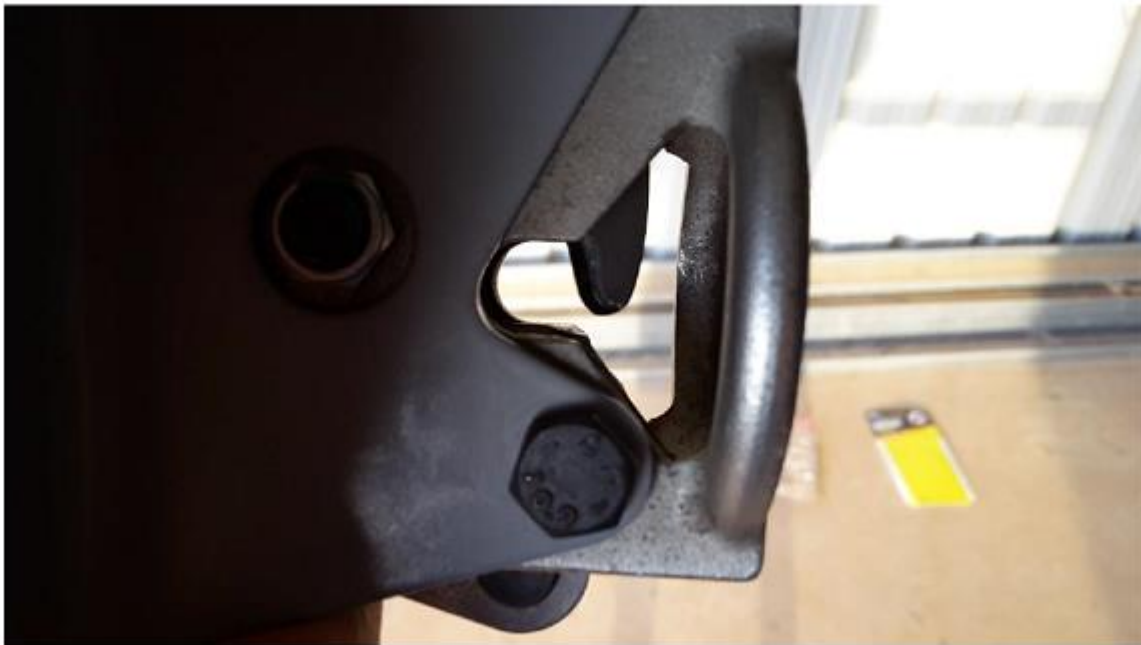
The investigation revealed a fully functional release system and release. The release showed little wear, was in good condition and deemed serviceable. The sailplane had logged 388 launches. The TOST rings used in this case measured 4.66mm. New TOST rings measure 6.7-7.0 mm. It was also noted that the E 22 beak when fully closed was about 3mm short of the casing slot. This was confirmed to be normal as per the TOST design. Subsequent tests carried out on the release using the same worn rings with 4.66mm diameter showed that with only slight upward angle of the tow rope, the curve of the rings would slip under the closed beak. The following is an extract from correspondence received from TOST: *"The release E22 was designed and certified to be only operated with the connecting ring pair according to LN 65091. According to the aerospace norm LN 65091 the circular link (the small ring) needs to have a diameter of 7 mm (tolerance: +0,0 mm and -0,3mm). A diameter of 5,1 mm is way too far from any allowable tolerance. Please do not use connecting rings with a diameter of 5 mm with our releases, that's very dangerous."* Sailplanes fitted with a E 22 release, if not using rings meeting new or close to new dimensions, have an increased risk of an uncommanded release.

**Figure 1: TOST E 22 release. Beak when fully closed has 3mm gap**

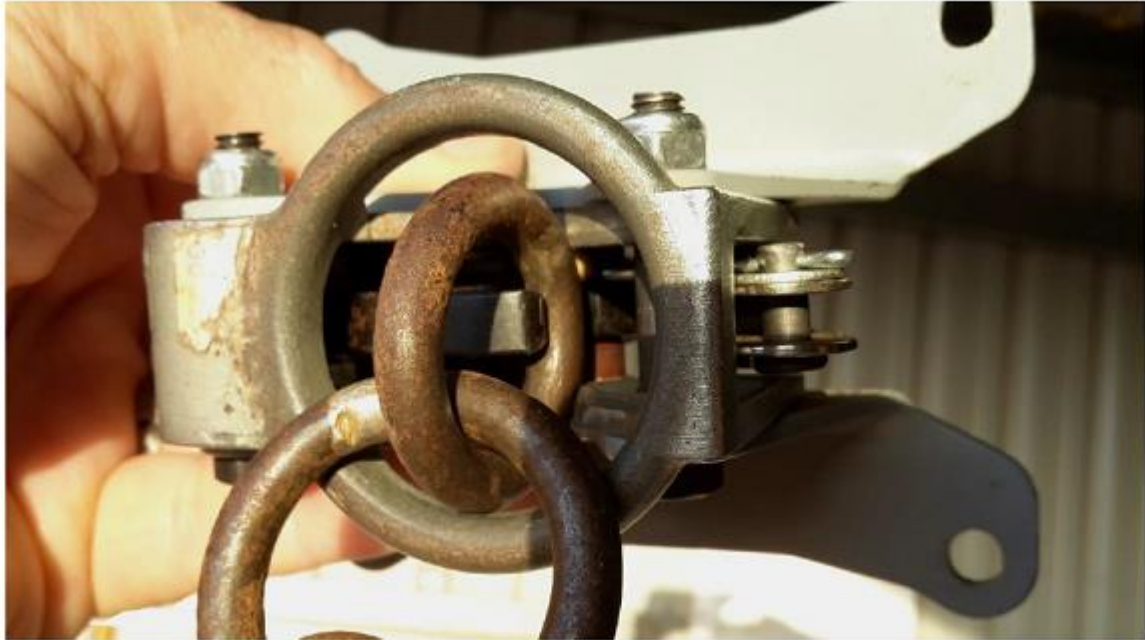
**Figure 2: TOST E 22 release. Worn rings wedging under beak.**

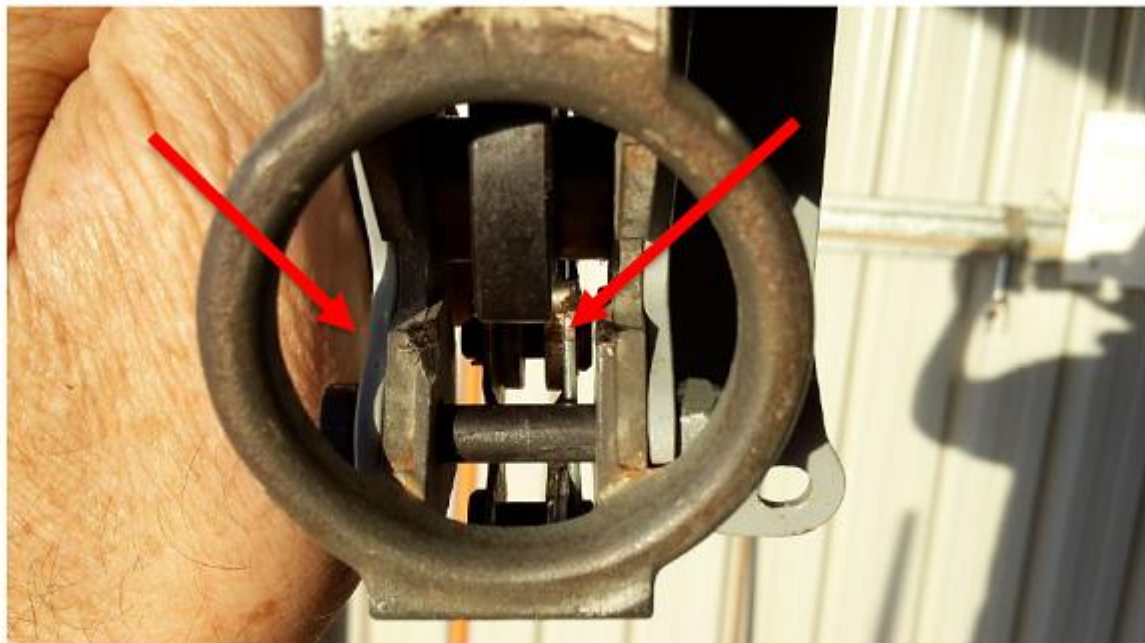
**Figure 3: TOST E 22 release. Note the wear on the side plates.**

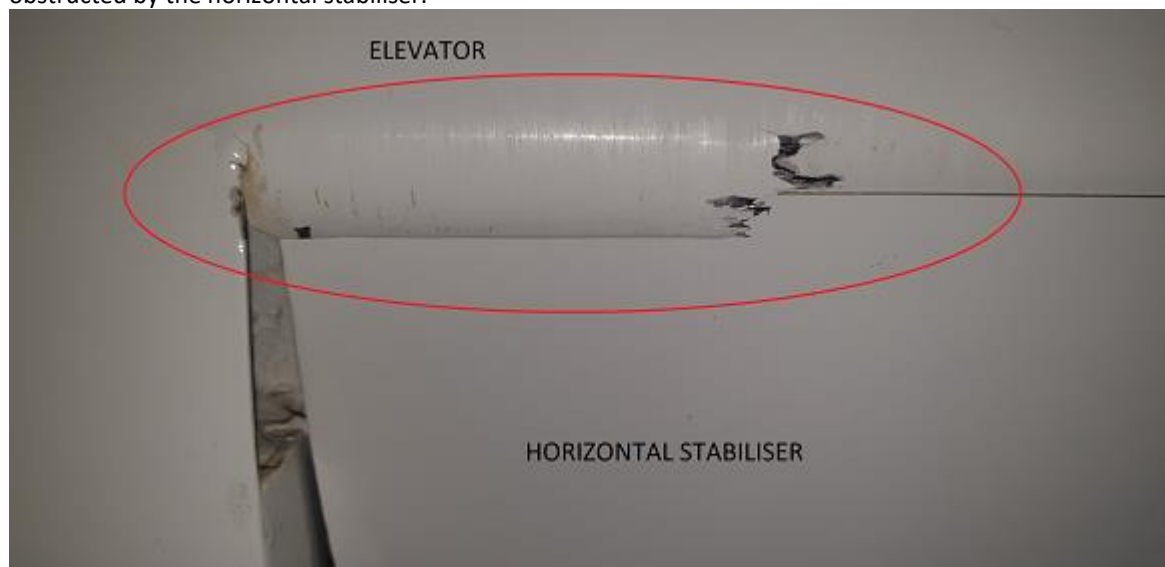
Following a normal landing, the pilot held the control column fully back during the ground roll to keep the tailwheel on the ground. Due to recent runway repair work, the runway surface was rough and the pilot commented on the amount of bumping during rollout. When the pilot eventually eased the back pressure on the control column, it remained in the full back position and could not be moved. On exiting the glider, the pilot found the elevators had jammed because the last 25 mm of elevator had popped out of its housing and obstructed by the horizontal stabiliser.

Subsequent inspection at an Approved Maintenance Organisation found the elevator had moved beyond the control stop and the elevator leading edge seam had got caught on the bottom edge of the horizontal stabiliser. The control stops were undamaged and in its usual position. After the repair and when tested on the ground, full back stick brought the elevator to its nominated deflection with several mm of further travel required to "catch" the lip on the elevator leading edge against the trailing edge of the stabiliser. Given the problem could not be replicated, it is highly likely that the pilot's aft stick position coupled with a rough runway surface caused the elevator to flex to an excess deflection. The designer/maker recommends avoiding "excessive control forces. The aircraft designer is aware of this incident.

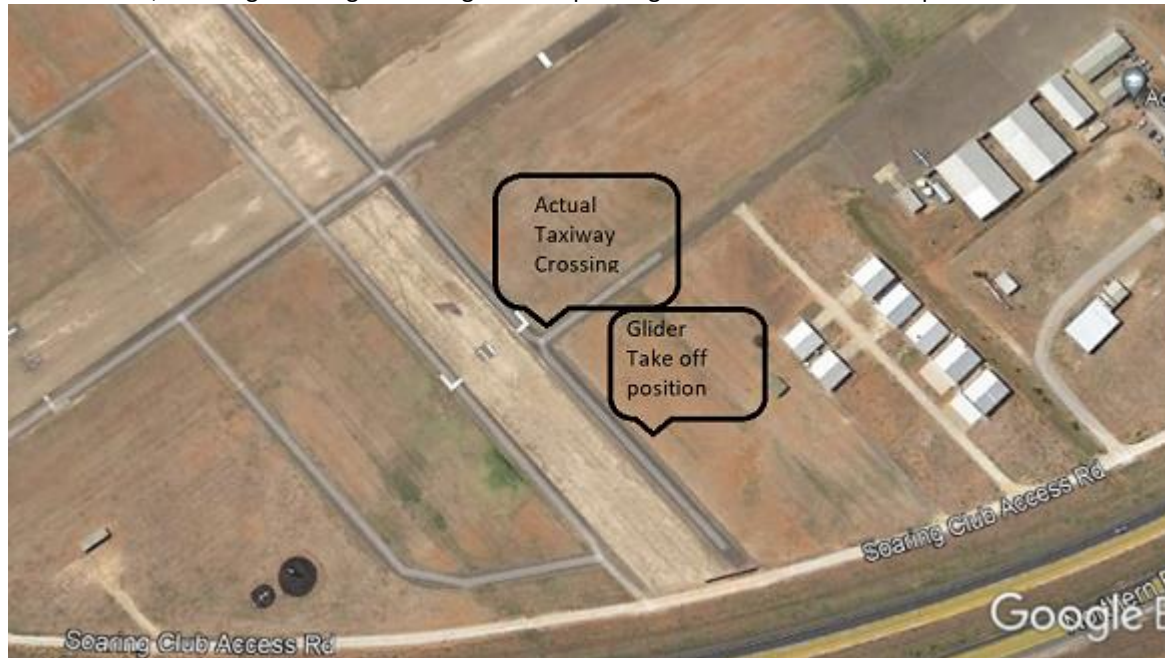
During the initial ground roll of an aerotow launch being flown by the student pilot, the starboard wing dropped to the ground. The flight crew heard a noticeable 'bang' as the wingtip struck the edge of a taxiway. The student then experienced problems controlling the aircraft, so the instructor assumed control. The flight continued with no further issues, but after landing the instructor noticed damage to, and excessive movement in, the winglet. The glider was grounded pending a detailed structural inspection.

At this regional aerodrome it is usual for gliders to launch from the right-hand side of runway 31 on the 4m wide bitumen edge of the main unsealed runway. During launch the glider's right wing overhangs the edge of the runway, and the take-off path crosses a taxiway to the north of RWY 05/23. The CFI reported that the soil around the bitumen moves due to changing moisture content, and at the time of this incident the soil was about a 20 to 30mm below the level of the bitumen. When the wing dropped to the ground, the wingtip wheel holder struck the edge of the bitumen and compressed against the wheel, and the shock caused the

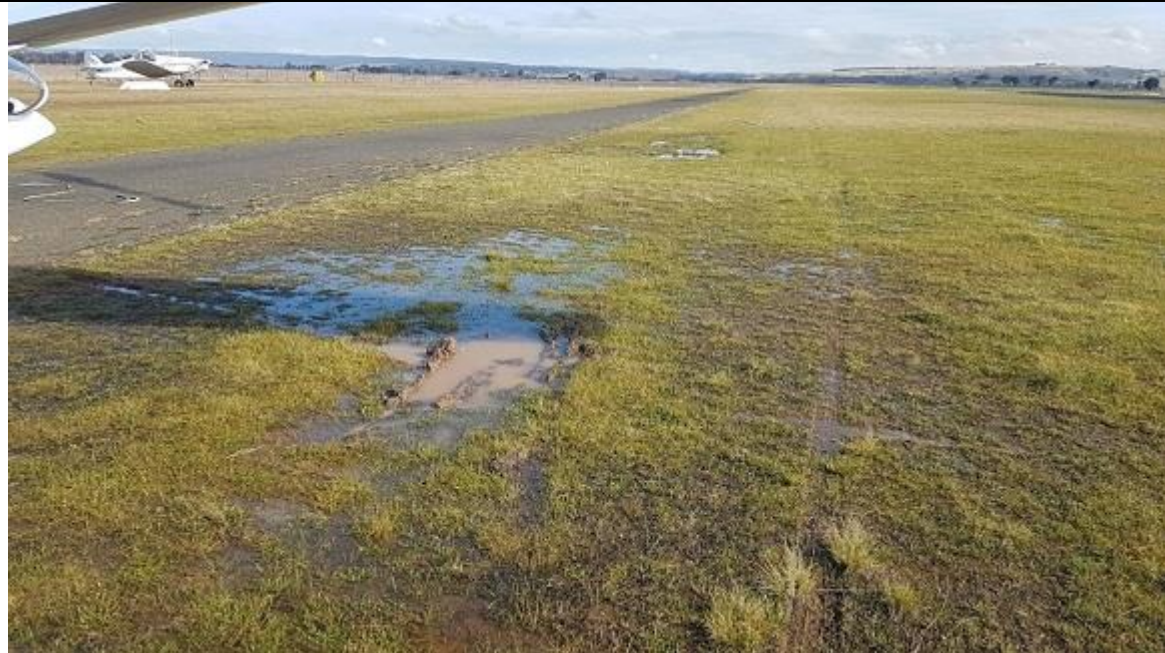
The pilot noted that the movement area where the incident occurred has been a problem for many months and the grass verge needs maintenance. There are several ruts and depressions in the take-off area. The bungees on the aircraft were changed in July. However, inspection revealed fluid from the strut had leaked onto the bungee and had degraded the rubber. The combination of the damaged bungee and shock from falling into the depression in the ground caused the bungee to break. The strut and bungee cable have been replaced, and a report was made to the aerodrome operator.

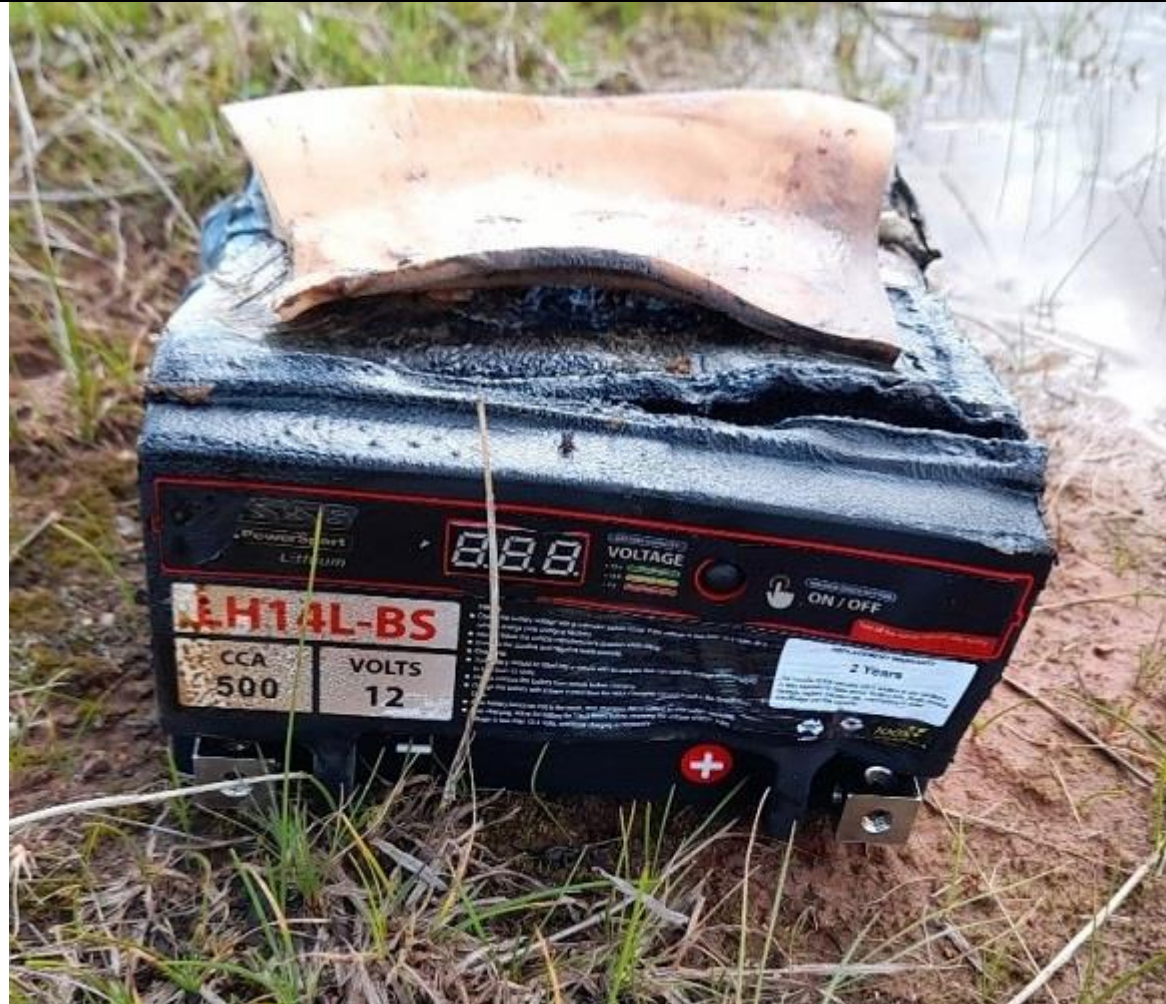
The pilot was testing engine performance and planned to conduct a long power-on climb to 6000ft and then an engine restart at about 4000ft. The climb was uneventful, and the engine shut down and retraction was normal. When at 4000ft and about 5NMs from the aerodrome the pilot extended the engine successfully but was unable to restart the engine, and then found the engine would not retract. The pilot flew towards the aerodrome, and during the decent he heard popping noises from behind the cockpit, which convinced him to expedite the landing. The pilot conducted a safe landing with the engine extended, and when he exited the glider observed smoke and fumes coming from the battery box in the engine bay. The pilot donned a pair of leather riggers gloves and, using a screwdriver, removed the Lithium-Ion Phosphate battery from the aircraft and placed it on the ground about 30 metres away. The pilot reported the battery was quite hot, and the case was deformed.

Picture: Smouldering battery after removal from aircraft.
