AIRWORTHINESS ADVICE NOTICE

TYPE AFFECTED: Arcus M

SUBJECT: Miscellaneous airworthiness information.

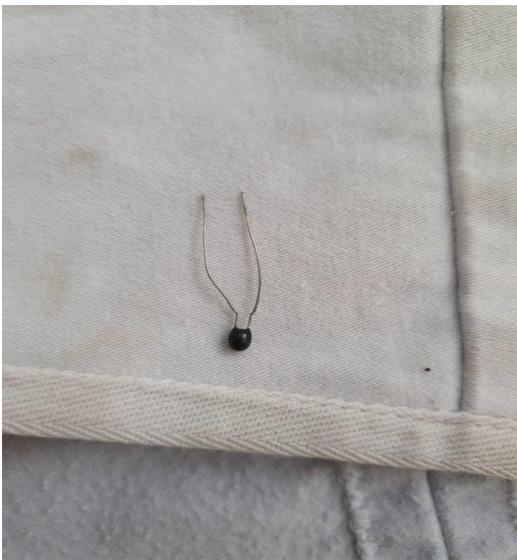
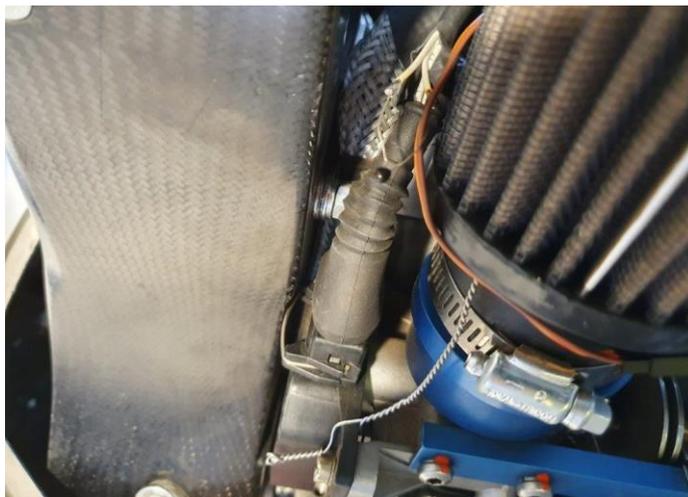
2. Thermistor fault-engine fuel injection management. In self-launch mode the fuel injection system requires air temperature measurement to control fuel flow. Should this fail a redundancy operation is invoked with less power available. Could not achieve full power for a self-launch procedure when previous launch was normal.

To locate the thermistor that is embedded in the wiring harness near mast and above throttle sensor. It is black, about the size of a match head (only this part exposed), it has two wires attached. Testing its operation using wiring diagram gave no results as no connection to this circuit. Dismantling the harness covering to expose the thermistor connection showed both ends not attached and unit free (poor soldering connection to both wires). Tested thermistor and found operational, soldered both wires into circuit and insulated and tested circuit, now shows it is connected. A software upgrade to fuel injection management system was also carried out before engine testing.

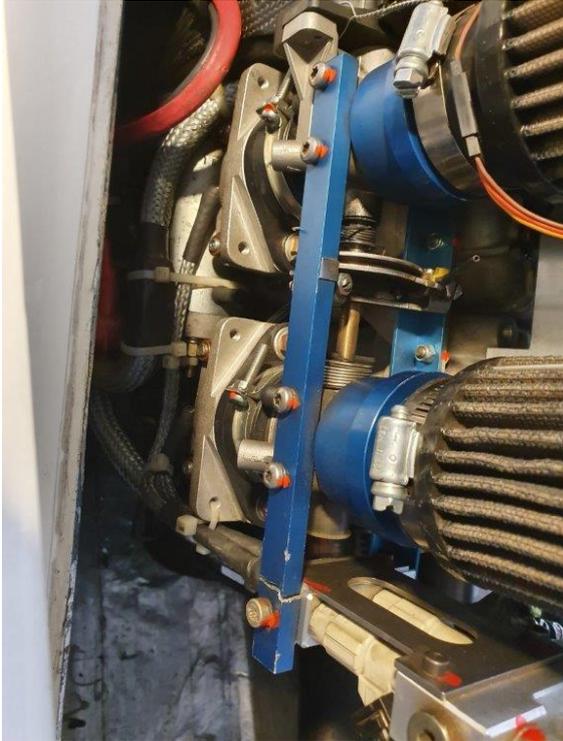
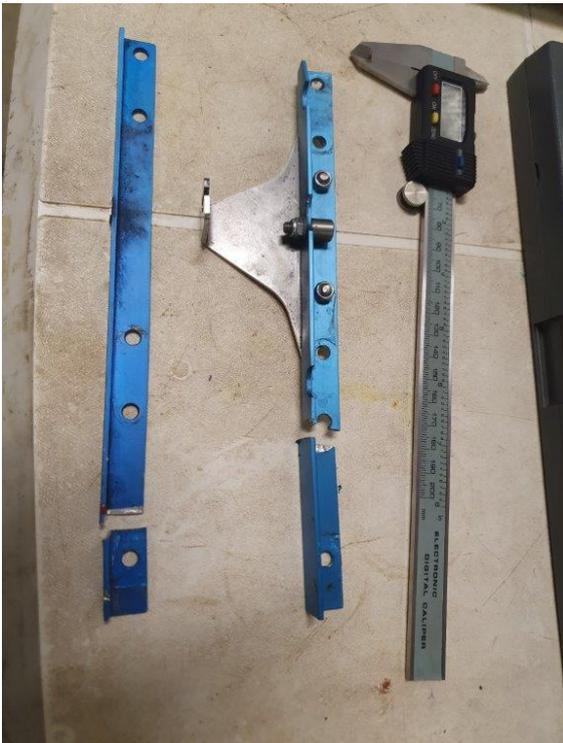
3. Throttle body aluminum rails fractured and replaced (reference Solo Service Bulletin Nr 4600-8). Vibration and mounting holes too close to edge of aluminum angle section caused the failure.

Rails replaced by composite material parts supplied by Schempp-Hirth from Solo. This required dismantling the unit in the engine bay and replacement / exchange with new parts. New engines do not require upgrade as have a modified throttle body unit.

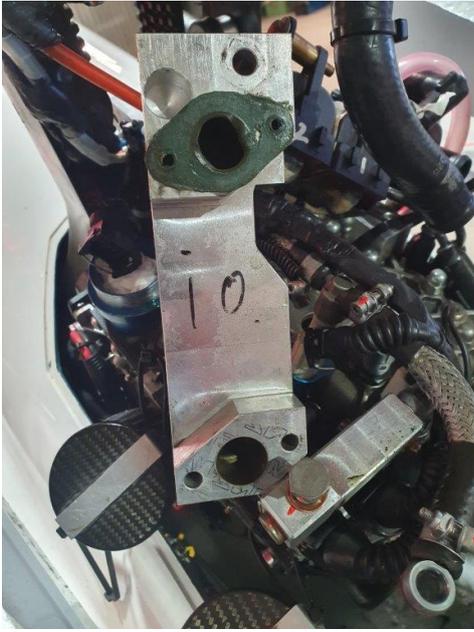
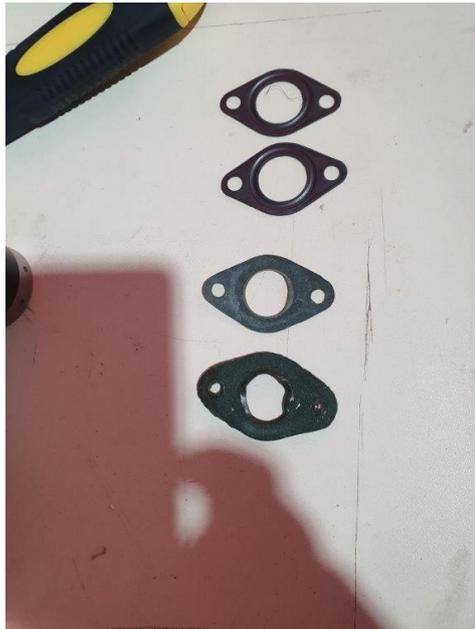
4. Leaking head manifold water gasket on No.2 cylinder head. When removed it was found that one gasket had collapsed, unable to seal under pressure, the other was secure. Replaced both gaskets, supplied by SOLO, significant work to access these gaskets and refill and bleed water system. Manual supplied bolt torques as required.

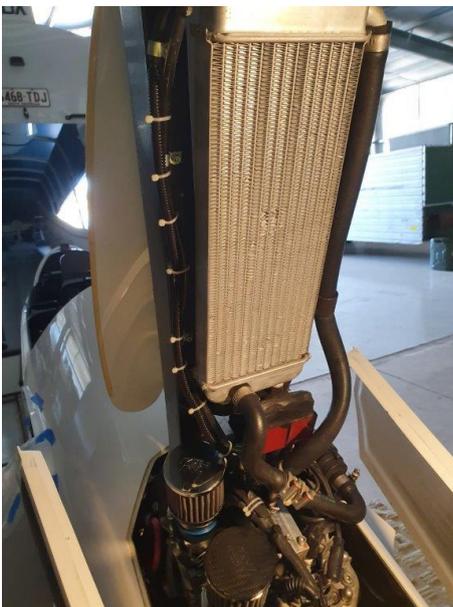
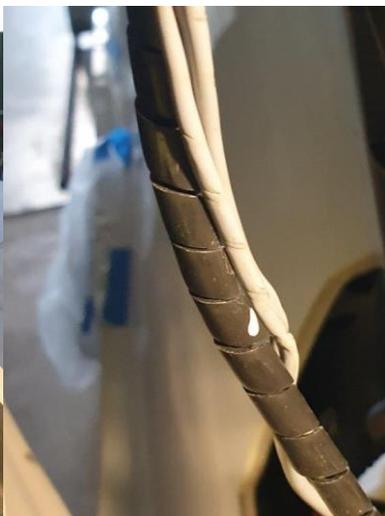
5. Spiral wrap on cables LH side of mast to propeller auto retract sensors. This material with vibration has cut into the cables it protects. The cuts are in a spiral format, and one has cut wiring and disabled function.

Tested system by ignition on and both sensors should glow dull red, one had failed. When propeller rotated, the retract function was not performed. Traced cable for broken wire, cut and soldered connection and tested circuit operation. Replaced spiral wrap with round plastic sleeve wrap with a cut on one side supporting cables inside. Secured to mast frame and tested engine operation after maintenance completed. Engine now operational and returned to service.

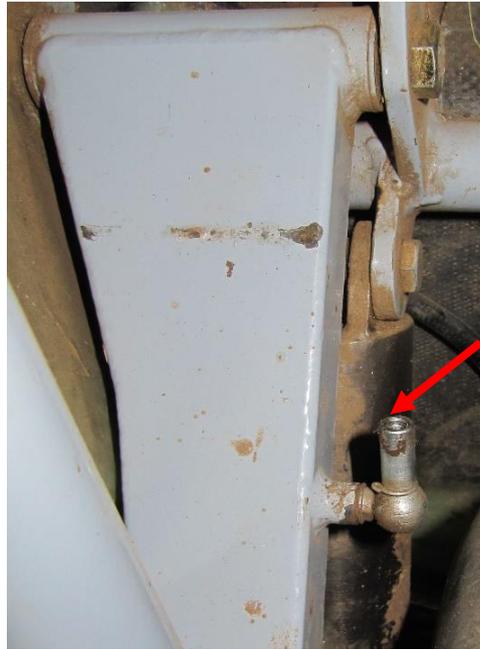
DISCUS (Same undercarriage mechanism as Arcus): The gas strut bottom end is suspected to have unwound at the bottom end fitting from the barrel of the gas strut. After detaching, the top attachment ball failed during operations and the gas strut penetrated the parcel shelf behind the rear cockpit.

Figure 1: View in the wheel well looking forward showing port undercarriage arm and disconnected gas strut connection

1. **LUBRICATION:** The ball ends of the undercarriage gas strut should be lubricated every annual inspection.
2. **THREAD LOCKING:** The threaded junctions on the undercarriage gas strut should be secured against unwinding by use of a thread locking compound (recommend Loctite 243).
3. **BALL REPLACEMENT:** The ball ends are subject to significant fatigue loads due to the high oscillatory loads on the rocker arm mechanism on the ground roll during take off and landing, and during towing. It is recommended to replace the ball ends whenever the gas strut is replaced.
4. **GAS STRUT REPLACEMENT:** Replace the gas strut when it becomes noticeable that the retraction effort has increased significantly. Pay attention that the gas strut force rating matches the mainwheel type installed. Refer maintenance manual.

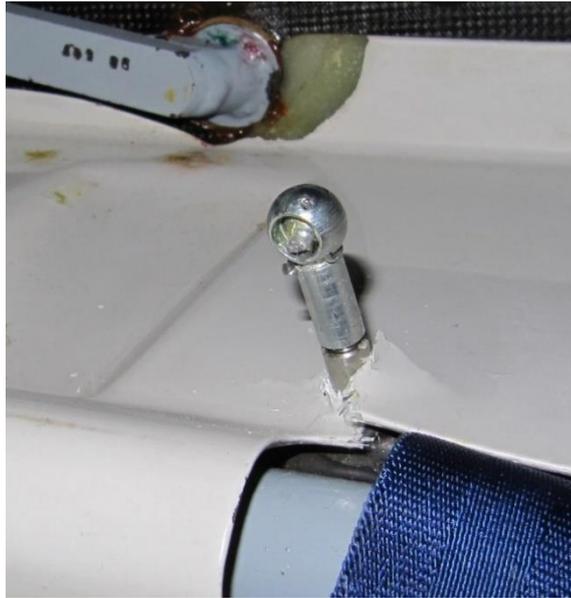
Figure 2: Gas strut end protruding through parcel shelf.

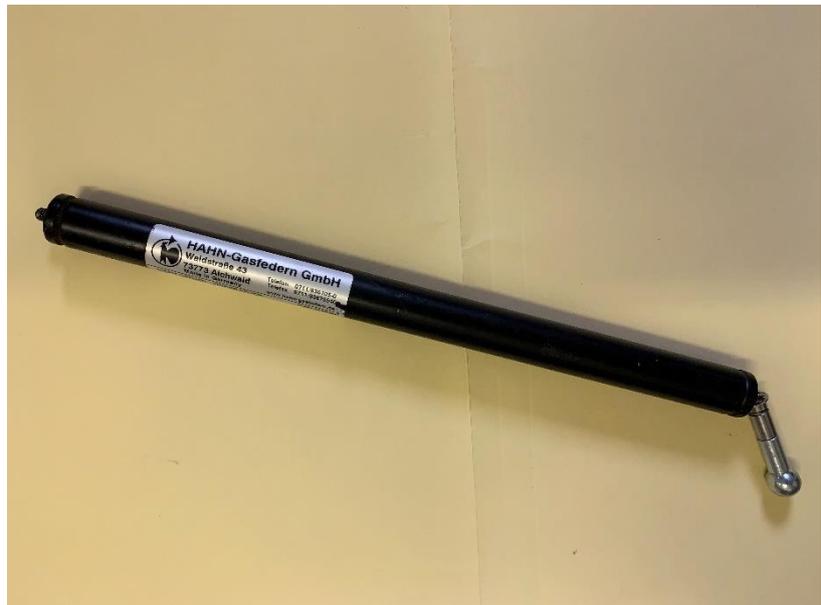
7. UNDERCARRIAGE GAS STRUT FAILURE ON DUO DISCUS: While preparing to put the fuselage in the trailer, the undercarriage gas strut was found disconnected from the lower and upper attachment points. The ball ends had sheared and the end attached to the top of the gas strut rod was bent. Reference defect 6 above, this was the second gas strut failure experienced on the same aircraft.

Figure 3: Failed gas with bent strut.

The balls which attach the strut are similar in design to L'Hotellier balls in control circuits, but smaller. Rather than being lubricated on a regular basis, they may or may not be lubricated subsequent to entering service and may not be lubricated at an annual inspection.
