AIRWORTHINESS ADVICE NOTICE

TYPE AFFECTED: Rotax 900 Series Engines

SUBJECT: Miscellaneous airworthiness information.

BACKGROUND: Aviation Investigation Final Report-Loss of Engine Power
(Total) NTSB Accident No. ERA20LA341.

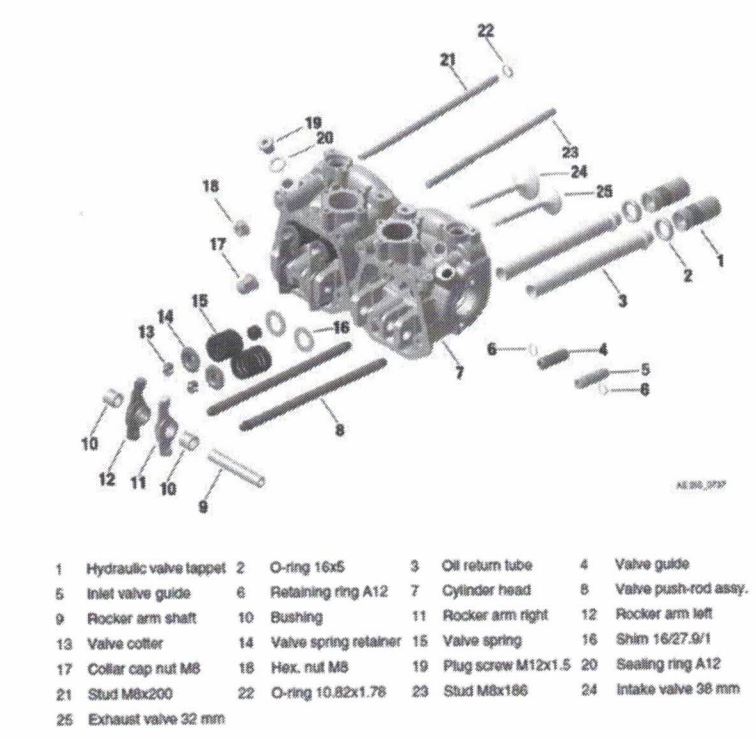
Review of the Rotax 912 Heavy Maintenance Manual 72-00-00, Edition 1, Revision 4, page 69, revealed that wear of "the valve spring support can indicate a malfunction of the valve train as a result of badly or insufficiently vented hydraulic valve tappets." Figure 1 shows the components of the engine valvetrain.

Figure 1. Illustration of components of the engine valvetrain.
