## AIRWORTHINESS ADVICE NOTICE

**TYPE AFFECTED:** All Types fitted with a Gadringer Harness

**SUBJECT:** Gadringer Harness Disassembly / Assembly

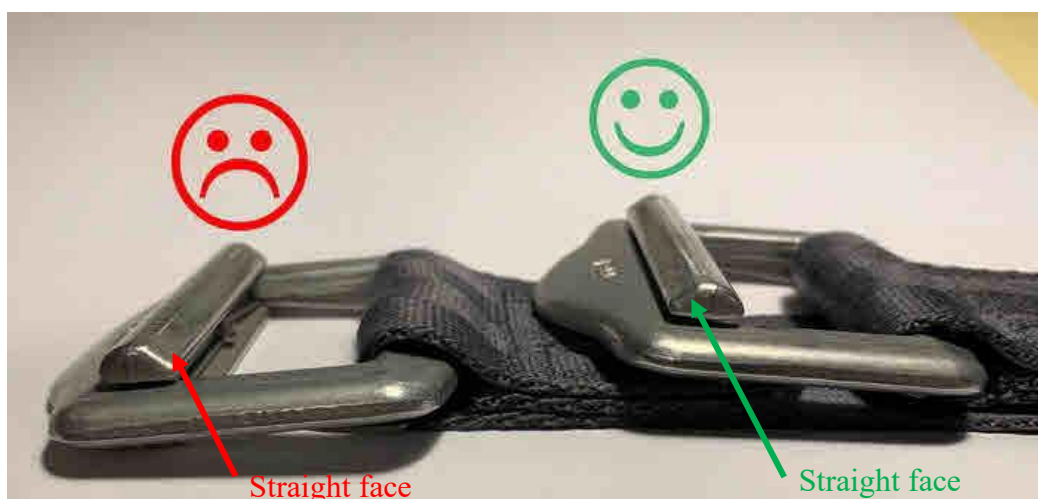
The observation reported here is more subtle. The slider has been reinstalled upright but inadvertently end for end. The slider does not have a symmetric cross section and so correct orientation does matter. The slider has a straight (almost flat) face and a curved face. Refer to the photo below.

**Figure 1: Left adjuster is wrong; straight face of slider is towards webbing. Right adjuster is correct; straight face of slider is towards adjuster nose.**

The orientation of the slider will influence the friction between the slider and the webbing. Incorrect orientation will reduce the friction when the harness is tightened and may allow slacking of the harness over time.

*'Correct installation of the slider must be with "straight (almost flat) face" orientation towards the adjuster nose - like the right one on your photo. This is to prevent micro-slip (slacking) of webbing.'*

Inspectors need to ensure that the sliders are correctly oriented on reassembly after maintenance.
