AIRWORTHINESS ALERT 2024-1

Duo Discus Tailplane Mount / Elevator Drive Pin Failure - Inspection

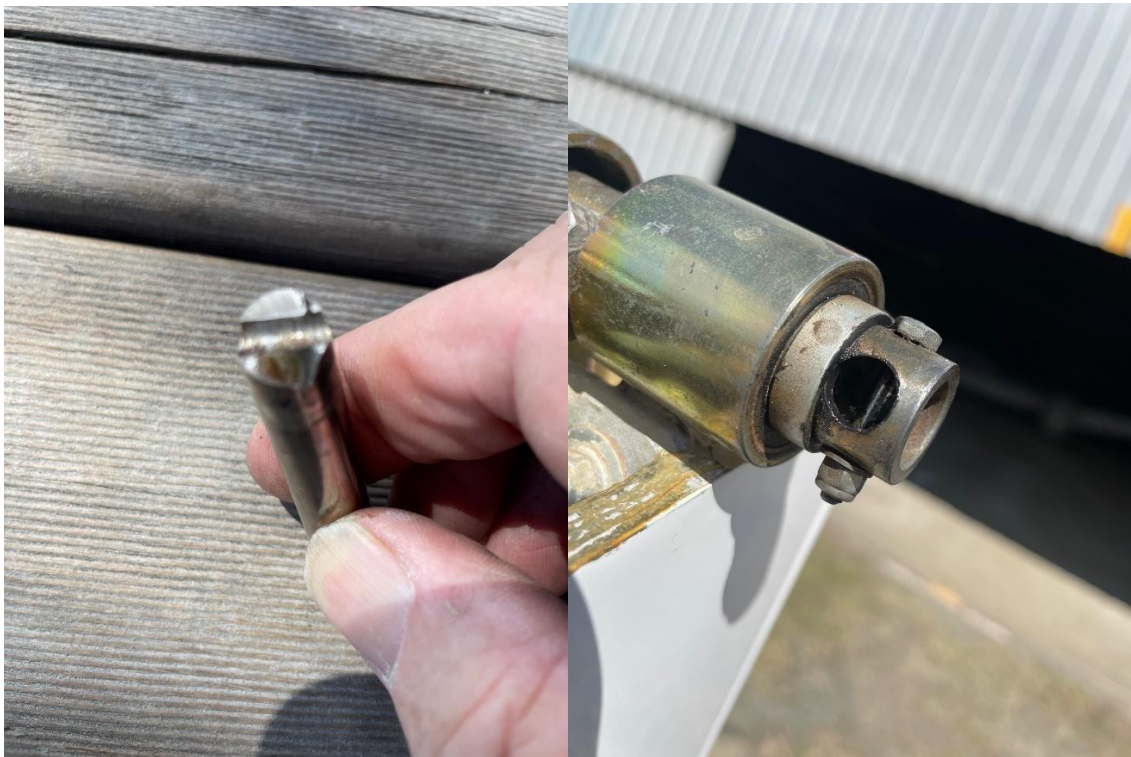
The failure was discovered whilst performing the Daily Inspection prior to flight. The tailplane exhibiting excess lateral play.

Figure 1: The affected sailplane on the daily inspection showed excessive tailplane lateral play. The pin fracture occurred at the attachment bolt.

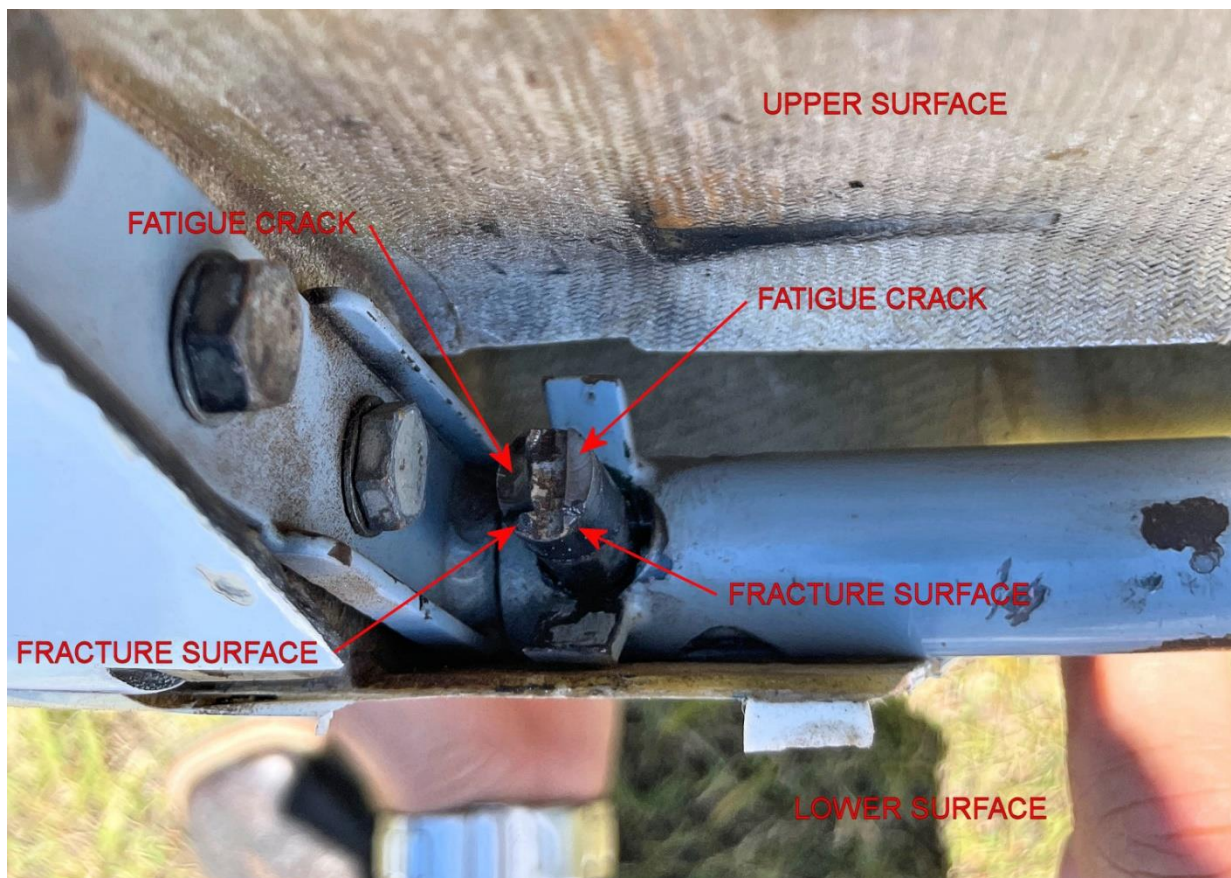
The port pin failed at the attachment bolt. Both pins on this aircraft are being replaced and will be sent for examination. The tailplane assembly will be inspected in depth for any further damage.

Figure 2: Initial analysis of the fracture

The initial analysis at this time suggests fatigue originated at upper surface of bolt hole on port elevator pin. Cracks grew downwards to about 80% depth before final fracture. The cracks have distinct beach marks showing crack growth stages.
