AIRWORTHINESS DIRECTIVE - GLIDERS

GFA/AD 101 DUSTER 1

Glider Type Affected: B.J.1B Duster

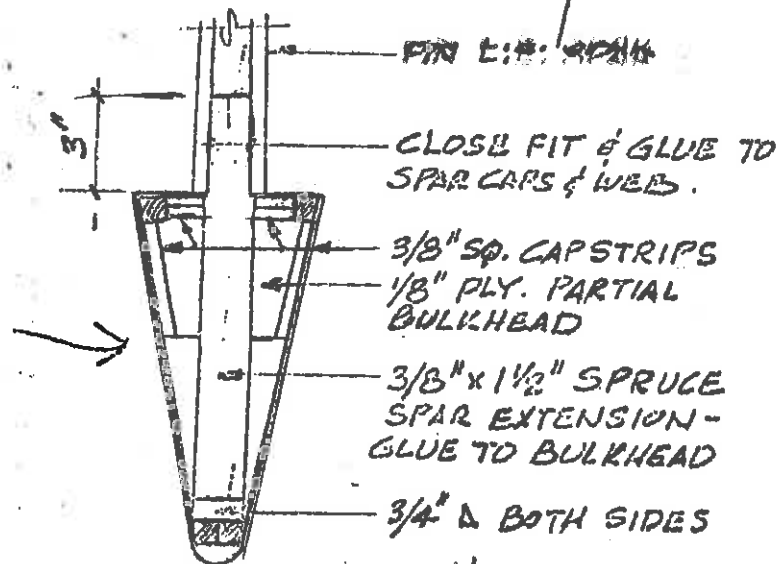
A number of cases of rudder flutter and separation of the fin from the fuselage of the subject glider type have occurred. This is attributed to structural inadequacy of the fin to fuselage attachment and insufficient mass balancing of the rudder.

HOLLOW OUT FOAM-GLASS  
FAIRING & FILL W/ LEAD SHOT  
POTTED IN RESIN.  
BALANCE RUDDER AS  
CLOSE TO HINGE LINE  
AS POSSIBLE
