COMMONWEALTH OF AUSTRALIA  
DEPARTMENT OF TRANSPORT

AIRWORTHINESS DIRECTIVE - GLIDERS

GFA/AD104 LET KUNOVICE 13

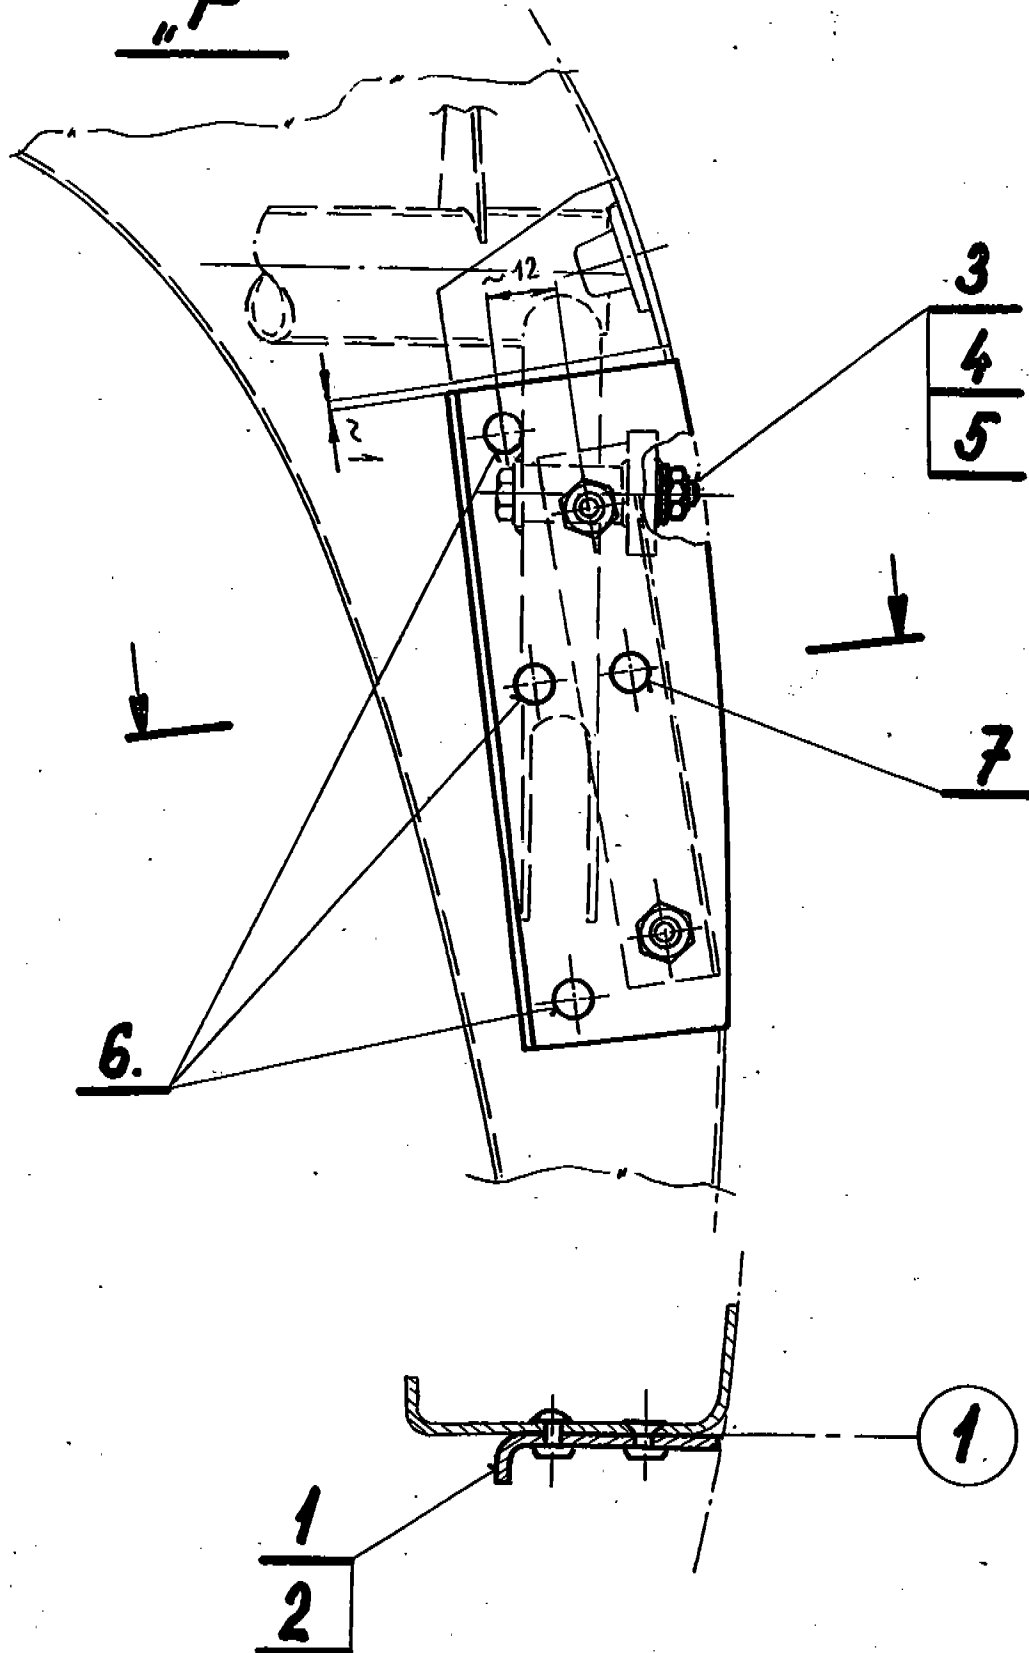
- A. To increase rigidity of No 1 bulkhead at the location of tow rope hook control system countershaft bracket.
- B. To secure tow rope hook control system countershaft (by means of bolts nuts and washers) against accidental sliding out of the bracket bearings.

1. Locate stiffeners (pos1,2) on the bulkhead No 1 as shown on figure 2. If necessary fit the stiffeners according to the contour of the bulkhead. According to the screw holes in the bulkhead mark centers for the holes on the stiffeners. Remove the stiffeners and rough drill holes 5.8 mm diameter then ream them together with holes in the bulkhead to the diameter of 6H8.
2. Fasten stiffeners on the No 1 bulkhead using original bolts washers and nuts.
3. According to rough drilled holes in the stiffeners drill holes 2.7 mm diameter countersunk for rivet heads(pos7) and rivet on the stiffeners using rivets(pos 6,7) see figure 2.

Fit bolts (pos 3) washers(pos 4) and nuts (pos5) as shown in figure 2.

Should the bolt be difficult to to slide in redrill the hole in the countershaft to the diameter of 4.2mm.
