GLIDING FEDERATION OF AUSTRALIAAIRWORTHINESS DIRECTIVE- GLIDERS/POWERED SAILPLANES

GFA/AD 106 LET KUNOVICE 14

ISSUE 2 Date 10/9/81SUPERSEDES:- Totally replaces AD/106 Issue 1 Dated 12/5/1978GLIDER TYPE AFFECTED: Blanik L13 - All Serial numbers.

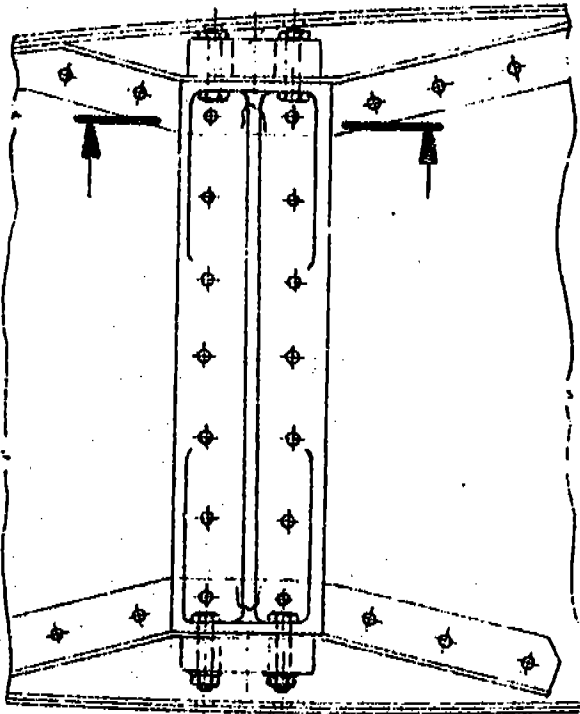
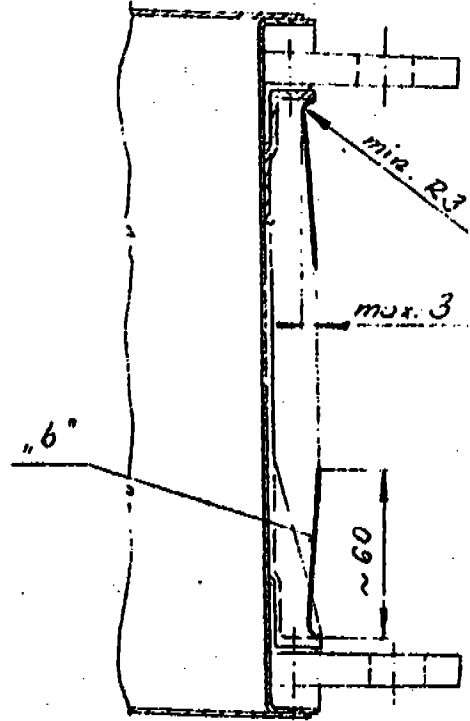
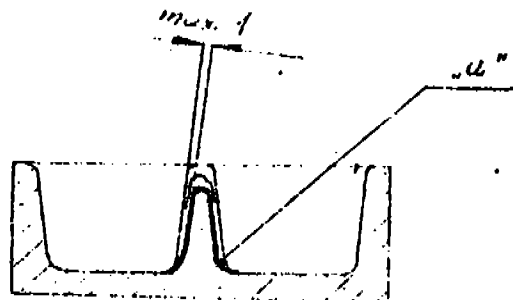
1. Remove wings from fuselage.
2. Put wing on trestles and support it so that it does not move.
3. Remove anodic coating using the chemical solution as per item 1 and inspect spacers using magnifying glass. Probable occurrences of laps is indicated by signs (see figure 1)
4. Should any laps be found remove them by means of a suitable tool (preferably a taper cutter fitted in an electrical hand drill).
Maximum amount of material to be removed is shown on figure 1.
5. Clean the worked surfaces and transition radii by means of fine emery paper.
6. Coat the cleaned surfaces with the above chemical solution and check for laps. After 5 minutes wash off with water. After drying degrease the spacer and paint with two coats of zinc chromate primer.

2. KEY TO FIGURE 1:

Probable occurrence of laps:

"A" - side face, lap may be removed to the bottom of spacer;

"B" - gentle run-out to be made after removal of laps.
