AIRWORTHINESS DIRECTIVE GLIDERS: G.F.A. AD 115 glaser dirks 4

GLIDER TYPES AFFECTED: DG100 GW Nr.5 and 21 to 103

SUBJECT: Elevator control (bearing stand RU 19)

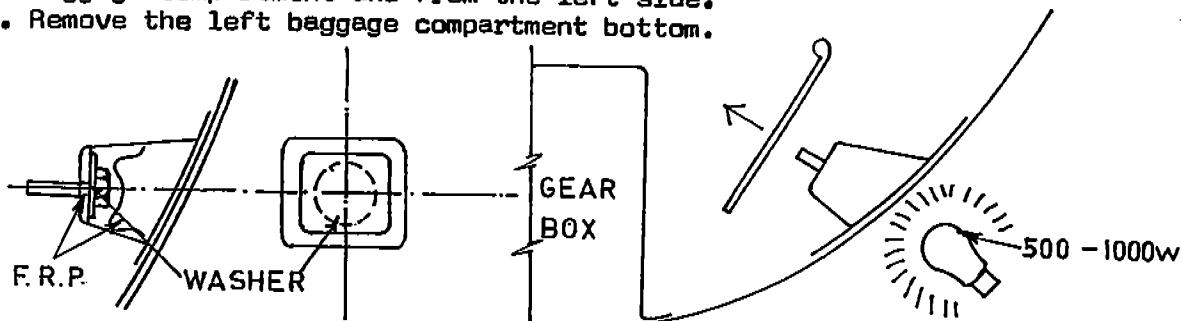
REASON: If a washer 6.4 DIN 9021 is not installed in the bearing stand RU 19 it is possible that the elevator control lever might loosen.

1. To carry out the works the fuselage must be accessible from the baggage compartment and from the left side.
2. Remove the left baggage compartment bottom.

INSTRUCTIONS: Check if a washer 6.4 DIN 9021 (outside diameter 18 mm) is installed in the bearing stand. If no washer is visible you have to exchange the bearing stand according to repair instruction 11/5/78.

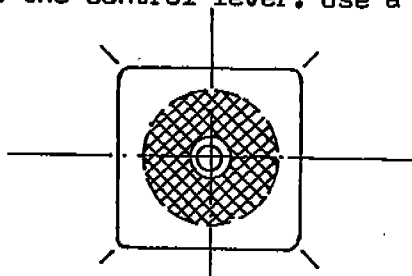
3. Remove the self locking nut M6 DIN 985 from the bearing stand and draw off the control lever.
4. Take a powerfull lamp (500 to 1000 watt) hold in against the fuselage from the outside and shine through the bearing stand. To prevent heating of the fuselage shell illuminate only for a short period. Carry out the inspection in a darkened room.
5. Look at the bearing stand from the baggage compartment.
6. (a) If the washer with 18 mm outside diameter is visible you may reassemble the control lever. Use a new self locking nut M6 DIN 985.

6. (b) If no washer is visible but the F.R.P. reinforcement is appearing constantly dark the bearing stand has to be exchanged according to repair instruction 11/5/78. Reassemble the control lever. After the exchange readjust the elevator control (see Service Manual page 22/23) if necessary. Take care that the control rod ends are not unscrewed too far!
7. Check the elevator control for free movement and proper operation.
8. Reinstall the baggage compartment bottom.

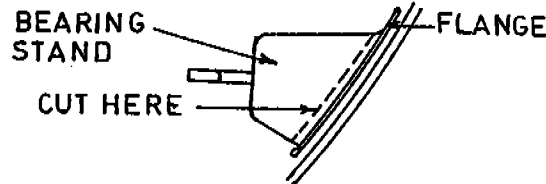
1. Disassemble the elevator control lever from the bearing stand.
2. Mark centre line locations of bearing stand at right angles on the fuselage shell with pencil to permit relocation of new bearing stand.
3. Cut away the bearing stand from the fuselage with a flexdisc taking care not to cut into the fuselage shell.

4. Abrade the flange of the bearing stand until the fibreglass of the flange is completely removed. DO NOT ABRADe THE FUSELAGE SHELL.
5. Sand the new bearing stand. For gluing, coat the bearing stand and the fuselage with mixed resin. Then put resin filled with chopped cotton fibres approximately 5mm thick on the bearing stand. Push the bearing stand against the fuselage shell. Wipe off excess surplus filled resin.
6. Let the resin cure a minimum of 12 hours at a minimum temperature 20 degrees C room temperature.
7. Reassemble the elevator control lever. Use a new self locking nut M 6 DIN 985.
8. Check the elevator displacements and readjust the elevator control if necessary (see Service Manual page 22).
