## AIRWORTHINESS DIRECTIVE

Pik 20 All variants

Cracks in lower rudder hinge

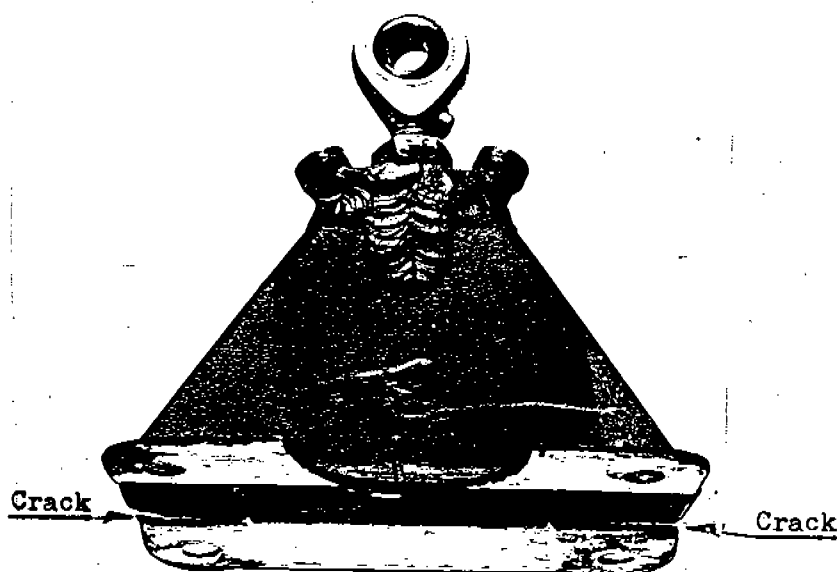
Inspection of a Pik 20D revealed cracks in the bend zone of the lower rudder hinge attached to the fin post. It is suspected that flapping of the rudder in the wind while the glider was tied down may have been a contributing factor, but also the fact that in the subject fitting it appears that the bend was made along the "grain" of the material.

Crack length limit of 15mm removed. Heavy landings are known to contribute to this problem, which since 1980 has been found extensively overseas and in Australia.

At every Form 2, and following ground loops or heavy landings, rudder hinge is to be inspected for cracks in the areas shown in the illustration. The inspection may be carried out by the holder of an Airworthiness Inspector Certificate DOA 1109 endorsed for replacement of components or higher rating. (any type). If cracks are present, the fitting may be repaired by welding carried out by an approved aircraft welder, or replaced with a new bracket.
