AIRWORTHINESS DIRECTIVE GLIDERS/POWERED SAILPLANES: GFA AD/198 BRASOV 5
ISSUE 2
DATE 13th October, 1981

GLIDER/POWERED SAILPLANE AFFECTED: 1S-28B2

SUBJECT: Ailerons & system rigging

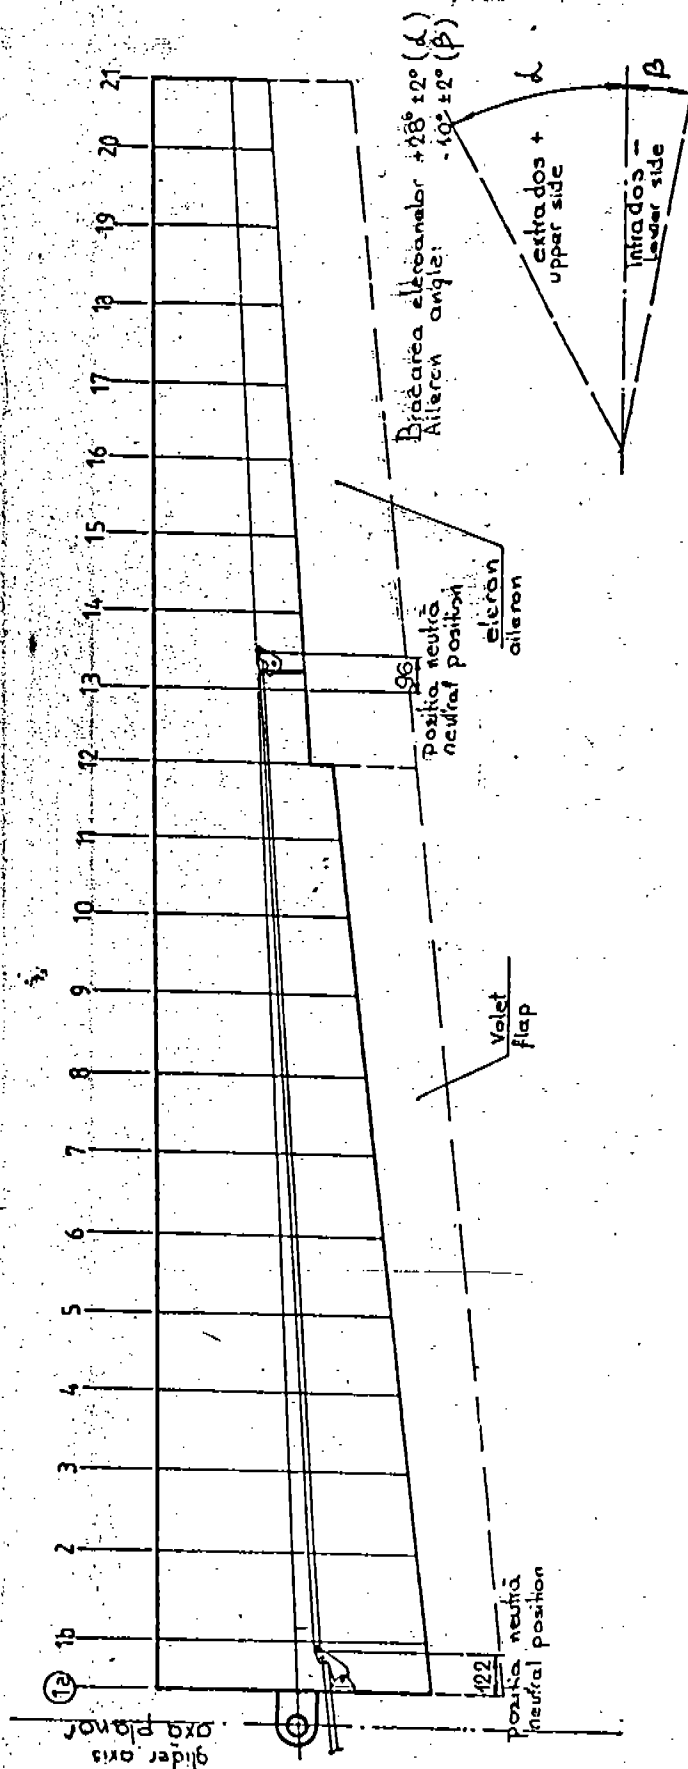
SHT 2 OF 2

Issue 1, dated 23/4/81, contained data provided by the Manufacturer which has proven to be incorrect. This issue fully replaces Issue 1 with new aileron system rigging data shown on sheet 2.

A number of operators of 1S28 B2 gliders have reported unpleasant handling characteristics when flying in turbulent conditions such as when passing through the tug aircraft's slipstream or in thermalling flight. Investigation has revealed discrepancies in the rigging adjustments in the aileron control circuits. However the glider's maintenance manual does not contain sufficient information to fully define correct adjustment.

Reglarea tijelor in pozitia neutra la c-a eleron in aripa Setting rods in neutral position aileron controls in wing

1. The attached illustration "positioning of aileron control levers "0" position" is to be inserted in the maintenance manual.
2. A check to ensure correct adjustment is to be made within 25 further hours in service and push rod length adjustment made as, and if, necessary.
