THE GLIDING FEDERATION OF AUSTRALIA

AIRWORTHINESS DIRECTIVE GLIDERS/POWERED SAILPLANES.

GFA/AD 218
SZD 21
Issue 1
23/11/1981
Sheet 1 of 2

Reinforcement of the central rib supporting the elevator in
the trailing part of the stabiliser.

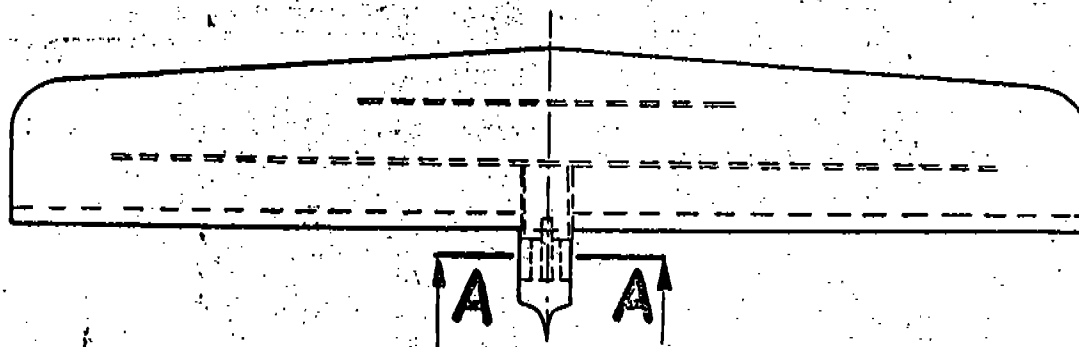
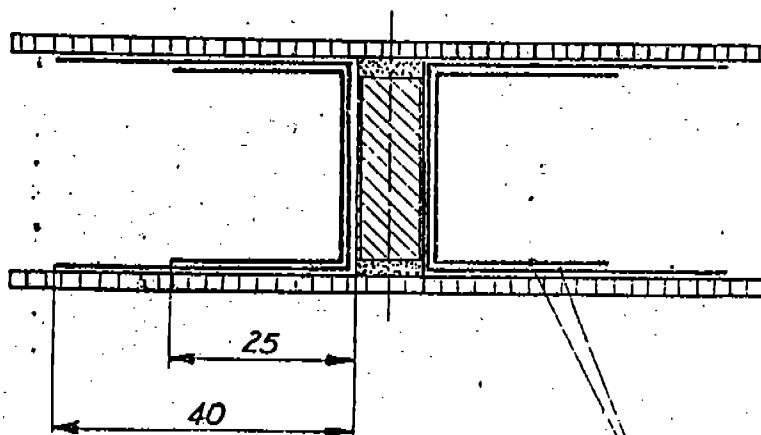
BULLETIN No BA-011/81 "JANTAR"

X Reinforcement to extend along the rib as far as possible.

- (a) A thorough inspection is to be made of the centre rib area for
delamination. This must be repaired at the same time as the
structure is reinforced.
- (b) The centre section must be carefully prepared by thorough
degreasing and rubbing back with coarse paper.
- (c) The additional reinforcement sections are to be laid in,
following the instructions on Sheet 2.
- (d) When re-assembling the elevators check clearances carefully
in the centre rib area.
- (e) Carry out an Independent control check.
- (f) Full modification details to be entered into the log book.
- (g) Remove the speed limiting placard and sign off the restriction
of the Maintenance Release.
